## **APPENDIX B**

### **SITE RECONNAISSANCE PHOTOGRAPHY**

**Coronation Park  
November 21, 2013**

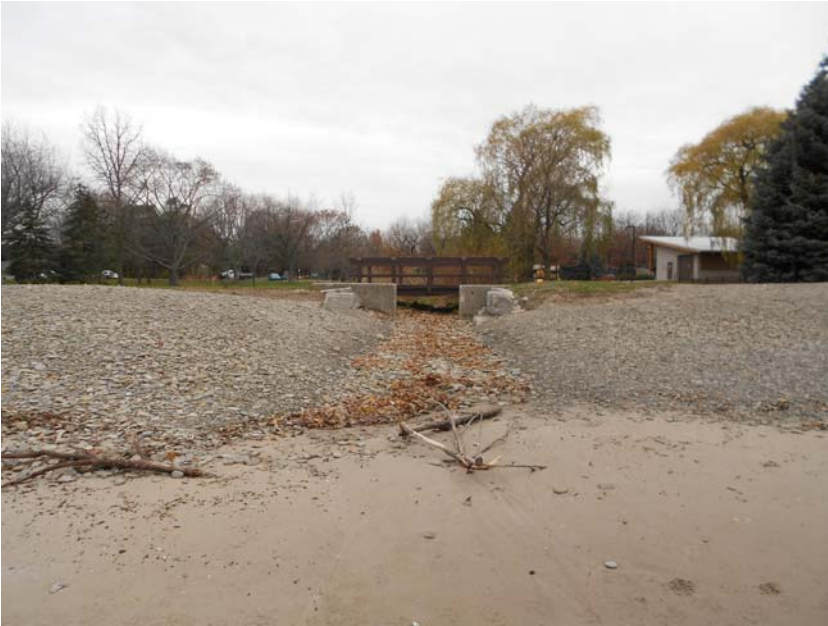
Photo 1: Looking upstream at channel and pedestrian bridge from Lake Ontario.

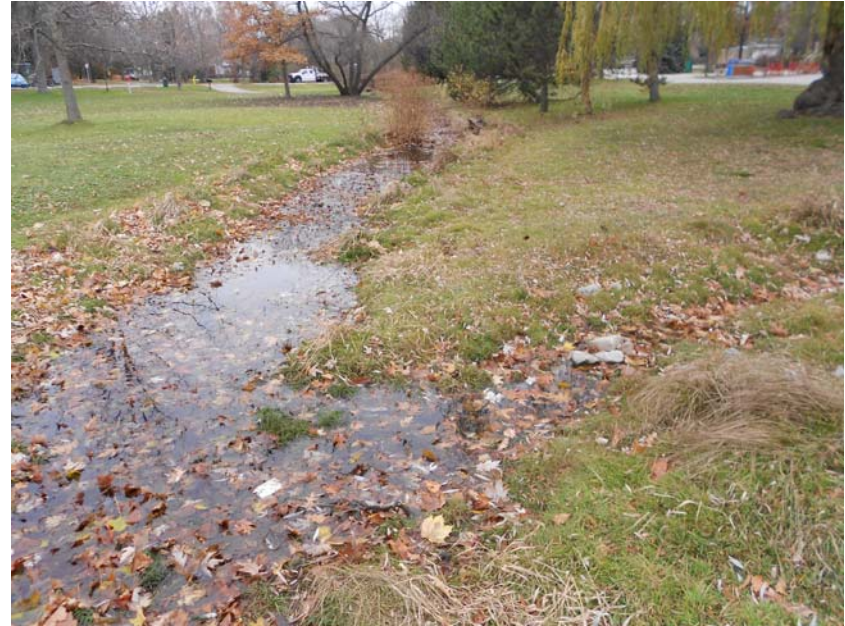
Photo 2: Looking upstream at channel.  
Note standing water.

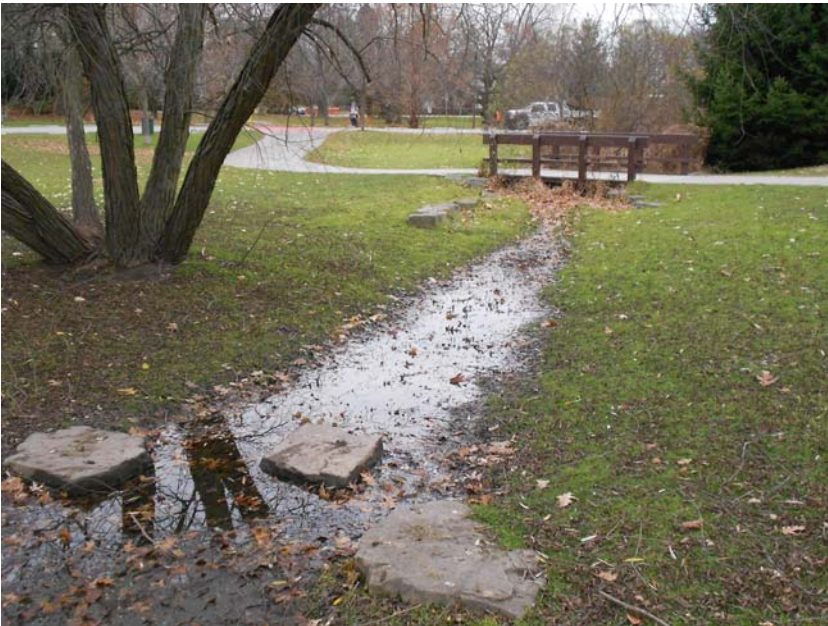
Photo 3: Looking upstream at channel and pedestrian bridge.  
Note standing water.

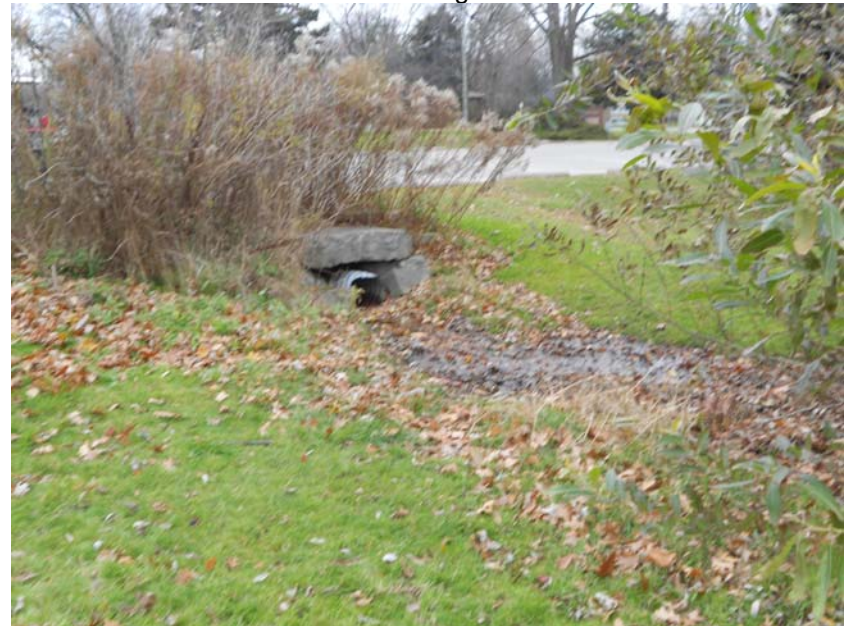
Photo 4: Looking upstream at culvert crossing of parking lot.  
Note standing water.

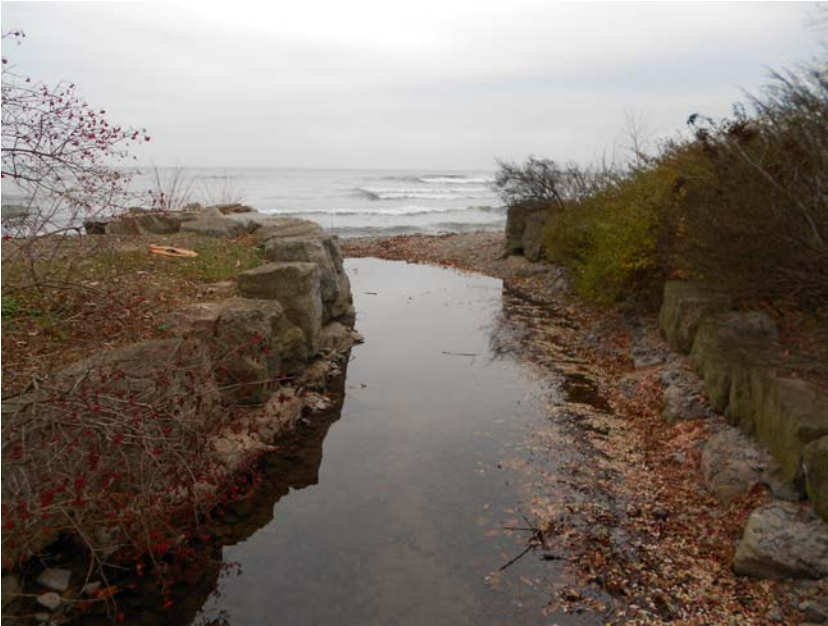
Photo 5: Looking downstream to Lake Ontario from pedestrian bridge.  
Note standing water.

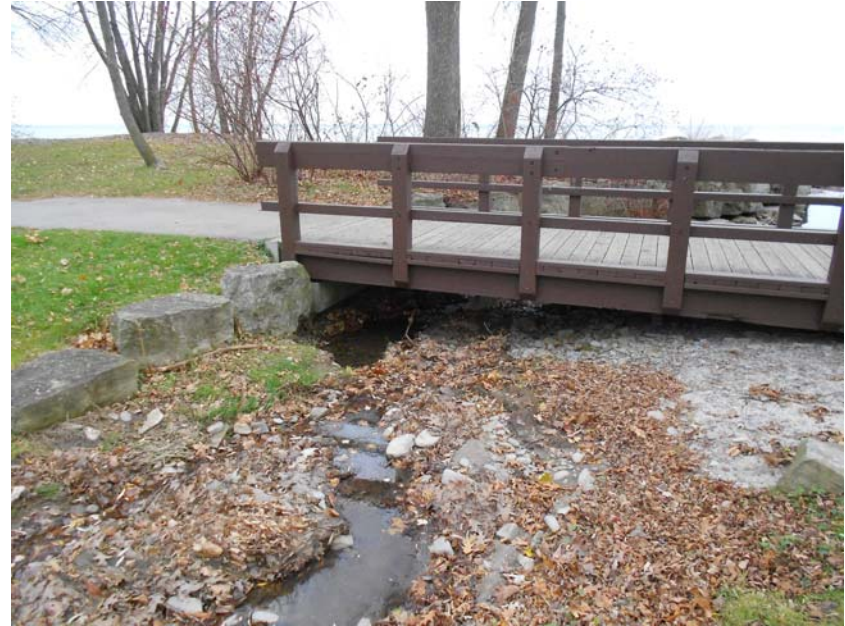
Photo 6: Looking downstream at pedestrian bridge.

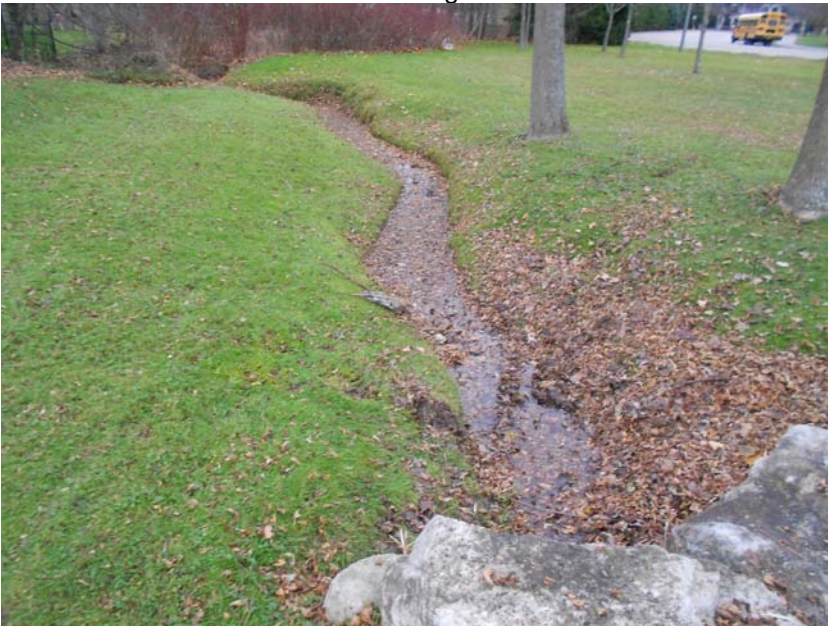
Photo 7: Looking upstream at channel.  
Note standing water.

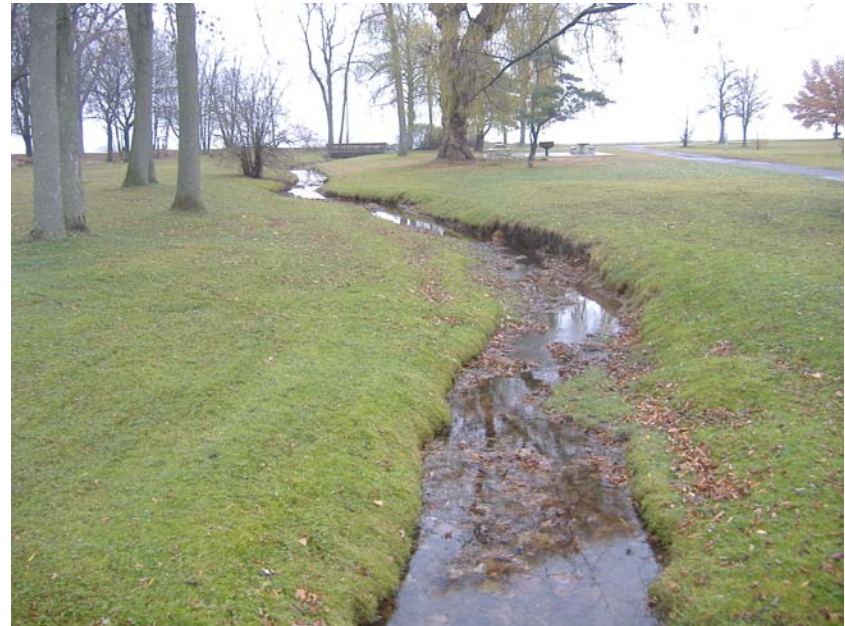
Photo 8: Looking downstream at channel from pedestrian culvert crossing. Note bank erosion and standing water.

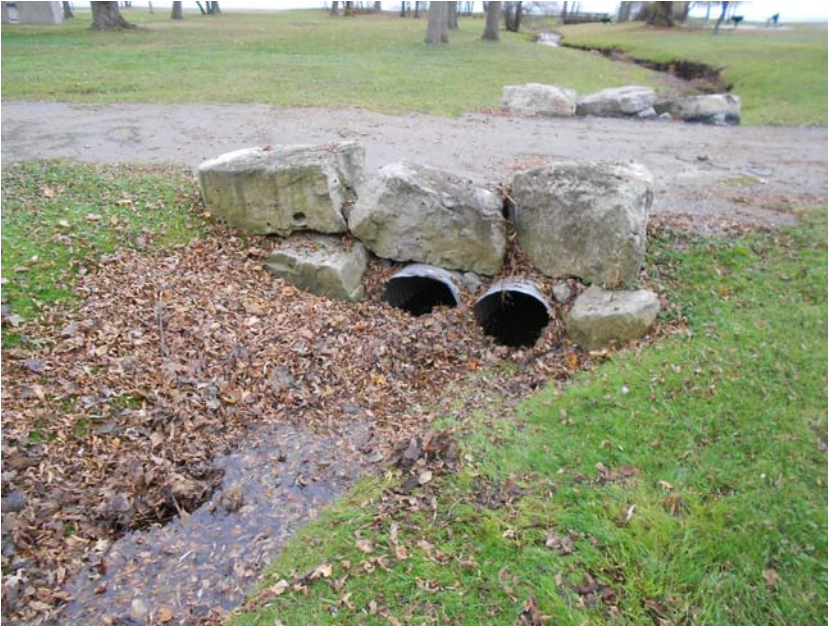
Photo 9: Looking downstream at culvert crossing. Note debris accumulation/blockage and standing water.

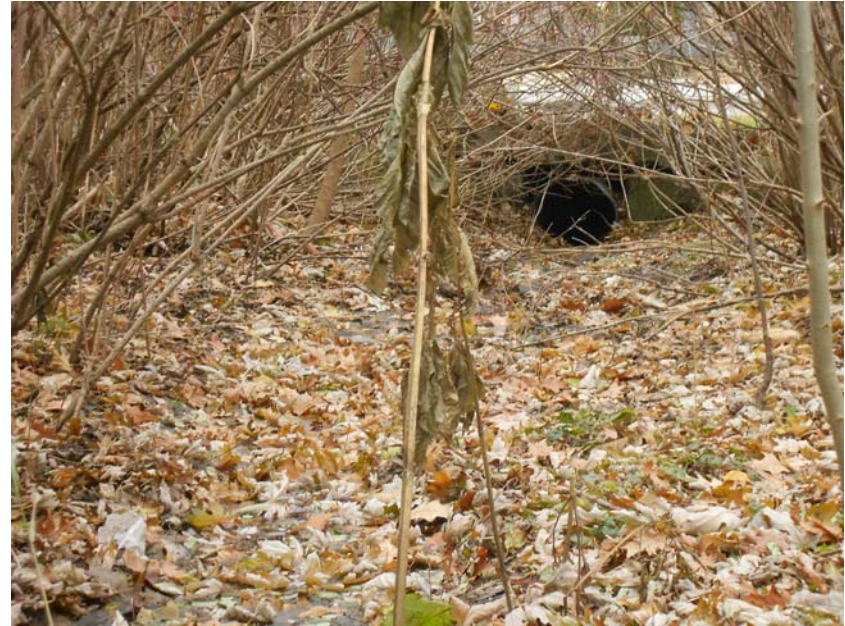
Photo 10: Looking upstream at culvert crossing.

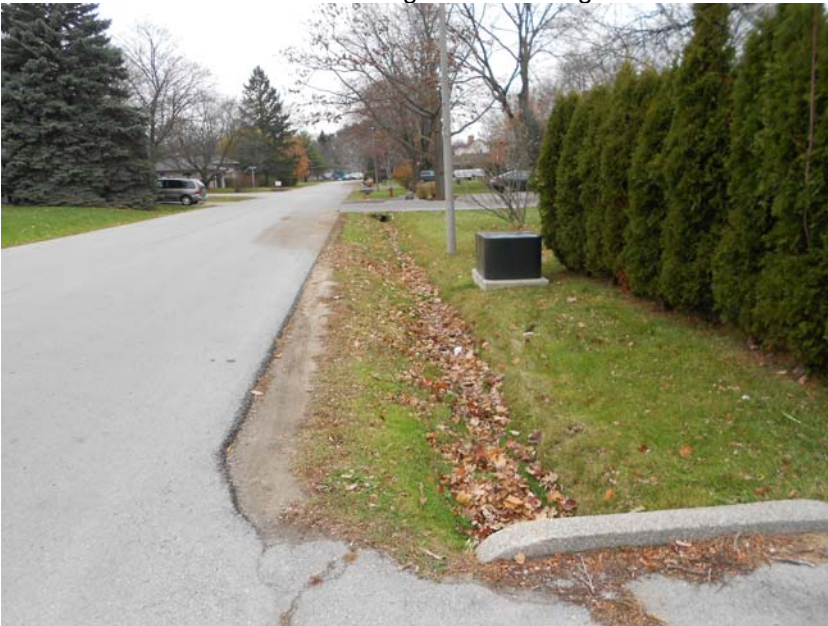
Photo 11: Looking upstream along east ditch of Westminster Drive.

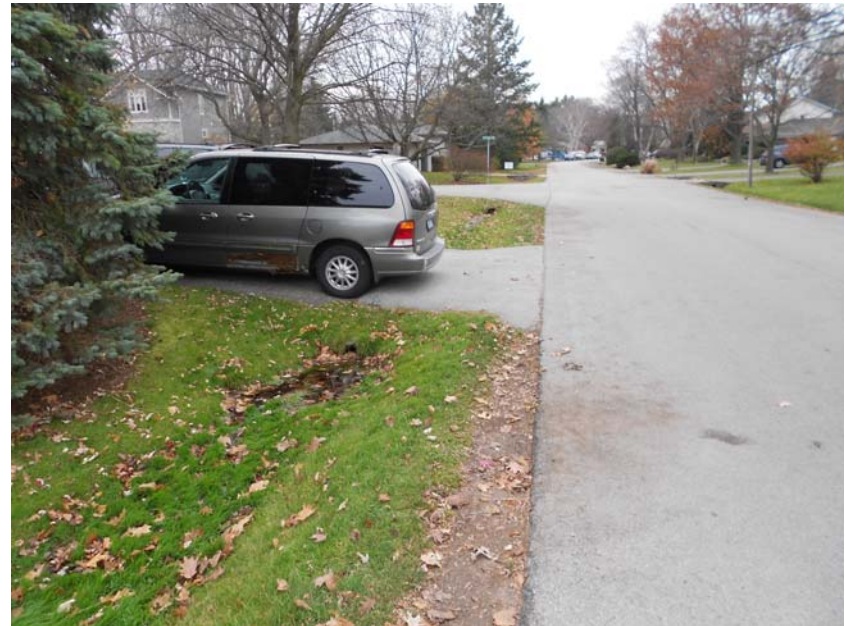
Photo 12: Looking upstream along west ditch of Westminster Drive. Note localized pooling and blocked culvert.

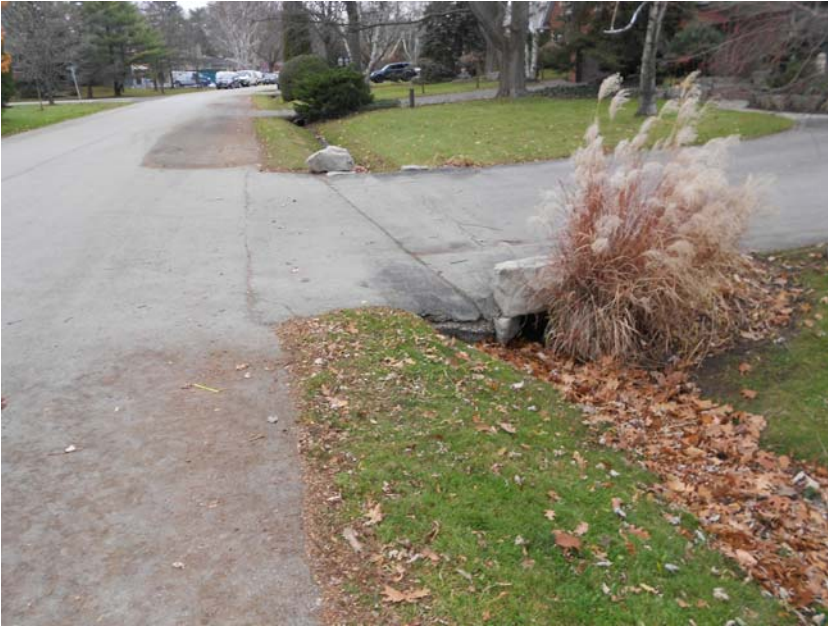
Photo 13: Looking upstream along east ditch of Westminster Drive.  
Note ditch plantings and culvert obstruction.

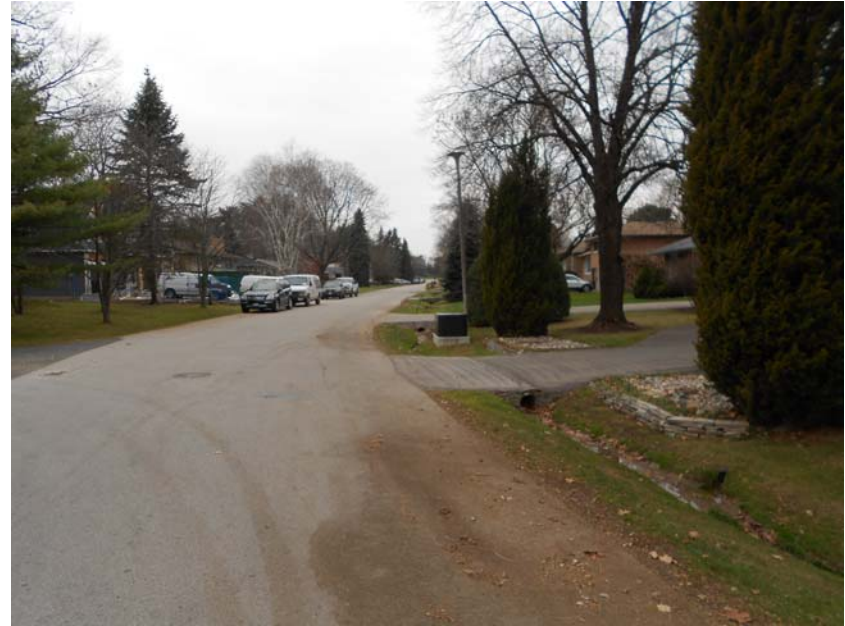
Photo 14: Looking upstream along east ditch of Westminster Drive.

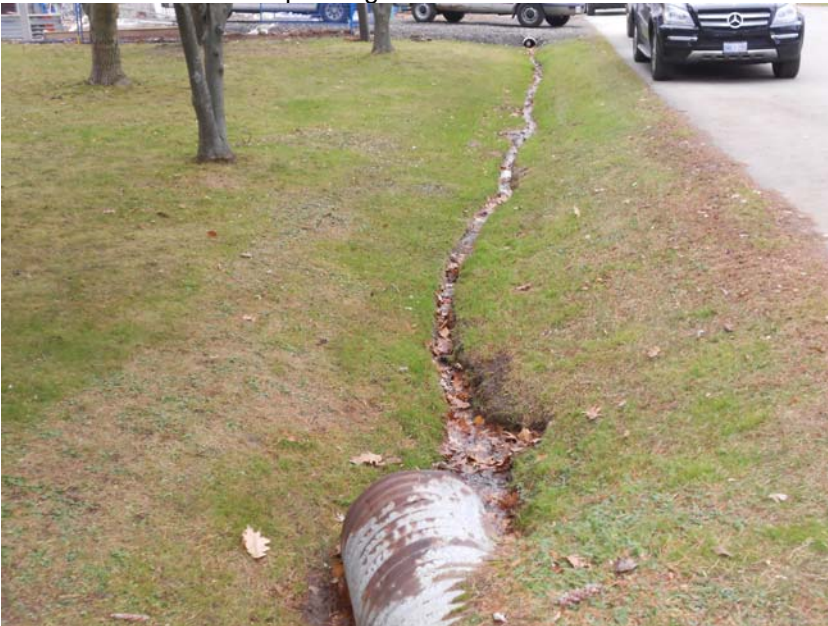
Photo 15: Looking upstream along west ditch of Westminster Drive.  
Note rutting erosion and skew culvert.

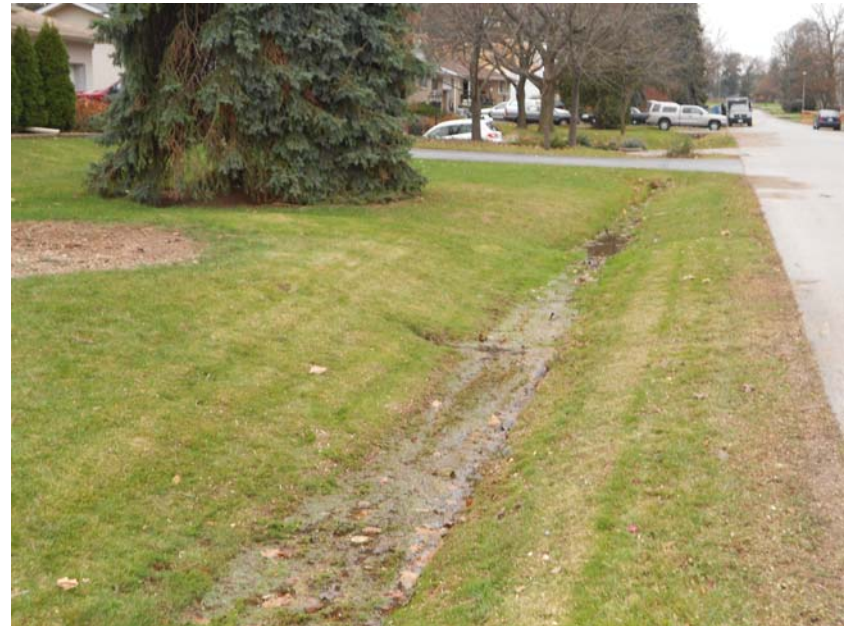
Photo 16: Looking upstream along west ditch of Westminster Drive.  
Note standing water in ditch.

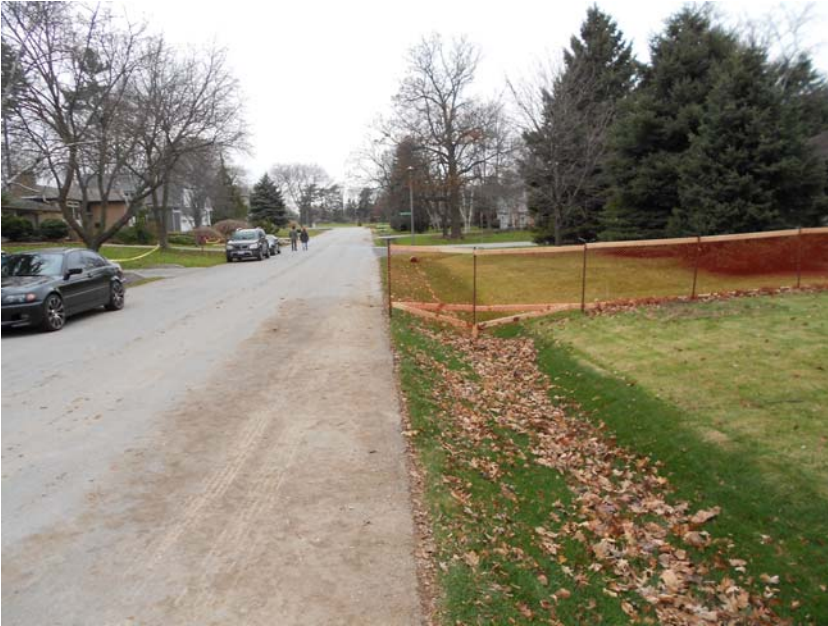
Photo 17: Looking upstream along east ditch of Westminster Drive.

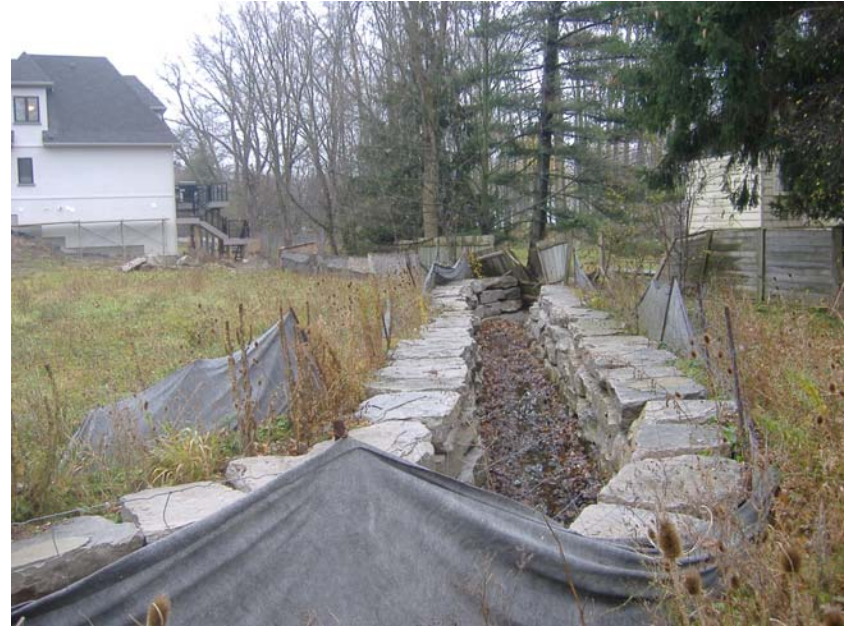
Photo 18: Looking downstream at recently constructed armour stone channel from Belvedere Drive.

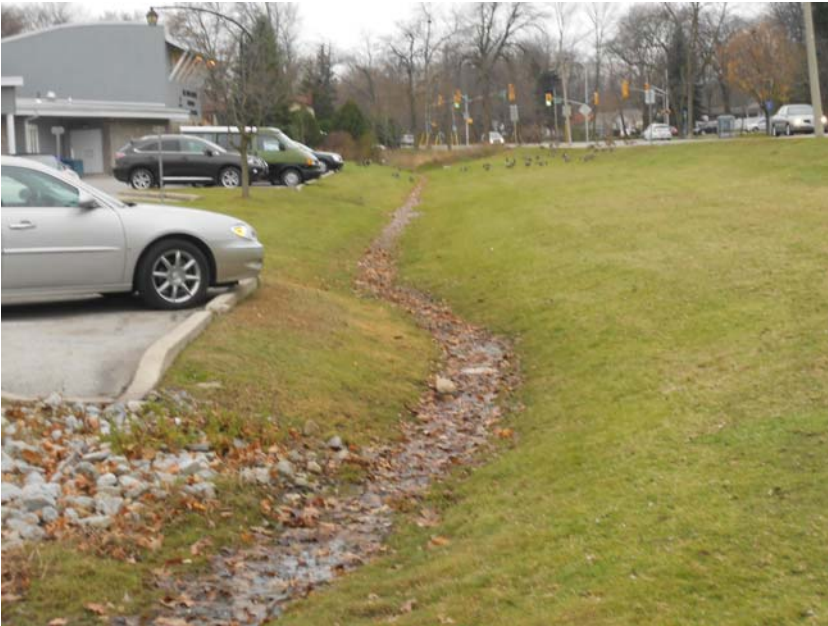
Photo 19: Looking upstream at open channel adjacent to Lakeshore Road. Note standing water.

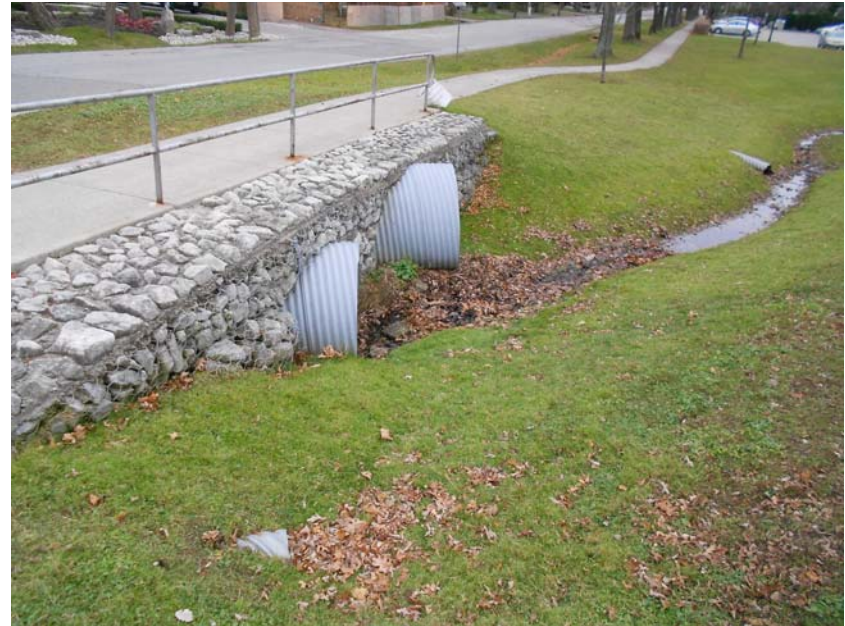
Photo 20: Looking at upstream face of culvert crossing of Old Lakeshore Road.

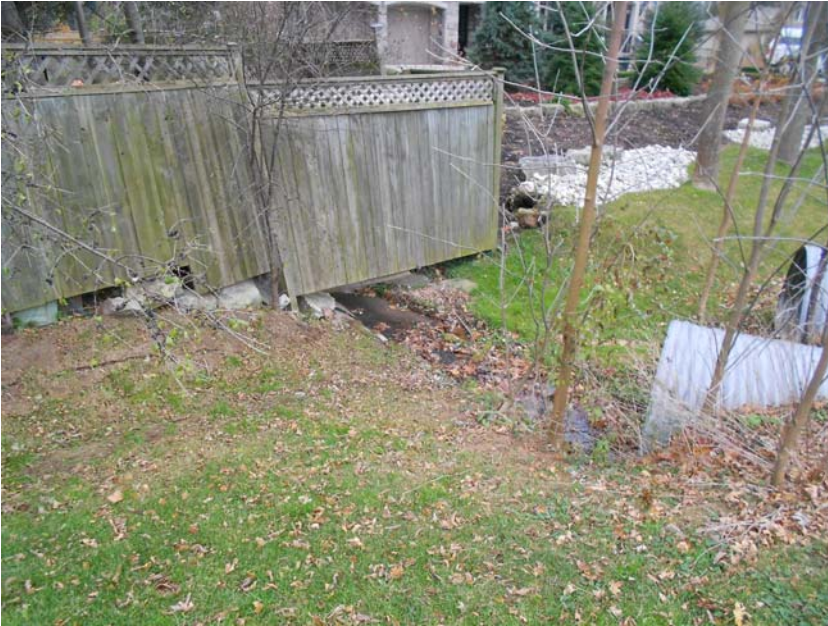
Photo 21: Looking at downstream face of culvert crossing of Old Lakeshore Road. Note flow obstruction (wooden fence).

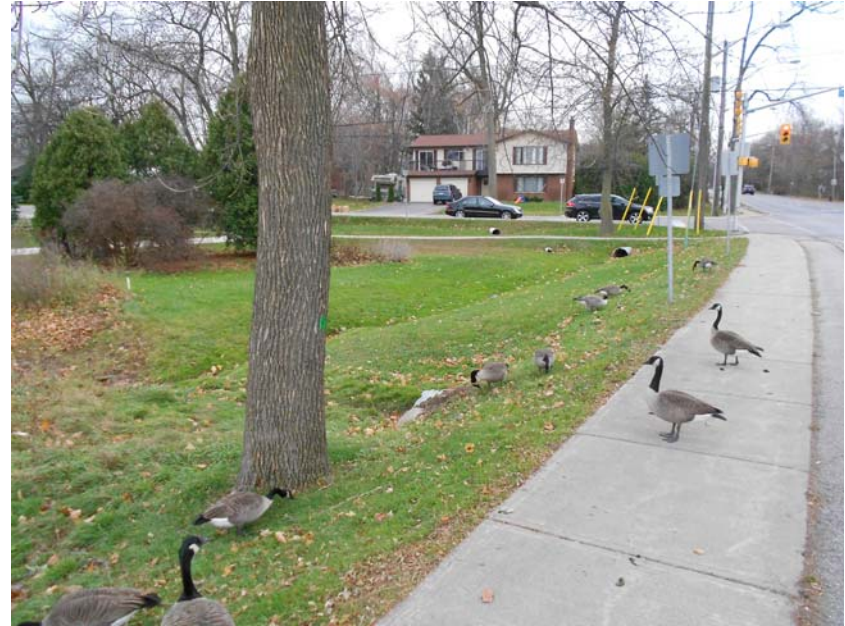
Photo 22: Looking upstream along south side of Lakeshore Road.

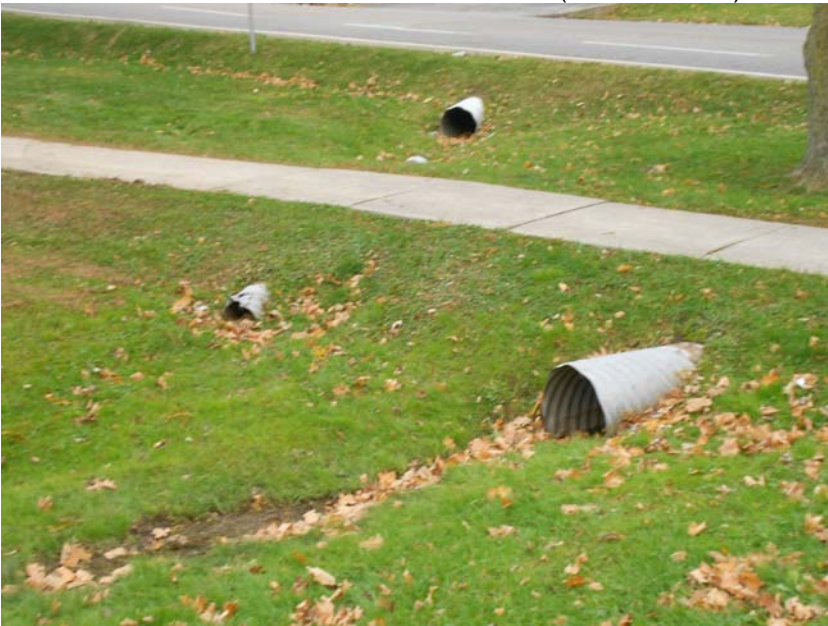
Photo 23: Looking upstream at south-east corner of Lakeshore Road and Third Line.

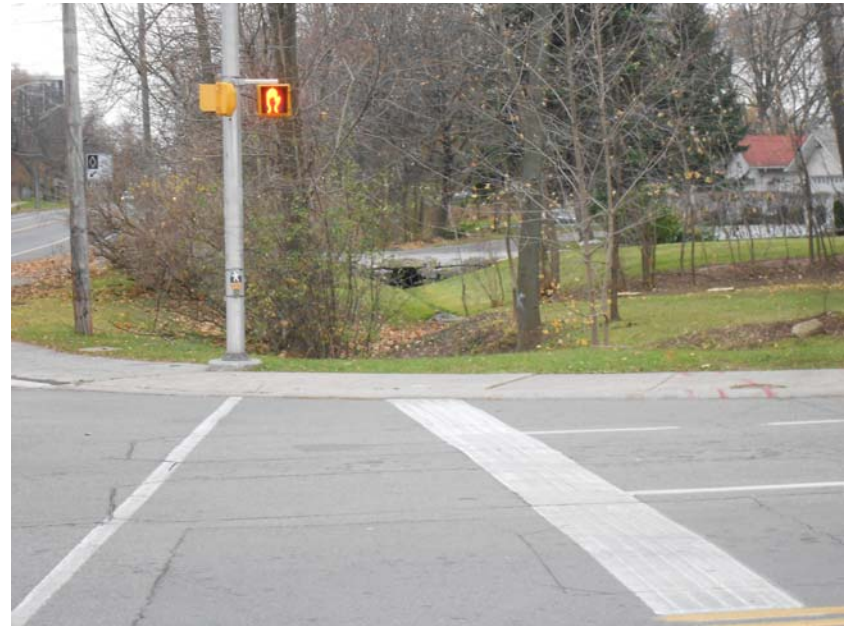
Photo 24: Looking west along Lakeshore Road across Third Line to open channel.

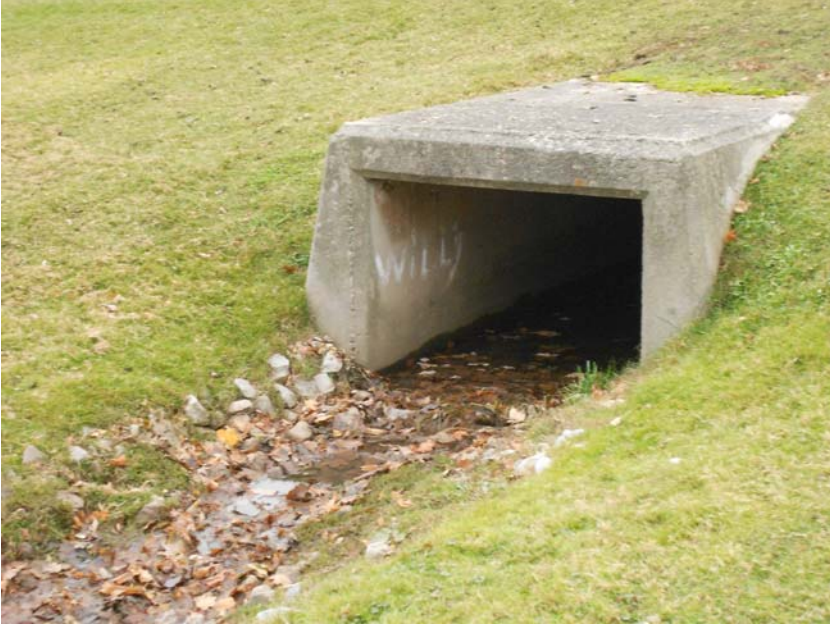
Photo 25: Looking at downstream face of culvert crossing of Lakeshore Road.

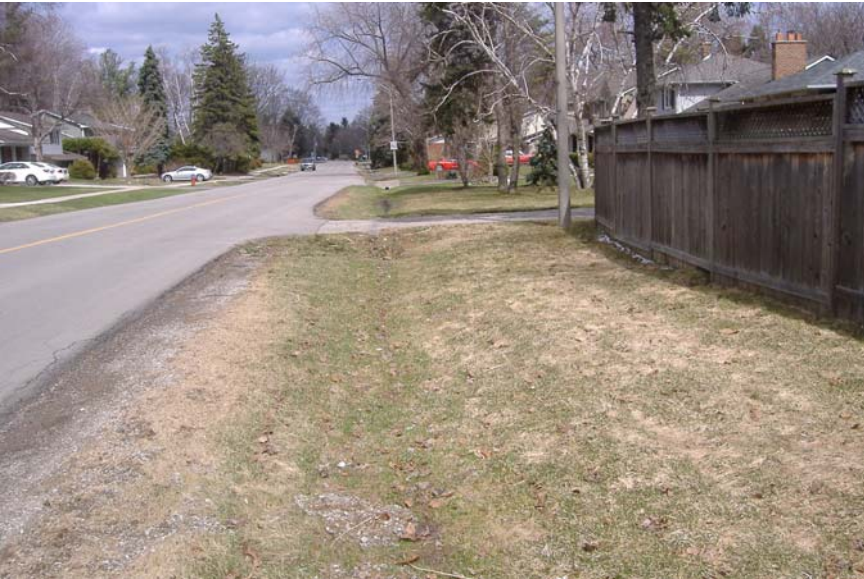
Photo 26: Looking east on south side of Hixon at Tracina.  
Note filled ditch/culvert.

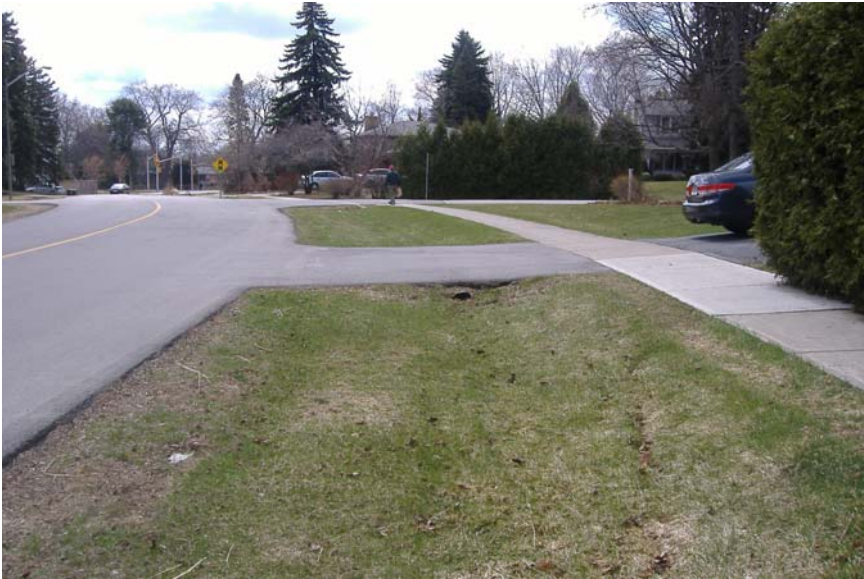
Photo 27: Looking west on north side of Hixon at Tracina.  
Note filled ditch/culvert.

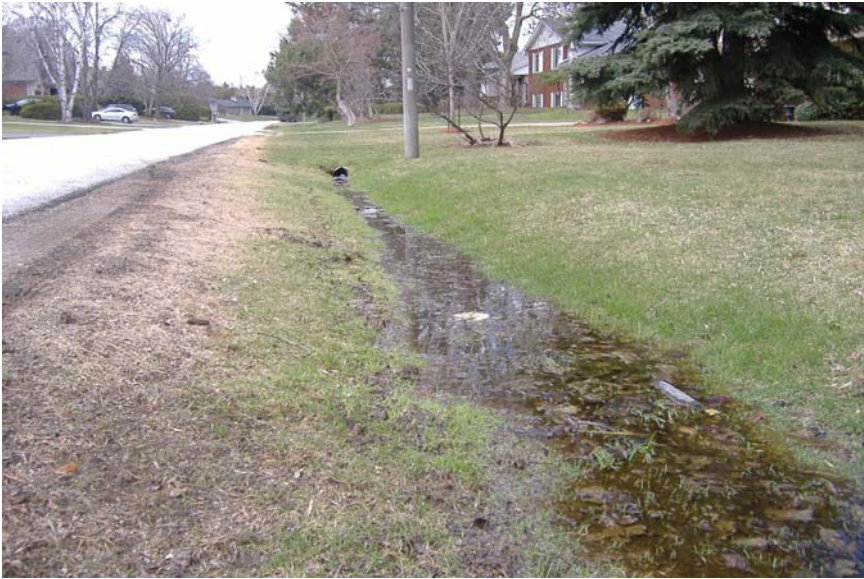
Photo 29: Looking north on Tracina at Hixon.  
Note standing water in ditch.

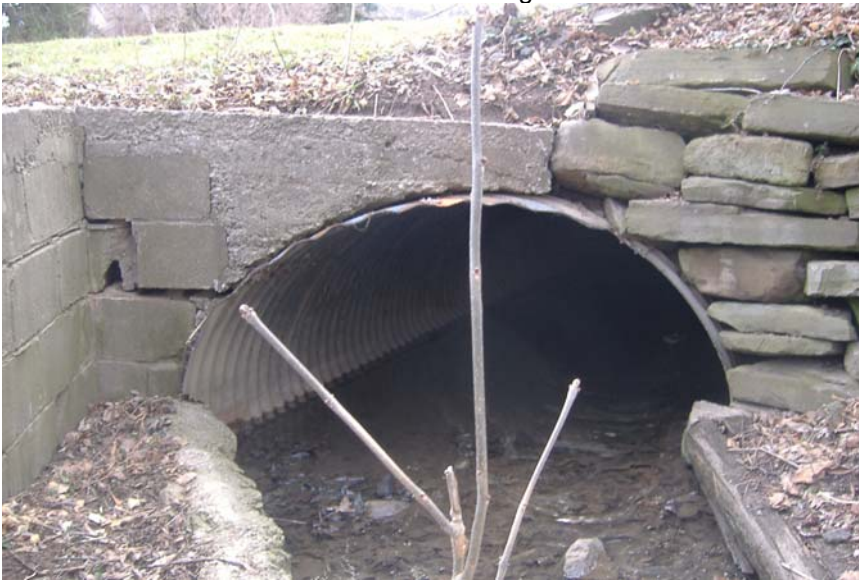
Photo 32: Looking at culvert outfall at Willowdown Road.

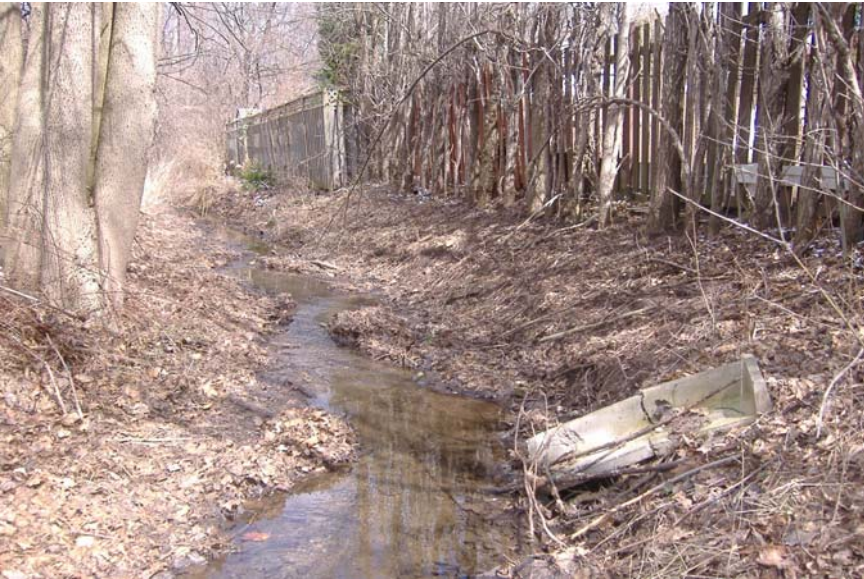
Photo 34: Looking downstream from Woodhaven Park Drive. Note minor bank erosion.

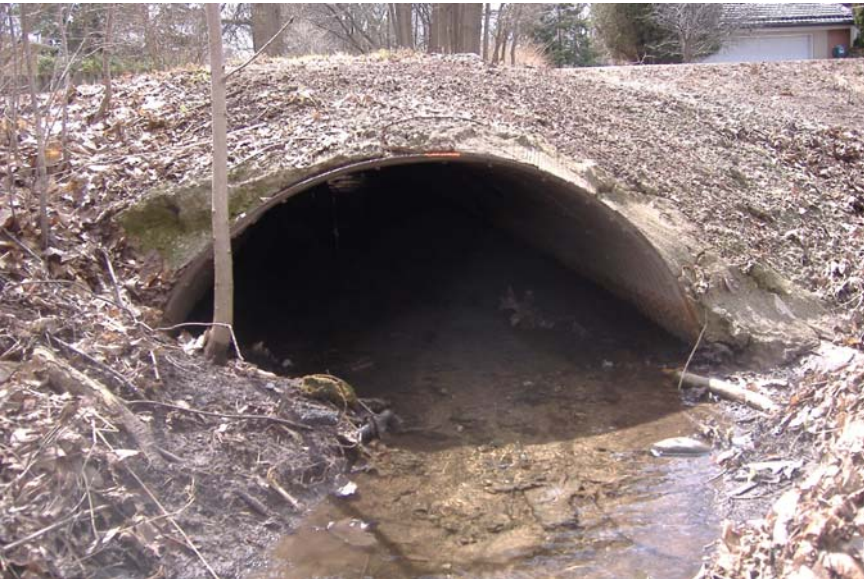
Photo 36: Downstream face of culvert at Woodhaven Park Drive. Note partial obstruction.

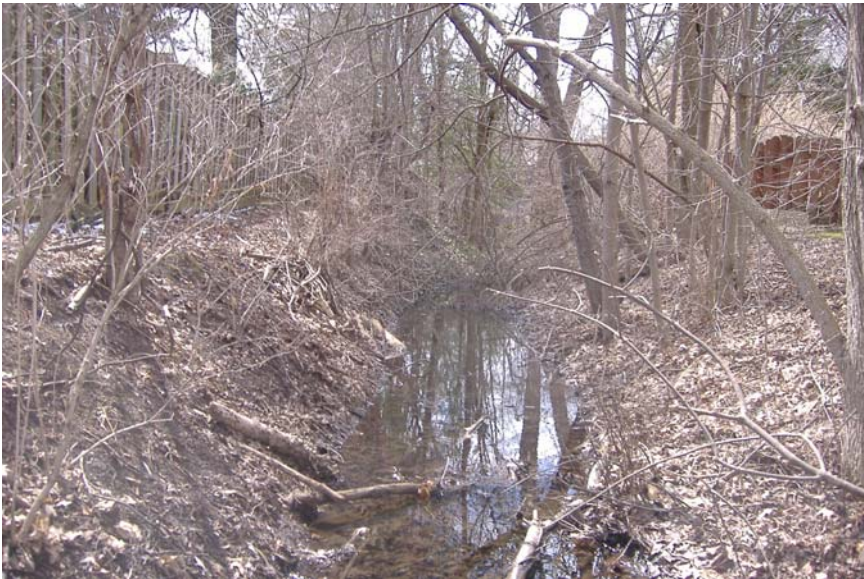
Photo 37: Looking upstream from Woodhaven Park Drive. Note minor bank erosion.

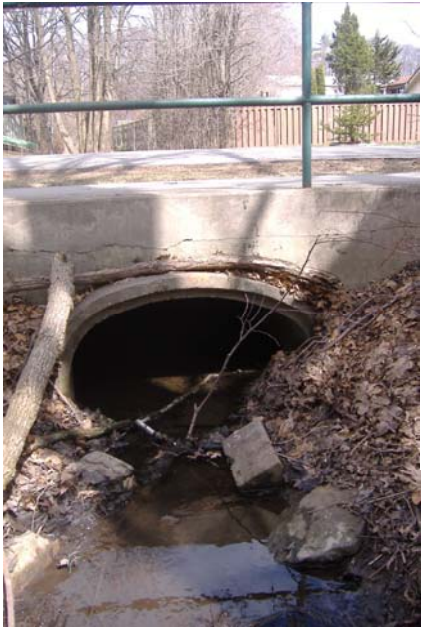
Photo 38: Upstream face of culvert at Woodhaven Park Drive.  
Note partial obstruction.

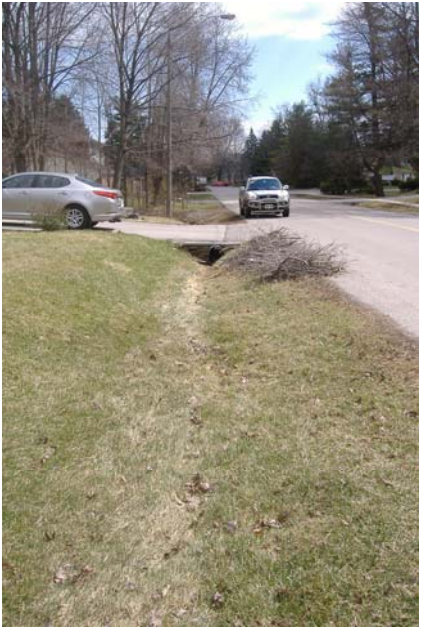
Photo 39: Looking south along Woodhaven Park Drive.

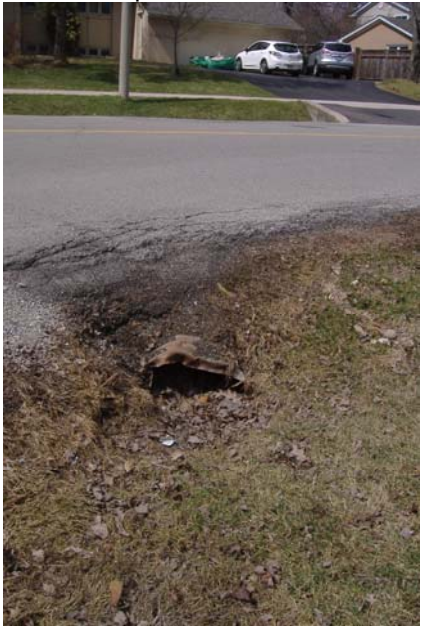
Photo 40: Downstream face of Sedgewick Crescent culvert.  
Note obstruction and crushing.

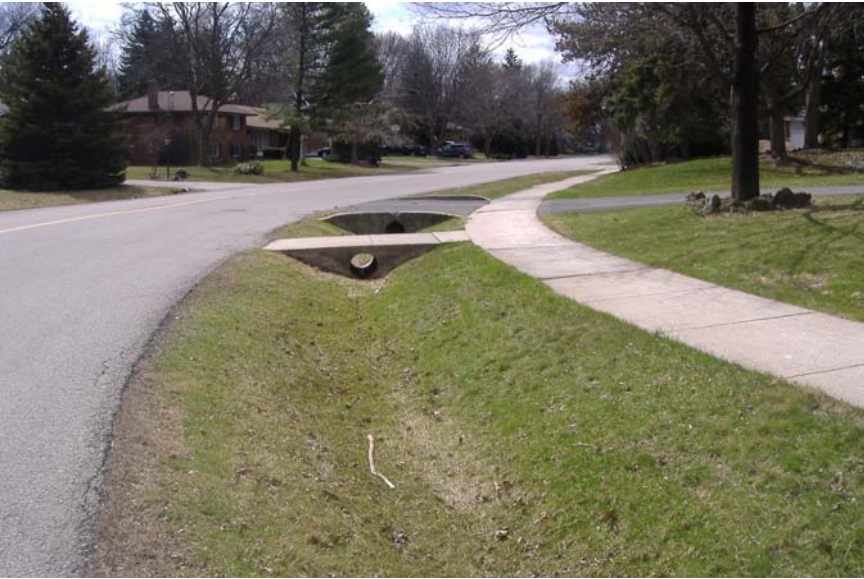
Photo 41: Looking west along Sedgewick Crescent.

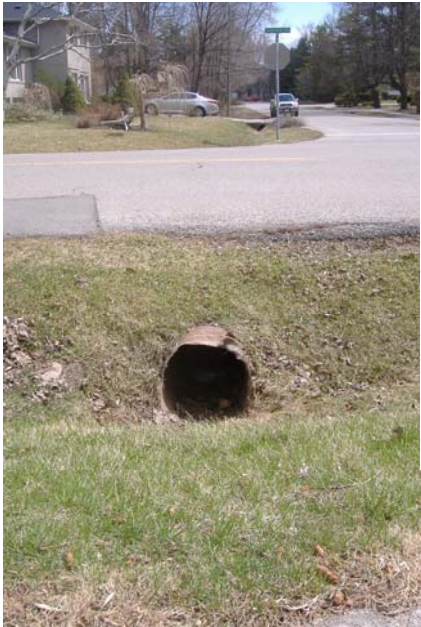
Photo 42: Upstream face of Sedgewick Crescent culvert.

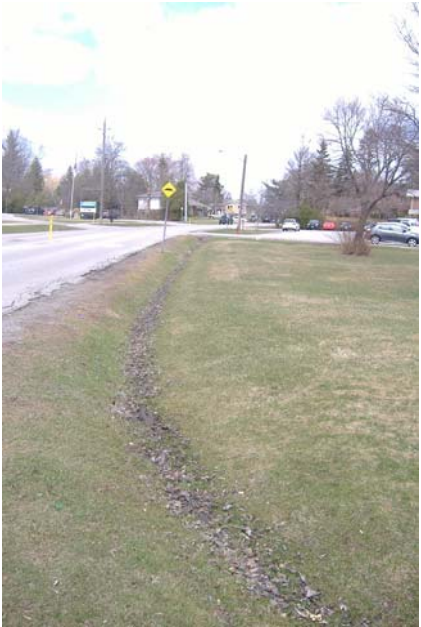
Photo 43: Looking east along Sedgewick Crescent.  
Note ditch erosion.

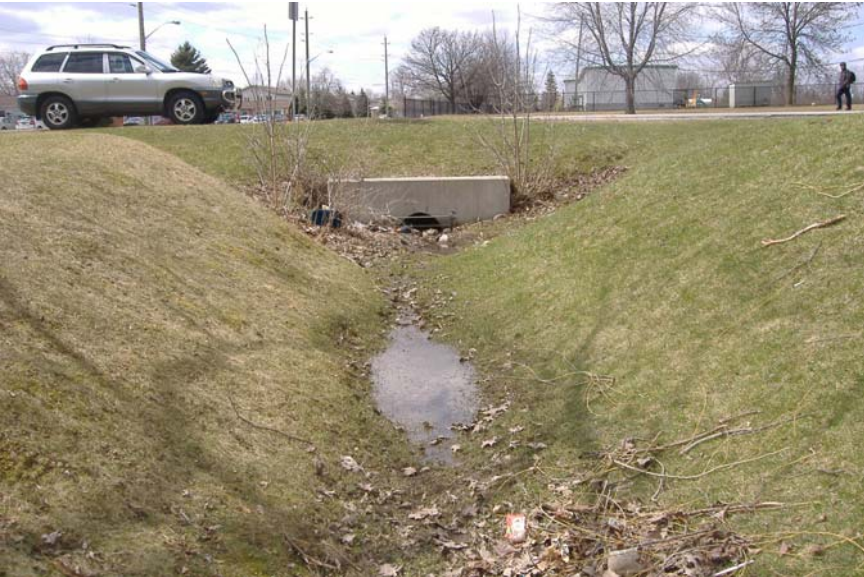
Photo 44: Looking upstream at culvert outfall.  
Note sedimentation and ponding.

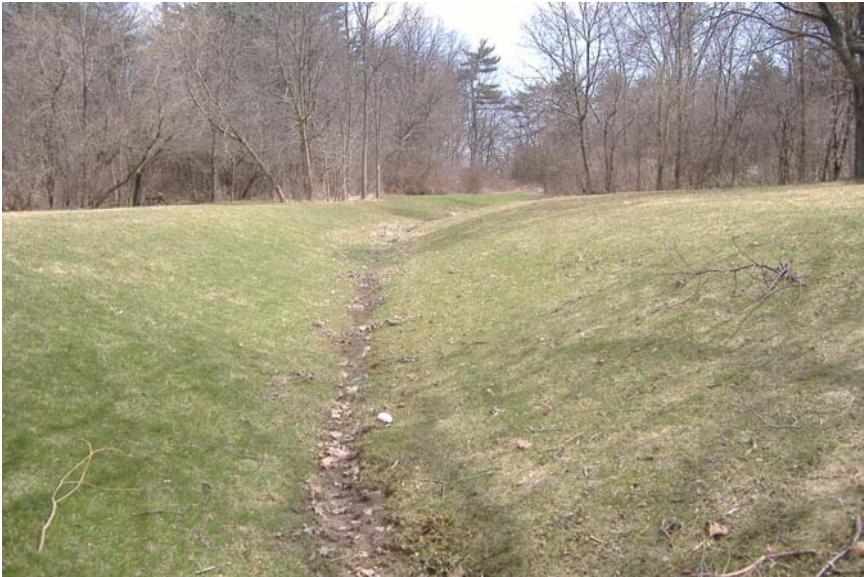
Photo 45: Looking downstream at outfall ditch.  
Note reverse slope.

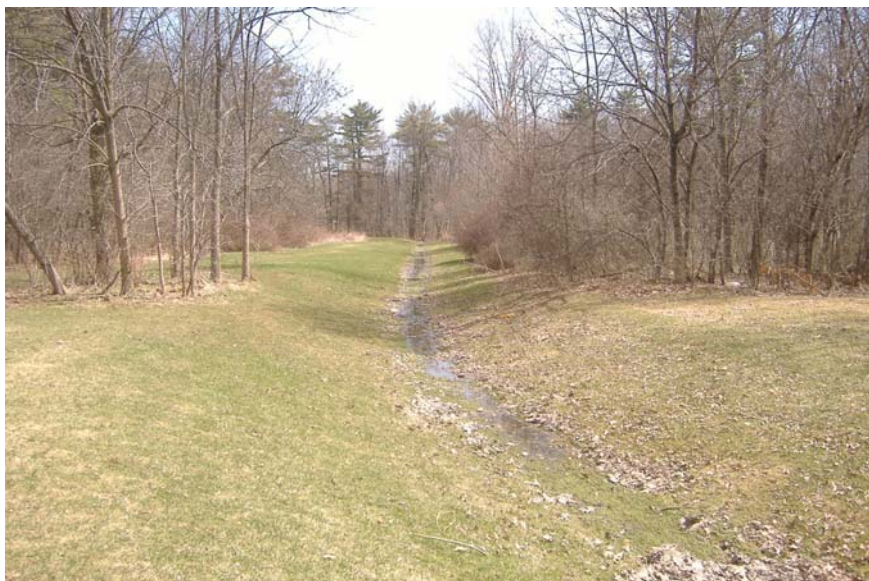
Photo 46: Looking downstream at outfall ditch.  
Note flat grade and standing water.

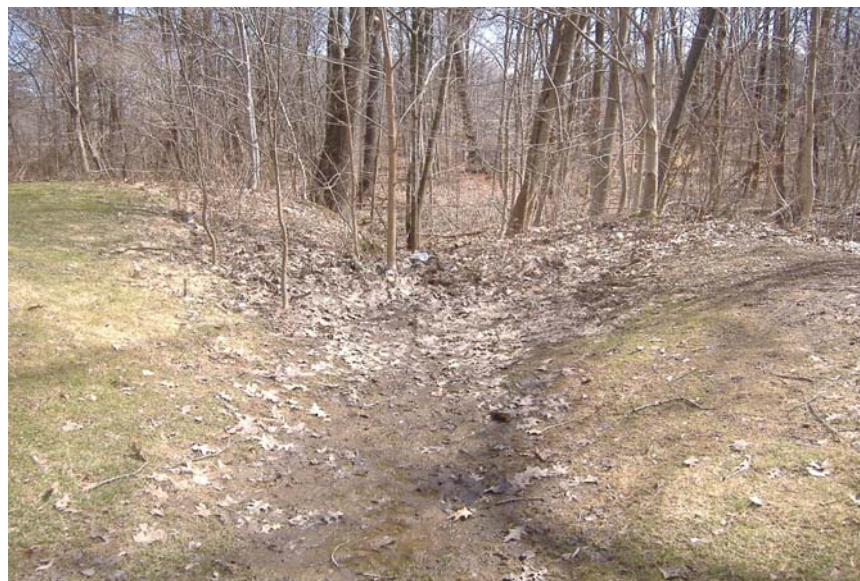
Photo 47: Looking downstream at ditch outfall to forest area.  
Note sedimentation.

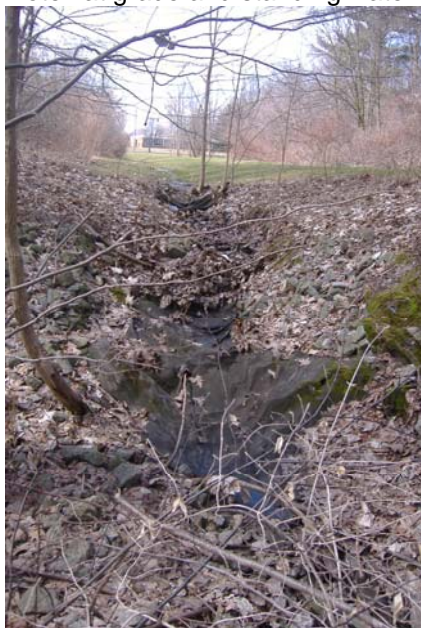
Photo 48: Looking upstream at ditch outfall.  
Note exposed erosion blanket and channel erosion.

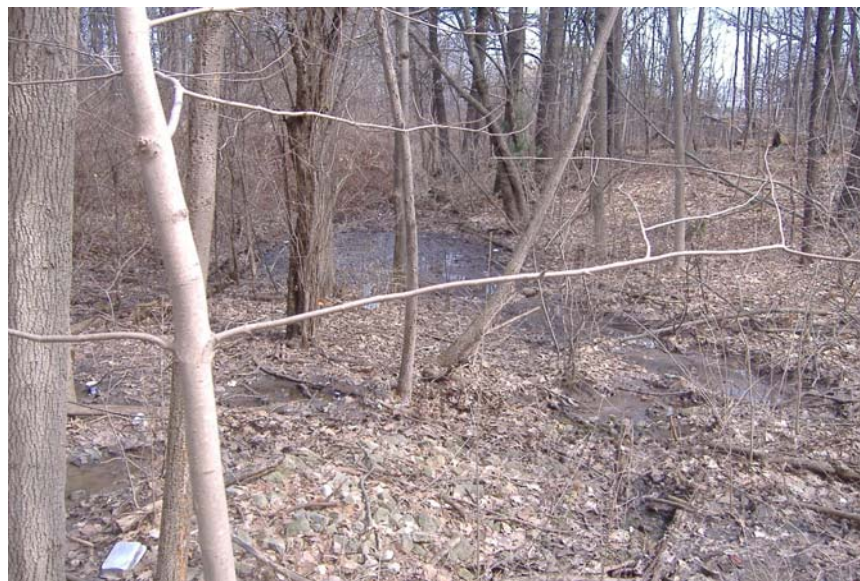
Photo 49: Looking downstream at forest area.  
Note flat area and lack of channel definition.

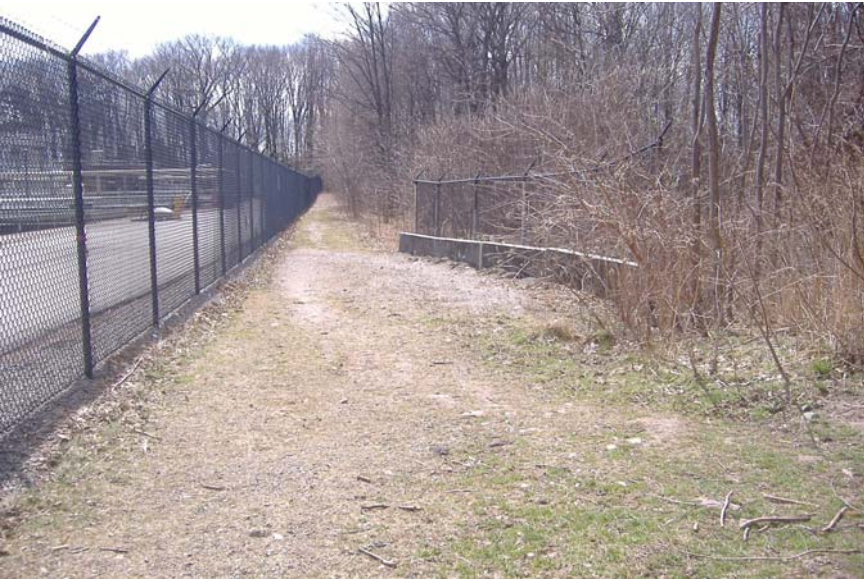
Photo 50: Looking downstream at headwall for culvert, and fence for WWTP site.

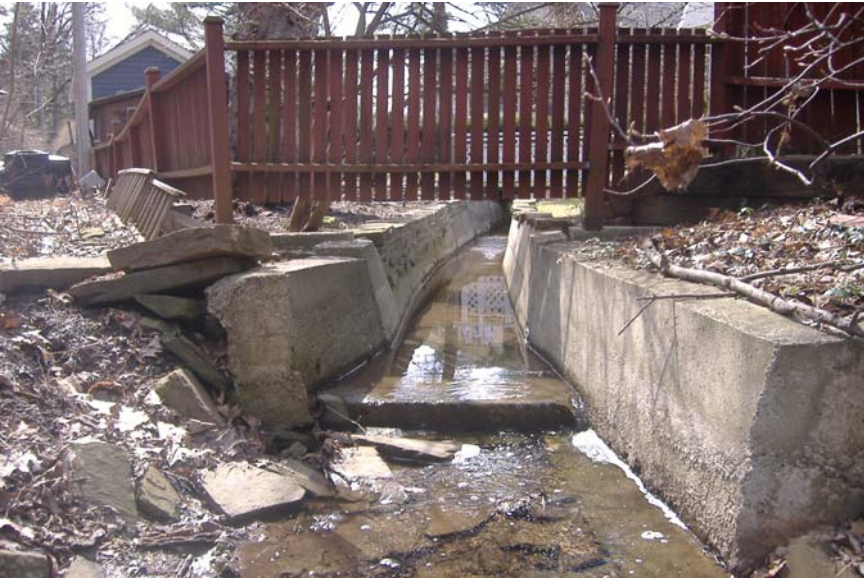
Photo 52: Looking upstream at concrete lined channel/storm outfall behind Hixon Street. Note debris accumulation.
