## **APPENDIX B**

### **SITE RECONNAISSANCE PHOTOGRAPHY**

**Coronation Park  
November 21, 2013**

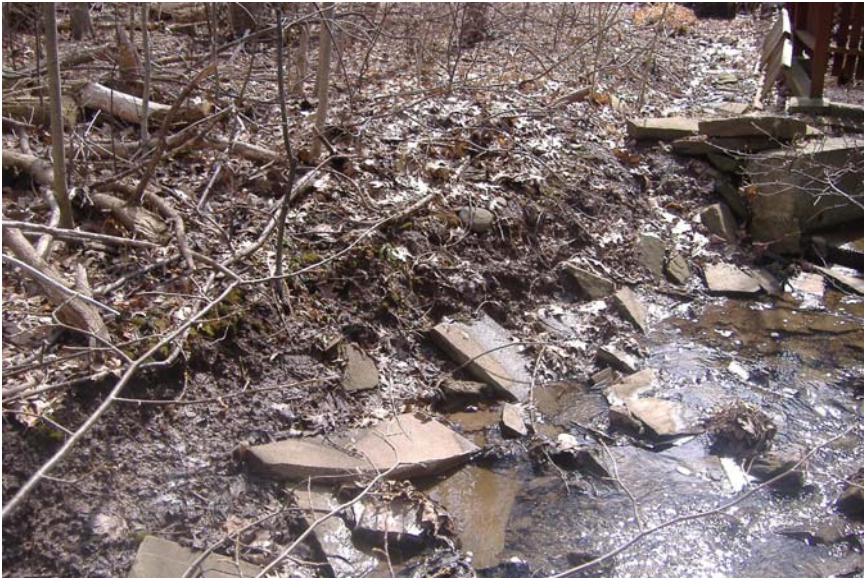
Photo 53: Looking at bank erosion adjacent to end of concrete lined channel behind Hixon Street.

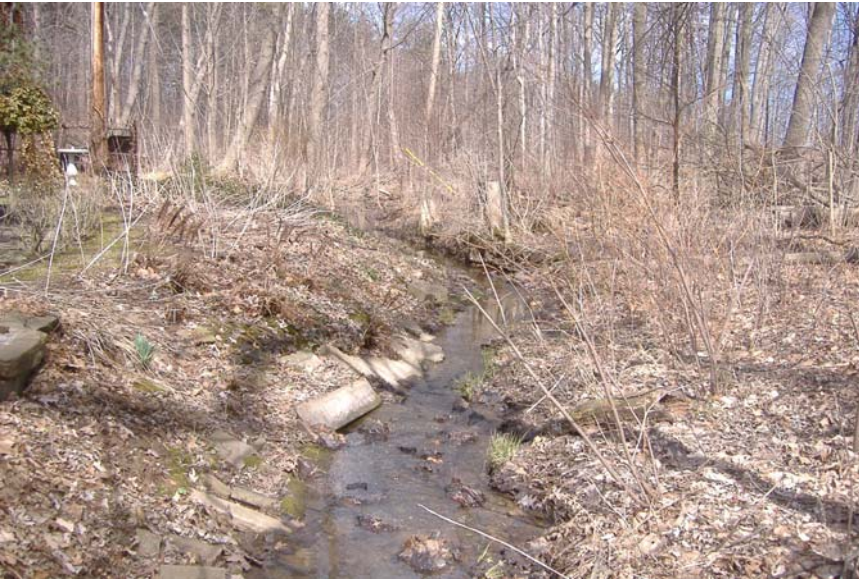
Photo 54: Looking downstream at open channel behind Hixon Street.  
Note bank erosion.

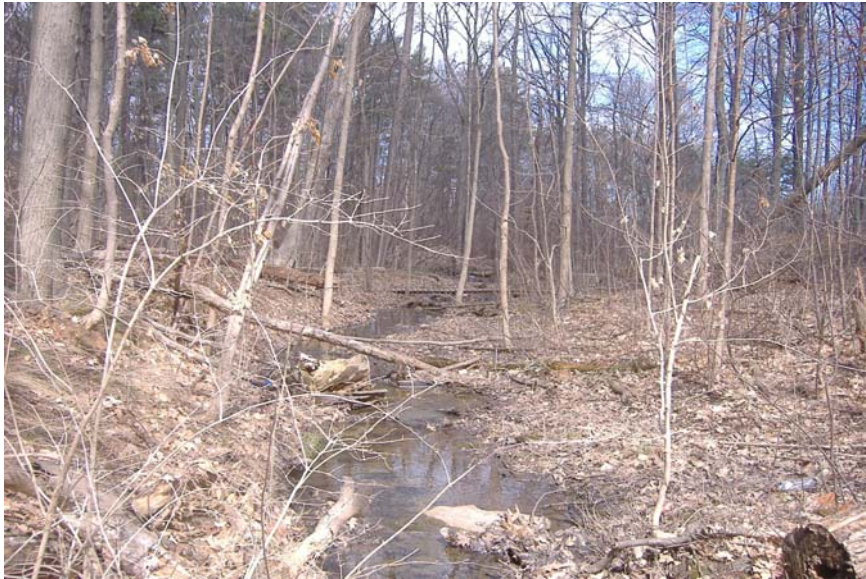
Photo 55: Looking downstream at open channel behind Hixon Street.  
Note bank erosion and tree debris.

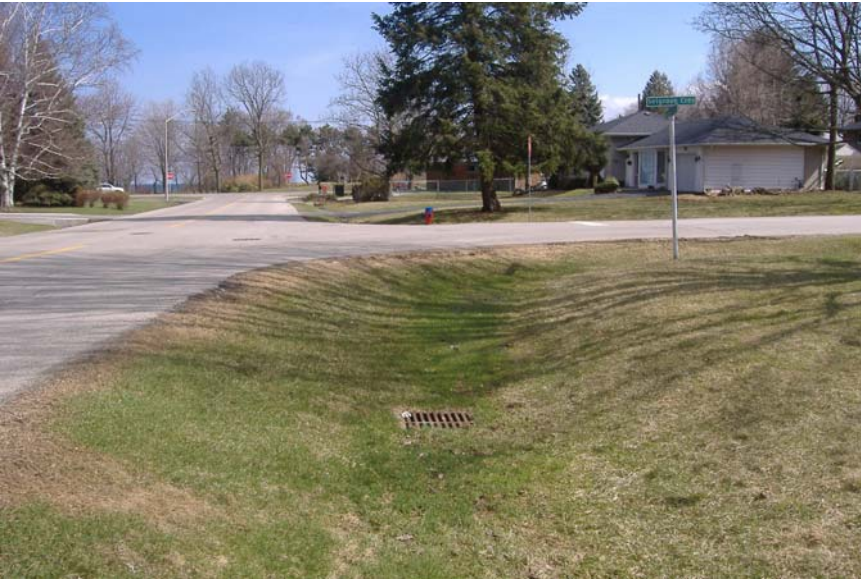
Photo 58: Looking south along west ditch of Woodhaven Park Drive at Selgrove Crescent. Note wet grass.

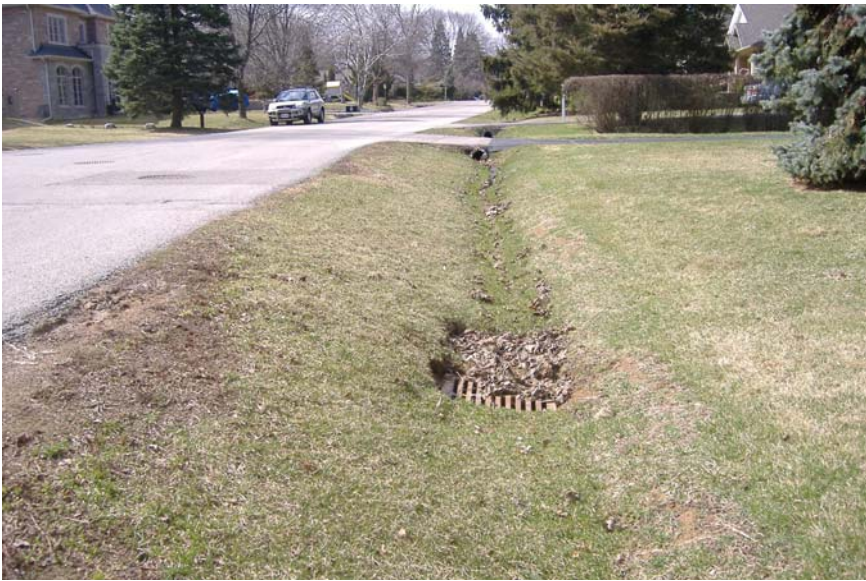
Photo 61: Looking north along east ditch of Woodhaven Park Drive. Note erosion around catchbasin.

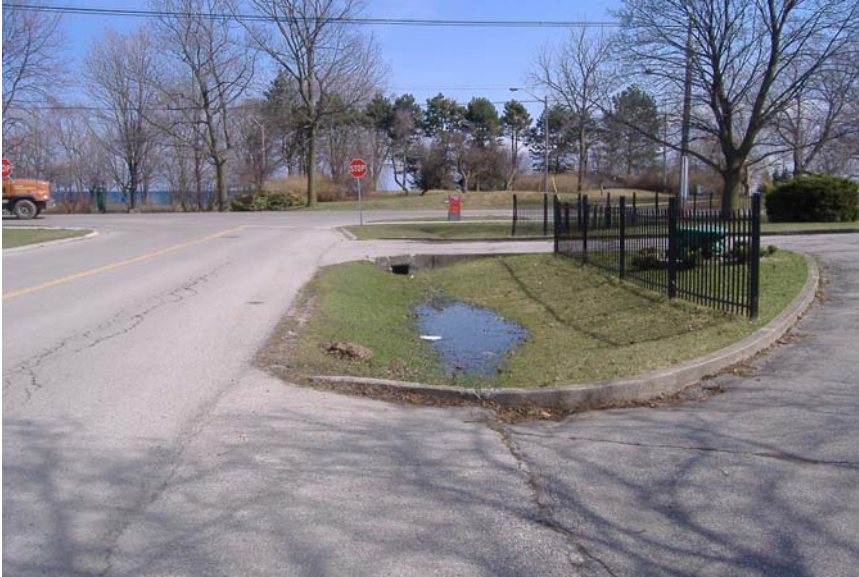
Photo 62: Looking south along west ditch of Woodhaven Park Drive.  
Note standing water.

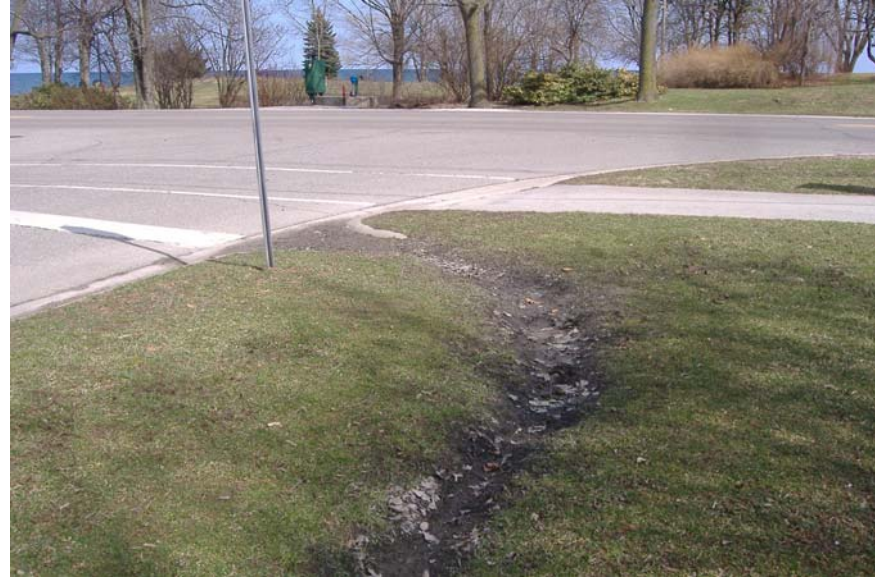
Photo 63: Curb cut at Lakeshore and Woodhaven Park Drive.  
Note sedimentation.

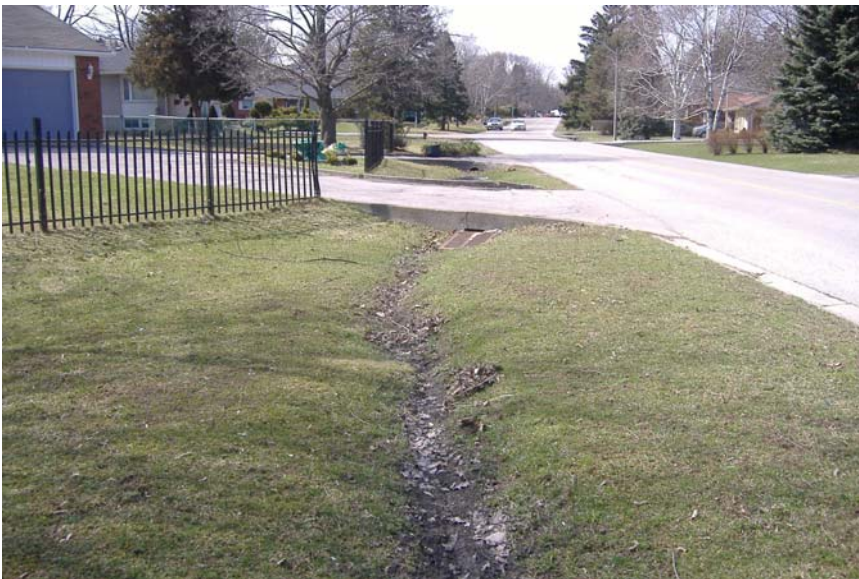
Photo 64: Looking north along west ditch of Woodhaven Park Drive.

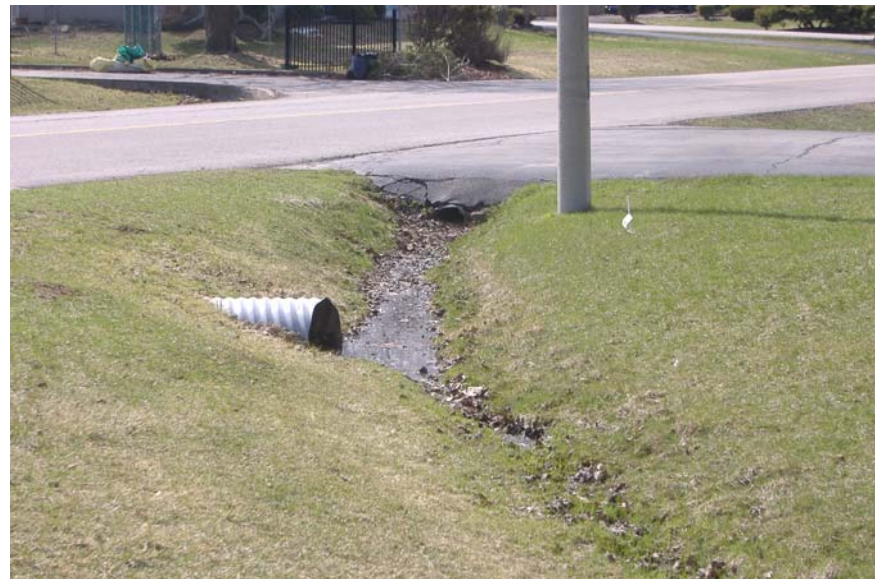
Photo 65: Looking north along east ditch of Woodhaven Park Drive at Lakeshore. Note standing water and partially crushed driveway culvert.

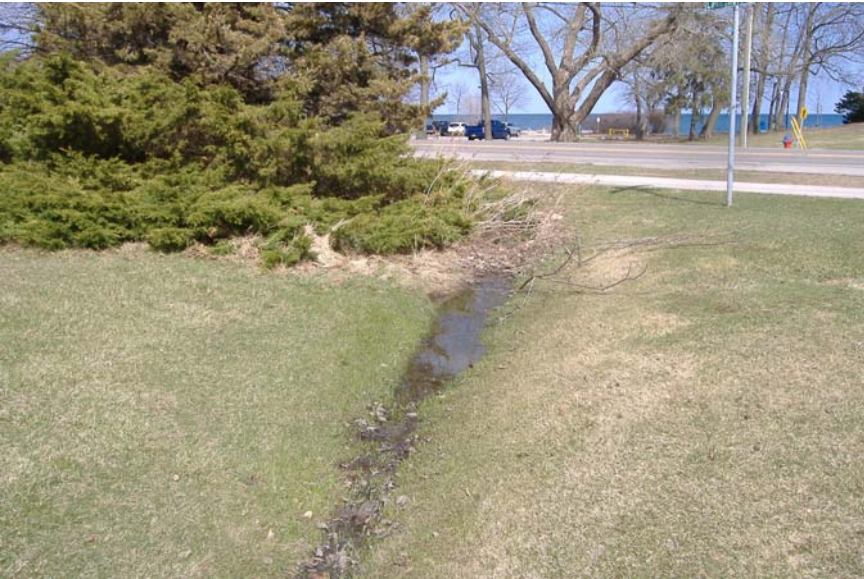
Photo 66: Looking downstream towards Lakeshore Rd from Woodhaven Park Drive. Note standing water & channel obstruction from vegetation.

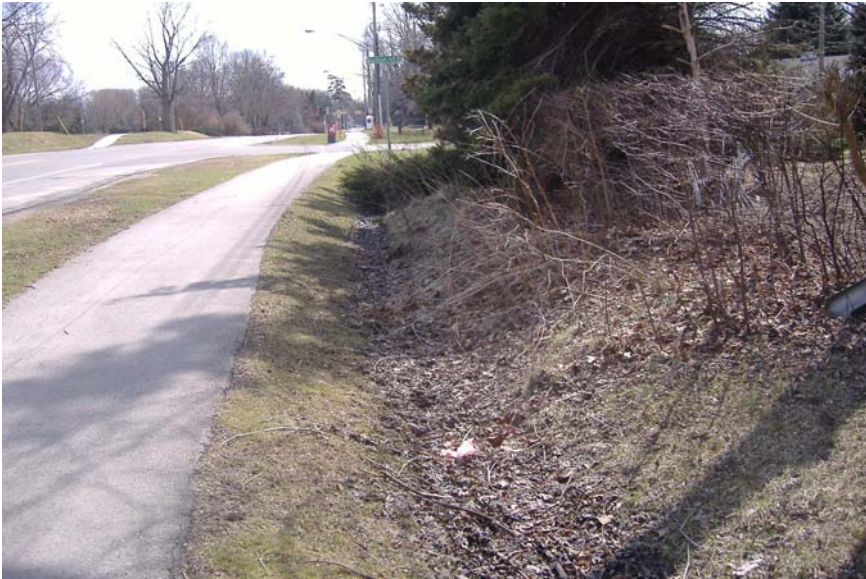
Photo 67: Looking west along Lakeshore Road

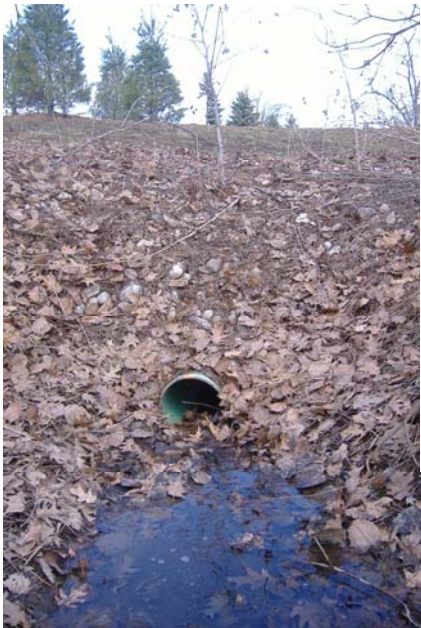
Photo 70: Undersized PVC culvert outlet on WWTP site.  
Note partial obstruction.

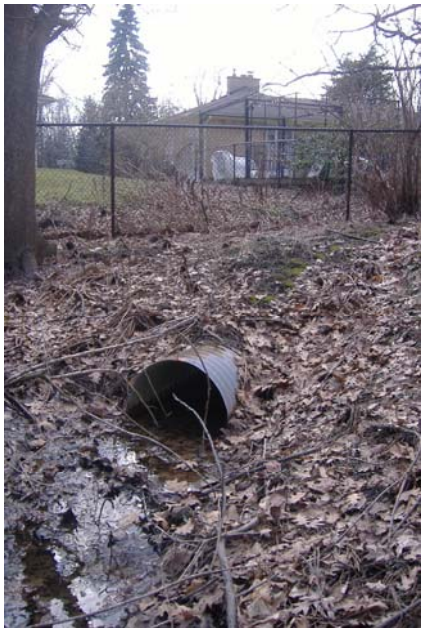
Photo 71: Storm sewer outfall behind Woodhaven Park Drive.  
Note partial obstruction.

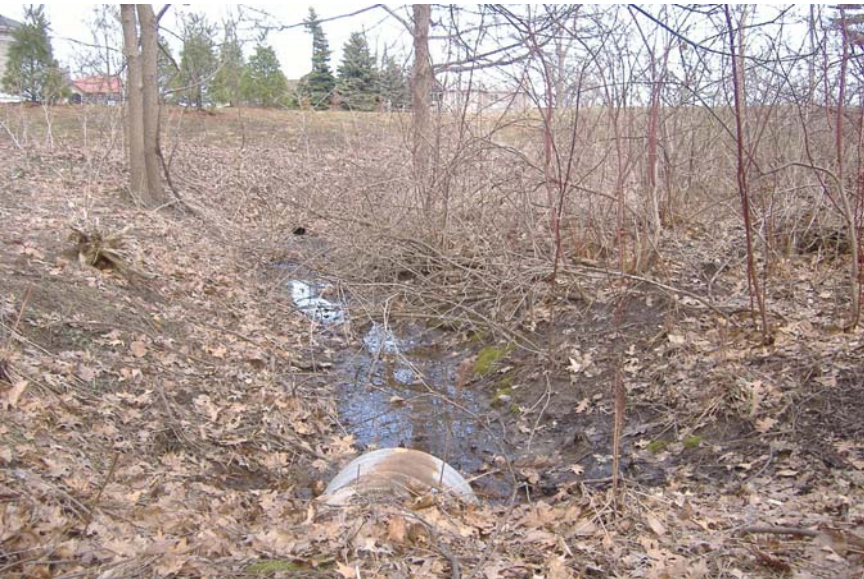
Photo 72: Looking downstream along channel behind  
Woodhaven Park Drive. Note minor bank erosion.

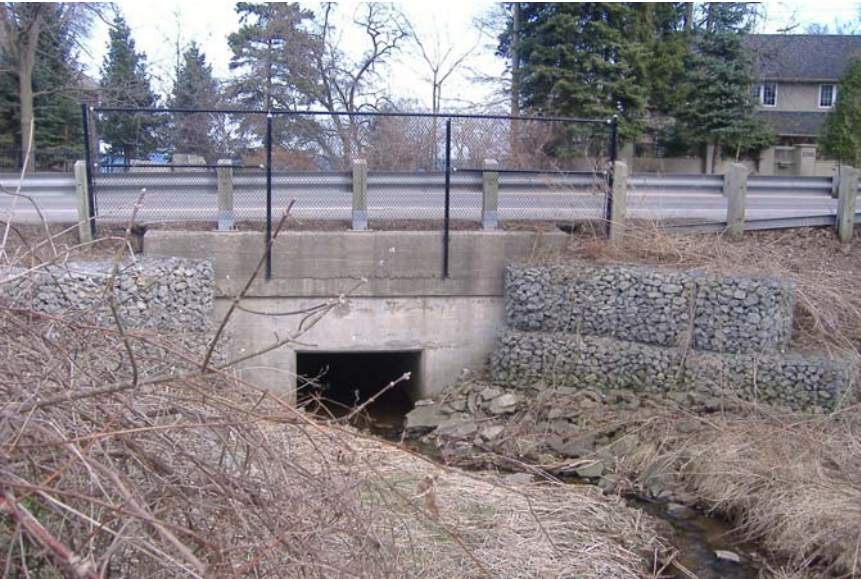
Photo 74: Upstream face of Lakeshore Road culvert.

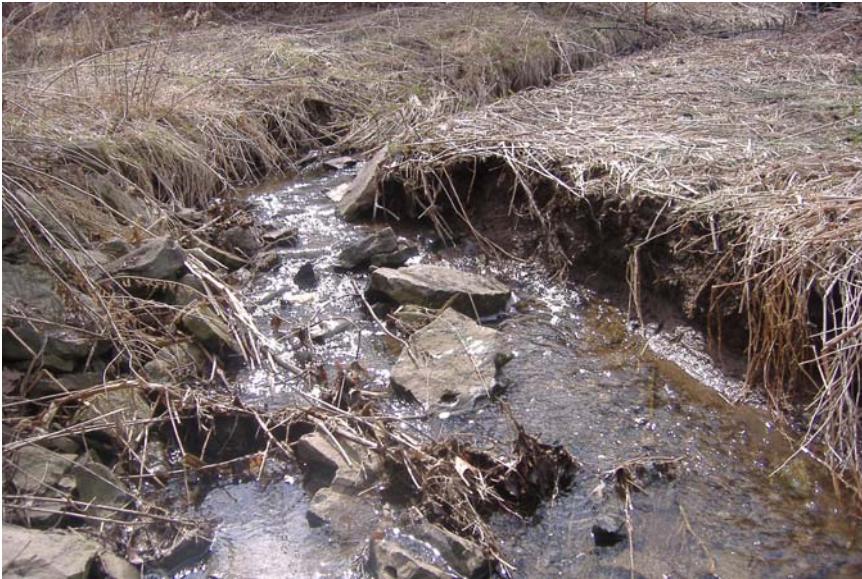
Photo 75: Looking upstream from Lakeshore Road culvert.  
Note bank erosion.

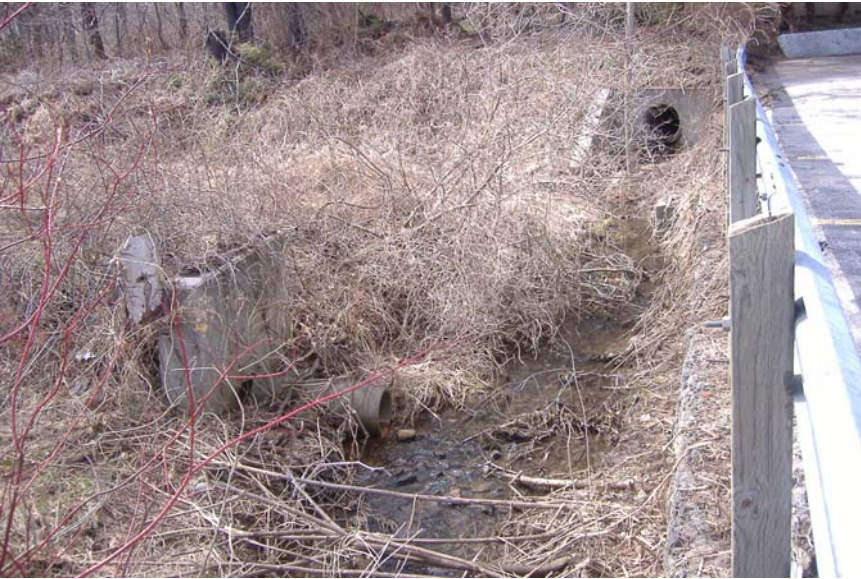
Photo 76: Looking upstream at municipal storm sewer outfall and unknown smaller outfall from WWTP site.

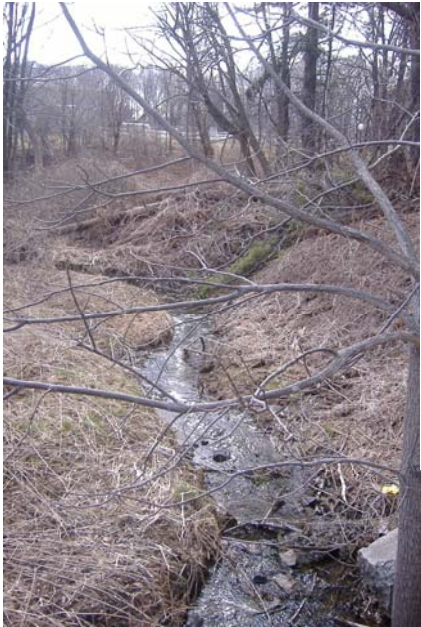
Photo 78: Looking upstream at open channel from Lakeshore Road.

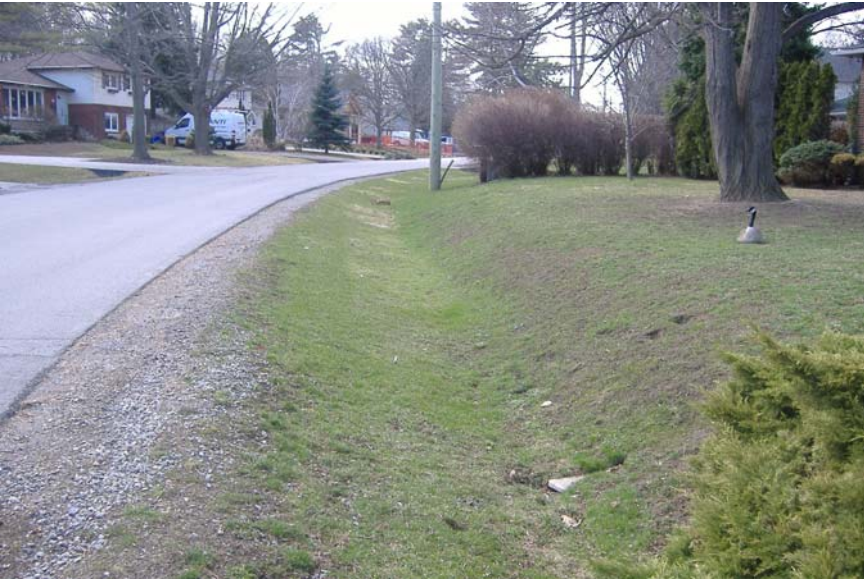
Photo 82: Looking along east ditch on Sandwell Drive.

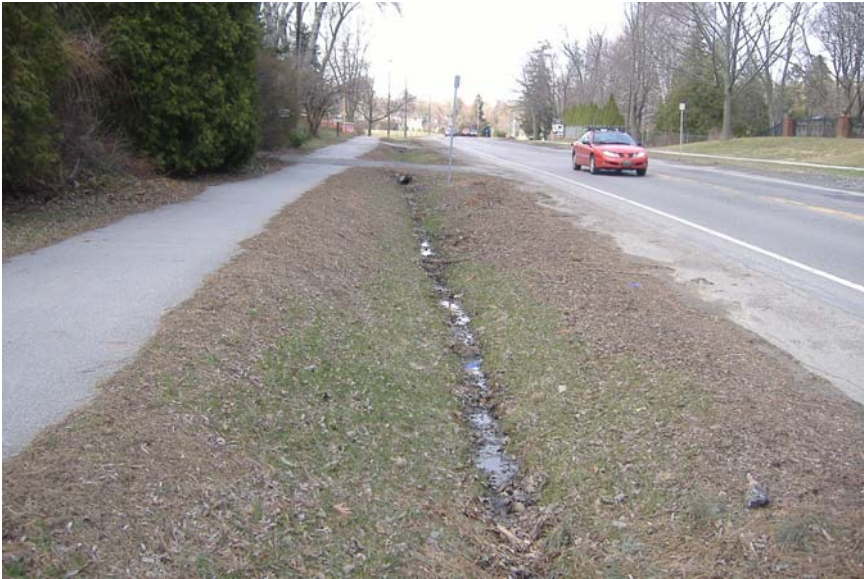
Photo 83: Looking east along north ditch of Lakeshore Road.  
Note standing water and erosion/rutting.

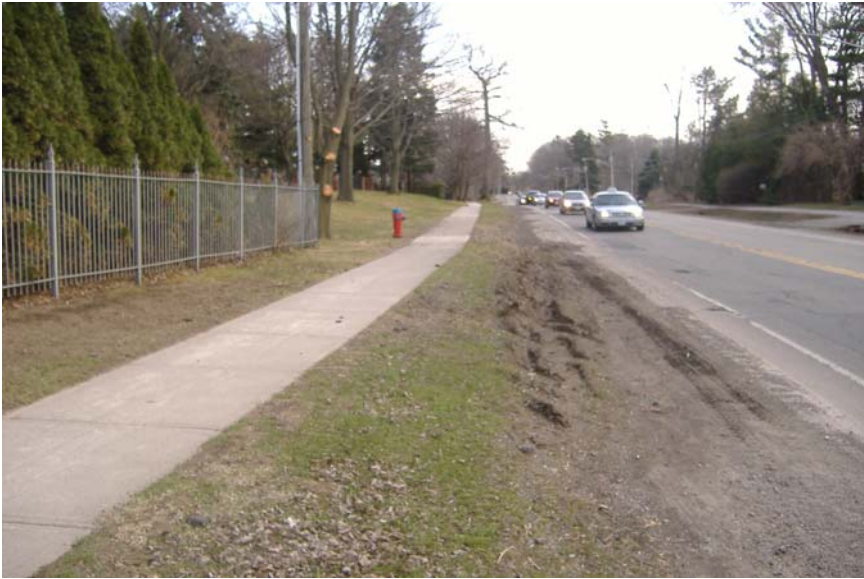
Photo 85: Looking west along south side of Lakeshore Road.  
Note lack of ditch.

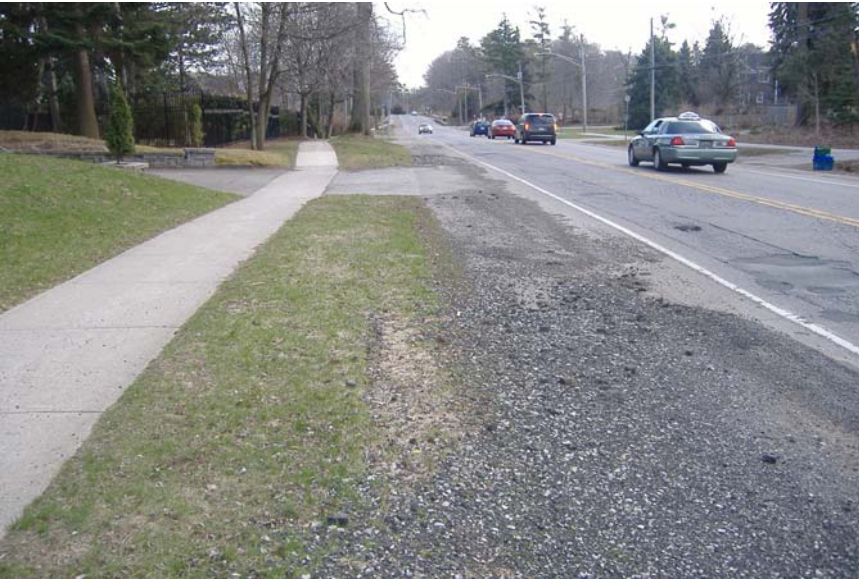
Photo 86: Looking west along south side of Lakeshore Road.  
Note lack of ditch and damage to roadway.

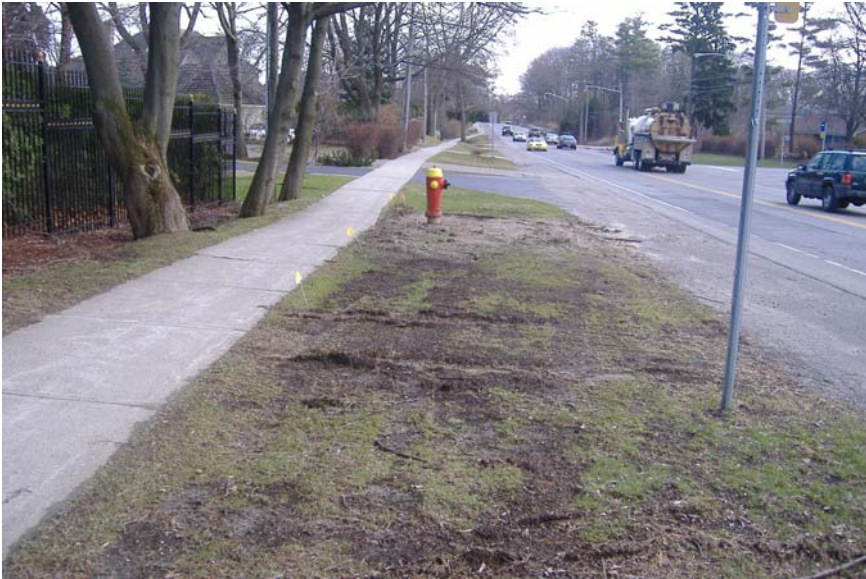
Photo 87: Looking west along south side of Lakeshore Road.  
Note lack of ditch and erosion on side of road.

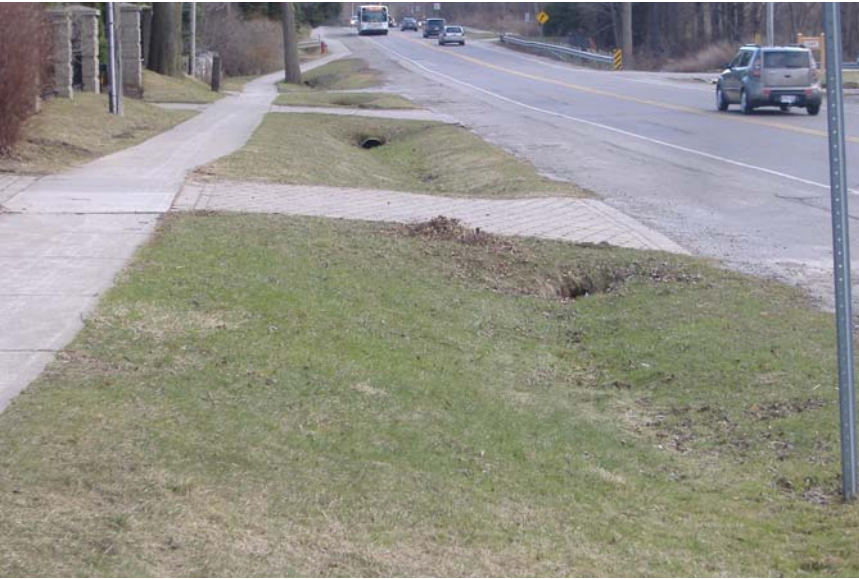
Photo 88: Looking west along south side of Lakeshore Road.  
Note beginning section of ditch and obstructed culverts.
