Arborist Report and Tree Protection Plan
3064 Trafalgar Road

Oakville, Ontario

Updated April 2024
Project 1902588

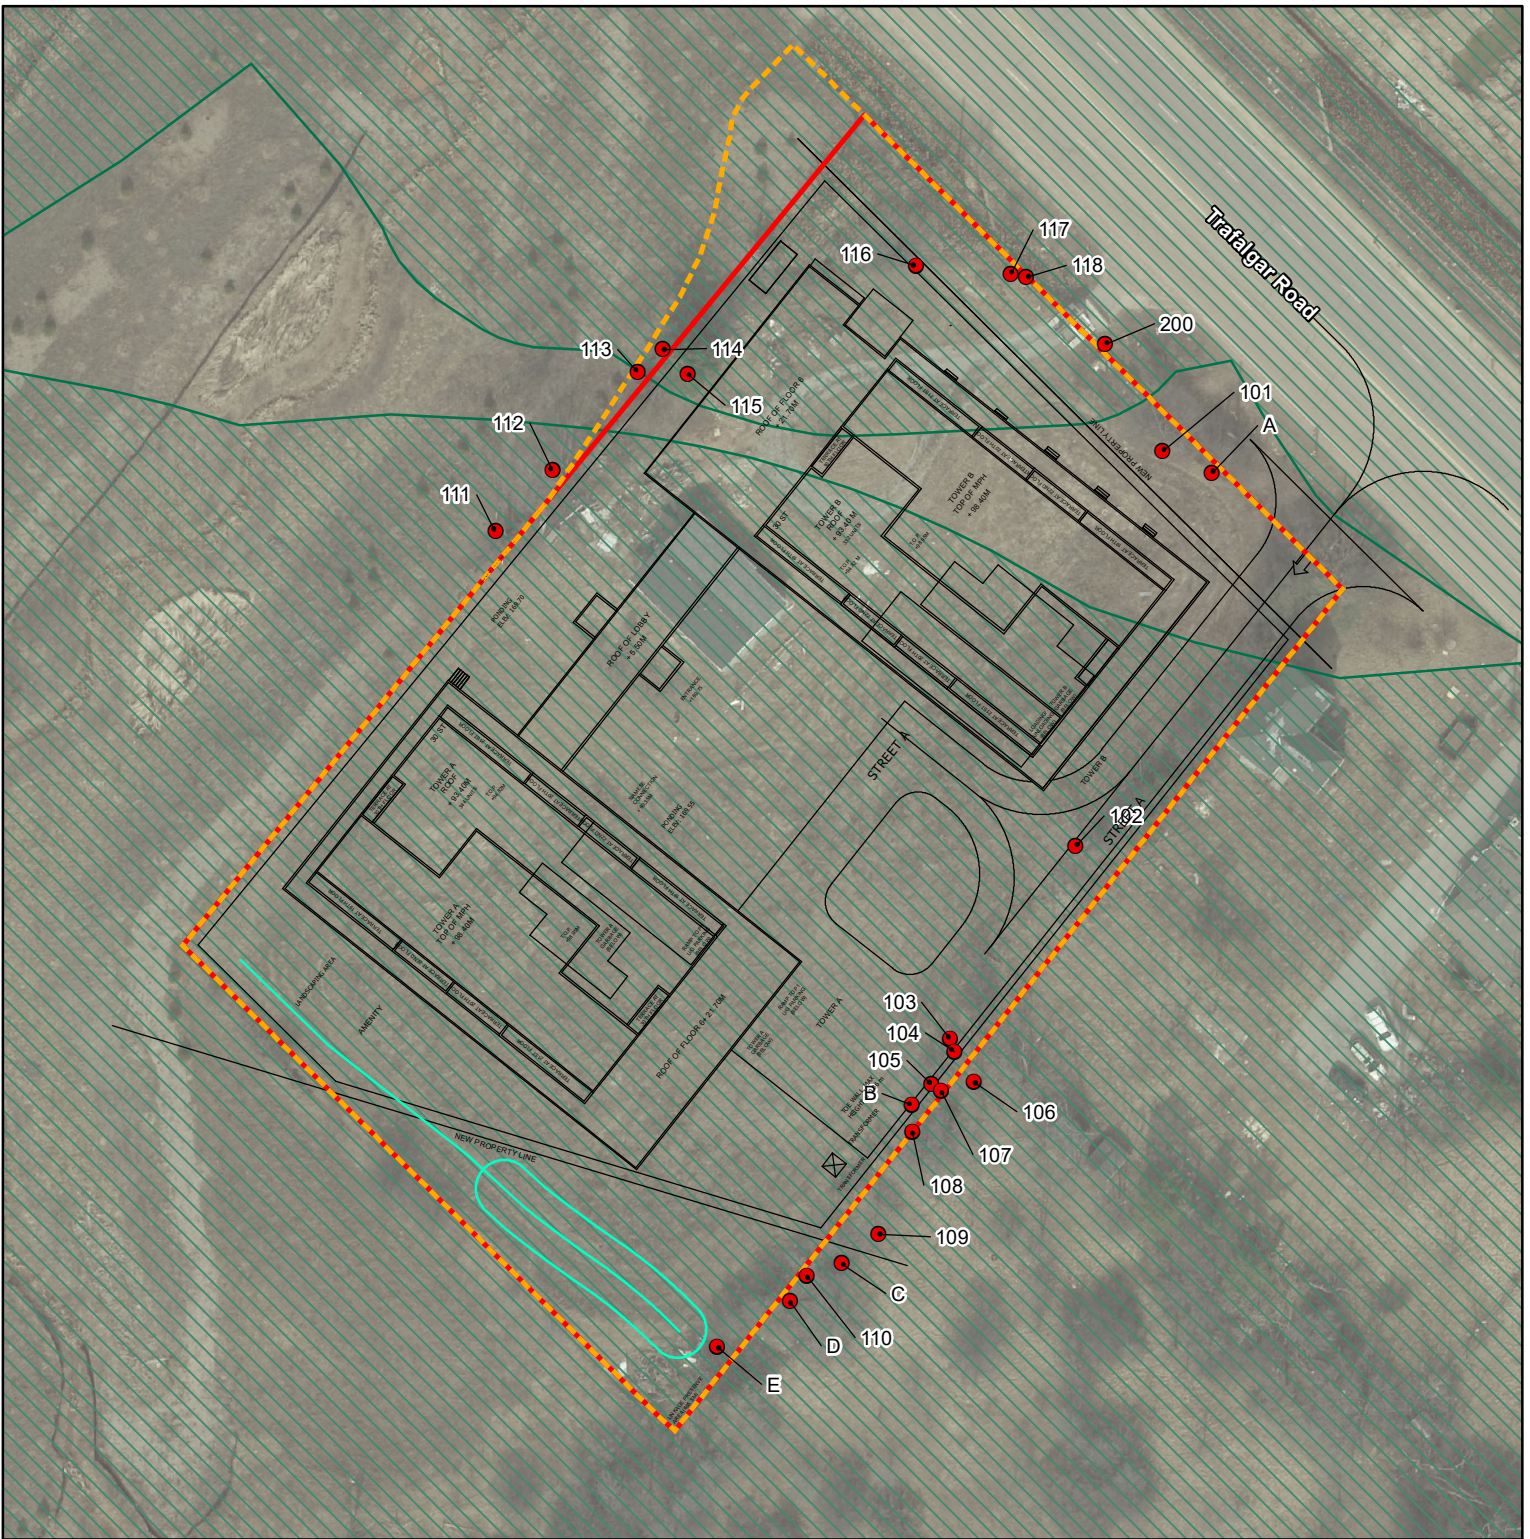
Figure 2
Tree Inventory

A total of 24 trees (all live) were mapped and assessed during this tree inventory (**Figure 2, Appendix A**). **Table 1 (Appendix B)** outlines the results of the tree inventory, including the tree identification number, species, DBH, crown radius, health category (biological, structural, and overall), comments, recommendations for preservation or removal, and the size of the Tree Protection Zone (TPZ).

Based on analysis of predicted impacts to the inventoried trees, all 24 trees are recommended for removal due to anticipated construction impacts or due to health condition. Further detail is provided in the following subsections.

Removal trees are those that are located within or at the edge of the proposed construction footprint and cannot be preserved. All of the 24 inventoried trees have been identified as removal trees. Eight of these removals are located on adjacent private lands. Compensation for removal trees is discussed in **Section 5**.
