ARBORIST REPORT AND TREE PRESERVATION PLAN

**1295 Sixth Line
Oakville, Ontario
L6H 1X1**

DECEMBER 12TH, 2024

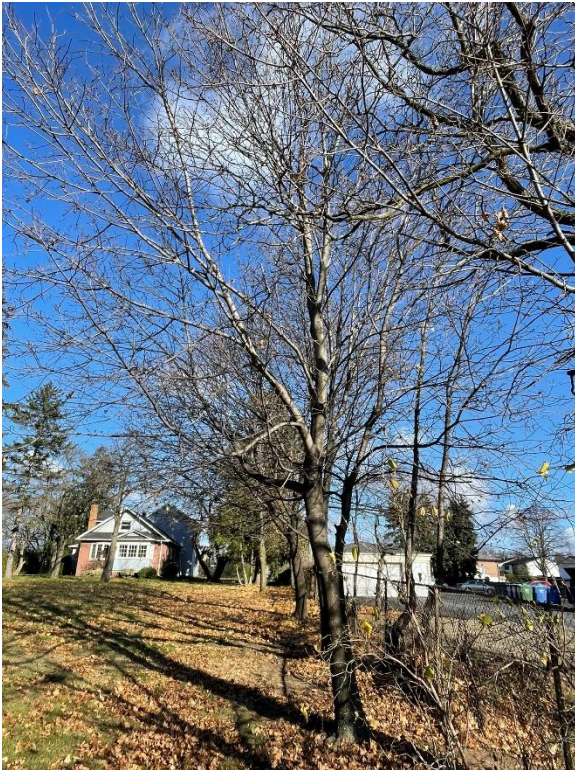
Image 1. Tree 140.

Tree ID	Common Name	Botanical Name	DBH (cm)	Dripline Radius (m)	Health	Structure	TPZ Radius (m)	Owner	Comments	Action
140	Norway Maple	<i>Acer platanoides</i>	27	4	G	F	2.4	Subject Site	Pruning wounds (L), Crook (L), Stem wound (M), Competing limb (L), Surface roots (L)	Preserve
141	Norway Maple	<i>Acer platanoides</i>	26	3.5	G	F	2.4	Subject Site	Pruning wounds (L), Codominant, V-shaped union @ ~2.0 m, Included bark, Surface roots (L)	Remove
142	Norway Maple	<i>Acer platanoides</i>	34	4	G	F	3.0	Subject Site	Sweep (L), Pruning wounds (L), U-shaped union @ ~2.5 m, Surface roots (L)	Remove
143	Red Maple	<i>Acer rubrum</i>	31	4	F	F	3.0	Subject Site	Codominant, U-shaped union @ ~1.5, Pruning wounds (M), Epicormic branches (M), Tip dieback (L)	Remove
144	Norway Maple	<i>Acer platanoides</i>	20	2	G	F	2.4	Subject Site	Pruned to clear hydro lines (M)	Remove
145	Eastern White Cedar	<i>Thuja occidentalis</i>	16, 16	2	G	G	2.4	Subject Site	Calculated DBH = 23 cm , Multi-stemmed @ ground with two stems cut off at 1.0 m, Pruning wounds (L)	Remove

If tree protection fencing is installed as per the Tree Preservation Plan (**PP-1**), then Trees 170, A, B, G, H, J, K, L, O, and Q will receive full protection. Where full TPZ protection cannot be provided (Trees 140 & P), tree protection fencing is to be installed along the edges of either existing or proposed driveway. Root pruning trenches are also recommended outside the protection fences of Tree 140 and P. The purpose of the root pruning work is to pre-emptively cut roots that may be beneath the driveway in a manner that encourages root replacement and does not cause unnecessary injury, such as what may occur if roots are pulled and torn by machinery. If roots are pruned prior to project commencement, then driveway work can proceed without constraint.

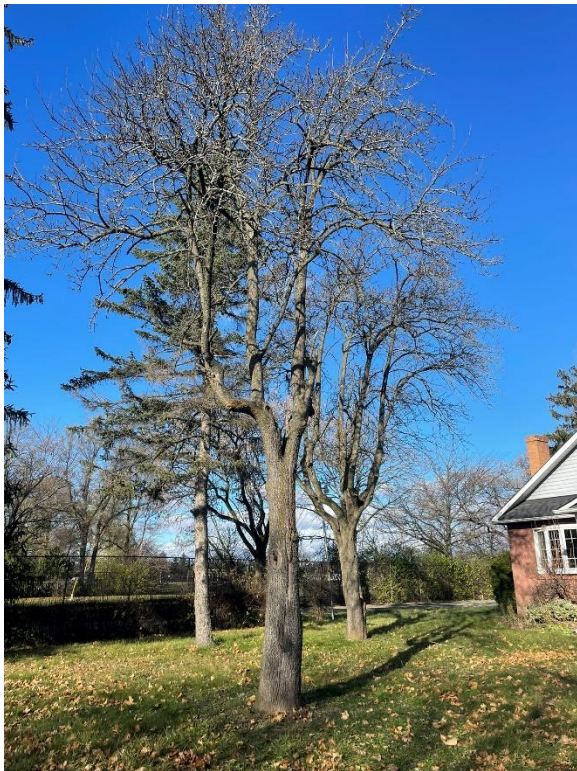
Image 7. Tree 146.

146	Pear	<i>Pyrus spp.</i>	42	3	P	P	3.0	Subject Site	Massive stem wound, Hollow trunk, Decay (H), Cavity (H), Dead branches (H)	Remove
147	Norway Spruce	<i>Picea abies</i>	44	4	G	G	3.0	Subject Site	Surface roots (L), Pruning wounds (L)	Remove
148	Norway Spruce	<i>Picea abies</i>	59	4	G	G	3.6	Subject Site	Surface roots (L), Pruning wounds (L)	Remove
149	White Mulberry	<i>Morus alba</i>	43, 43, 48	5.5	F	P	4.8	Subject Site	Calculated DBH = 77 cm , Three stems @ ground, Decaying stump @ base, Poor wound encapsulation, Pruning wounds (M), Dead branches (M)	Remove
150	Manitoba Maple	<i>Acer negundo</i>	61	5	P	F	4.2	Subject Site	Poor wound encapsulation, Dead wood (H), Epicormic branches (H), Pruning wounds (H), Over extended limbs (H), Burls	Remove
151	Manitoba Maple	<i>Acer negundo</i>	35	3.5	F	P	3.0	Subject Site	Poor form (H), Epicormic branches (H), Pruning wounds (H), Fair vigor, Some sealed wounds and some open wounds	Remove

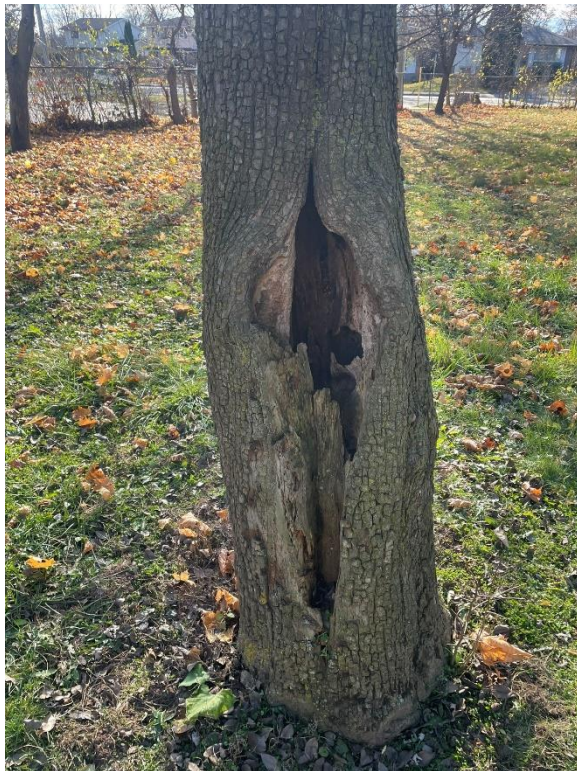
Image 8. Decaying trunk on Tree 146.

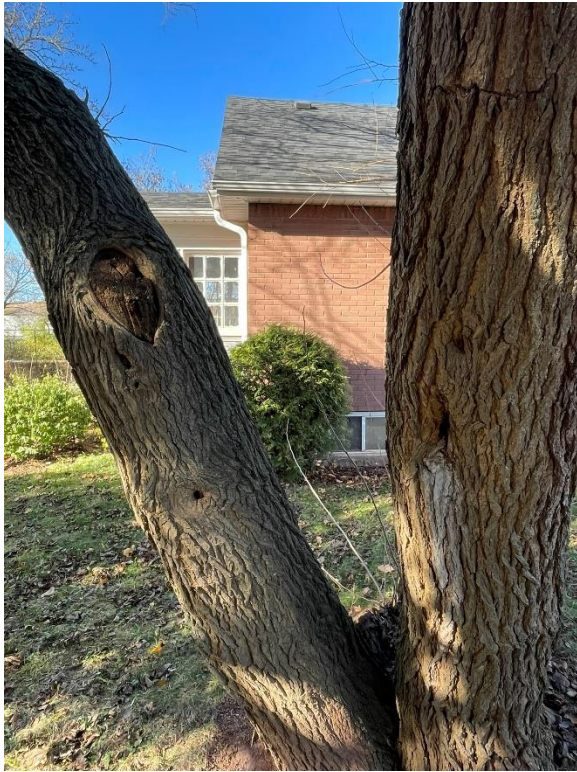
Image 13. Open wounds on Tree 149.

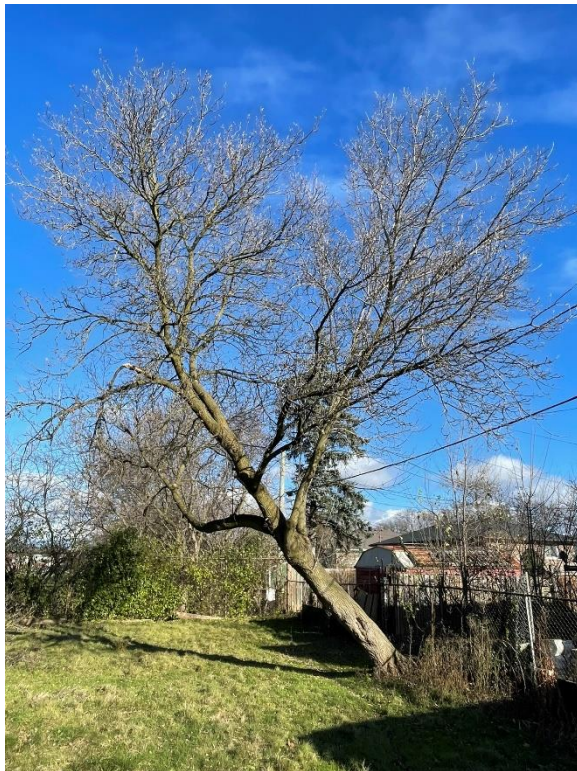
Image 16. Tree 152.

152	Manitoba Maple	<i>Acer negundo</i>	44	4	F	P	3.0	Subject Site	Lean (H), Trunk wound (L), Broken branches (L)	Remove

Justification for Removal	Tree ID	Tree Count
In direct conflict with proposed structures or excavation	141, 142, 143, 144, 145, 146, 147, 148, 149, 150, 153, 157, 158, 159, 160, 161, 162, 163, 164, 165, 166, 167, 168, 169, C, D, F, M, N	29
Poor condition, not suitable for retention near future parking lot	151, 152, 154, 155, 156, I	6

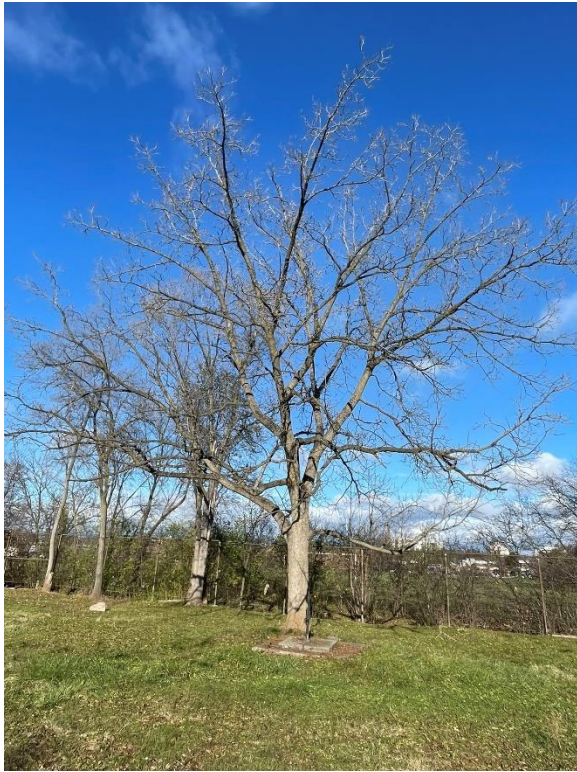
Image 17. Tree 153.

Tree ID	Common Name	Botanical Name	DBH (cm)	Dripline Radius (m)	Health	Structure	TPZ Radius (m)	Owner	Comments	Action
153	Black Walnut	<i>Juglans nigra</i>	55	7	G	G	3.6	Subject Site	Water well very near tree, Pruning wounds (L), U-shaped union @ ~4.0 m	Remove
154	Siberian Elm	<i>Ulmus pumila</i>	19, 30	3	P	P	3.0	Subject Site	Calculated DBH = 36 cm , Codominant, V-shaped union @ ground, Included bark, Dead wood (H)	Remove
155	Siberian Elm	<i>Ulmus pumila</i>	28	5	F	P	2.4	Subject Site	V-shaped union @ ~5.0 m, Dead branches (H), Cavity @ base (M), Broken branches (M)	Remove
156	Siberian Elm	<i>Ulmus pumila</i>	21	2	F	P	2.4	Subject Site	Old stem cut off @ ~70 cm - now decaying and hollow, Dead branches (M)	Remove
157	Siberian Elm	<i>Ulmus pumila</i>	38, ~21	2.5	G	F	3.0	Shared (White Oaks S.S.)	Calculated DBH = 43 cm , V-shaped union @ ground, Growing through chain link fence, Pruning wounds (L), Broken branches (L), Good encapsulation	Remove

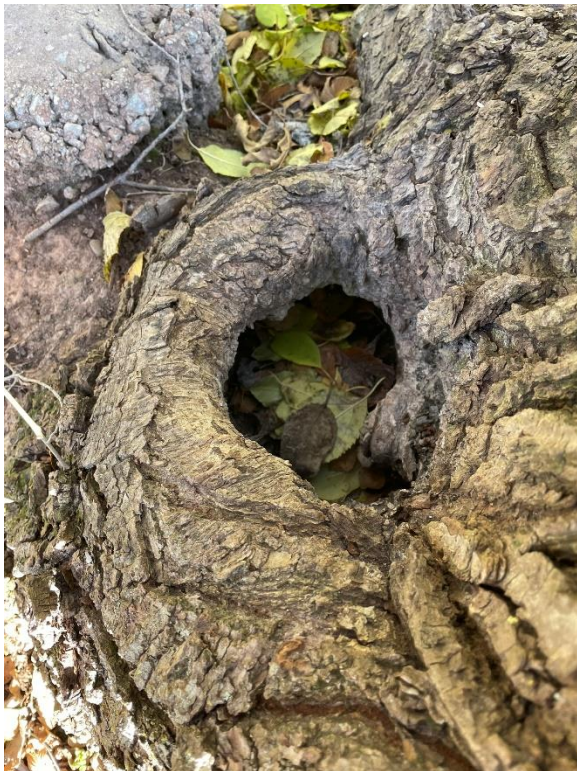
Image 19. Basal cavity on Tree 155.

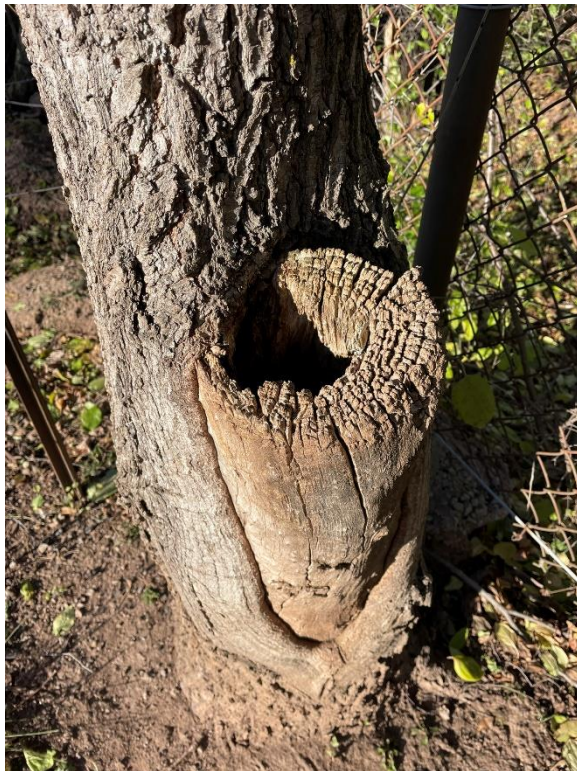
Image 20. Decaying wound on Tree 156.

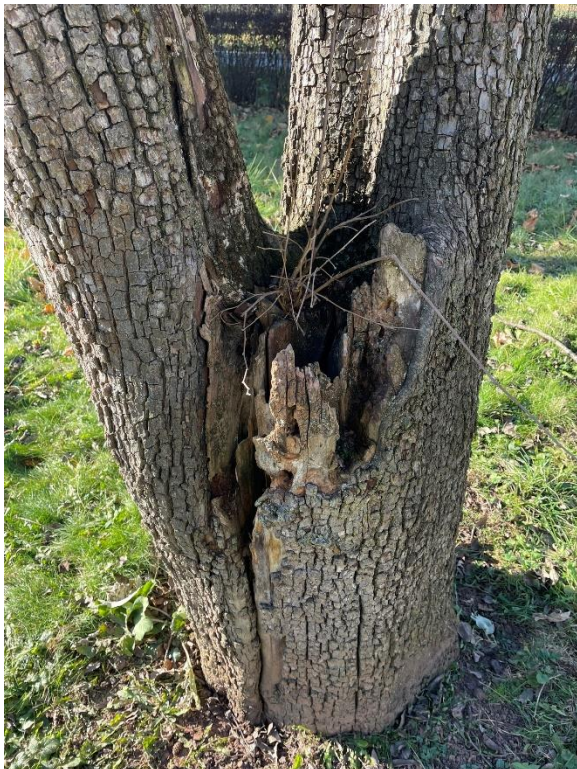
Image 27. Decaying union on Tree 163.

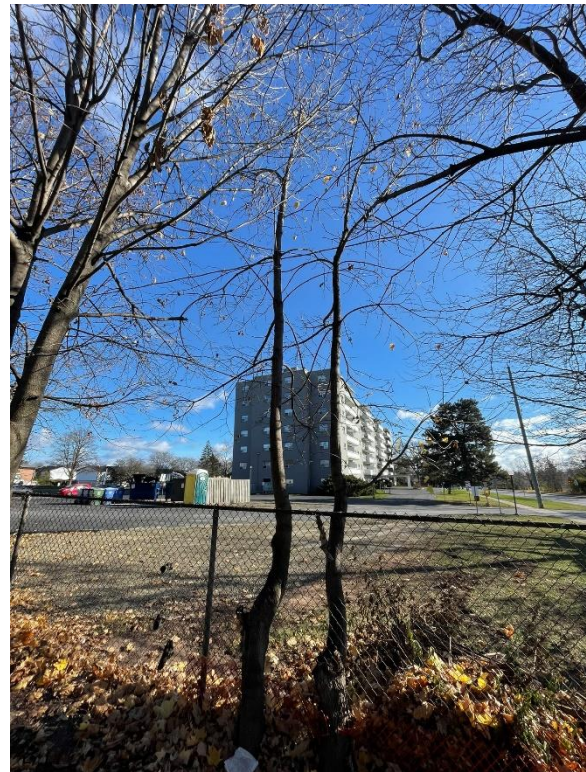
Image 36. Trees C & D (right to left).

C	Norway Maple	<i>Acer platanoides</i>	~15	2	F	F	2.4	Shared (1265 Sixth L)	Base growing through chain link fence, Pruning wounds (M), Sweep (M)	Remove
D	Norway Maple	<i>Acer platanoides</i>	~16	2	F	F	2.4	Shared (1265 Sixth L)	Base growing through chain link fence, Pruning wounds (M), Sweep (M)	Remove
E	Pear	<i>Pyrus spp.</i>	~15	1.5	P	P	2.4	Neighbour (1265 Sixth L)	Epicormic branches (H), Pruning wounds (H), Dead branches (M)	Preserve
F	Manitoba Maple	<i>Acer negundo</i>	~16, 16	3	F	P	2.4	Shared (1265 Sixth L)	Calculated DBH = 23 cm , Growing through chain link fence, Lean (M), Two stems fused together, Pruning wounds (M)	Remove
G	Blue Spruce	<i>Picea pungens</i>	~38	2.5	F	F	3.0	Neighbour (1274 Redbank Cr)	Pruning wounds (H), Dead stubs (M), Pruned to clear hydro wires	Preserve
H	Manitoba Maple	<i>Acer negundo</i>	~20, 25, 30, 30	3	F	P	3.6	Shared (White Oaks S.S.)	Calculated DBH = 53 cm , Poor form (H), Multi-stemmed @ ground, Dead branches (L)	Preserve

Based on the currently proposed Site Plan, as well as some instances of poor condition, 35 trees are recommended for removal (**Table 3**). Trees C, D, and F are shared with 1265 Sixth Line and consent from their owner will be required to remove them. Trees I, M, and N are on the public property of White Oaks Secondary School, and consent will likewise be required prior to their removal. Private tree removal permits will need to be secured for all trees with numeric Tree ID's prior to the commencement of tree removal work.

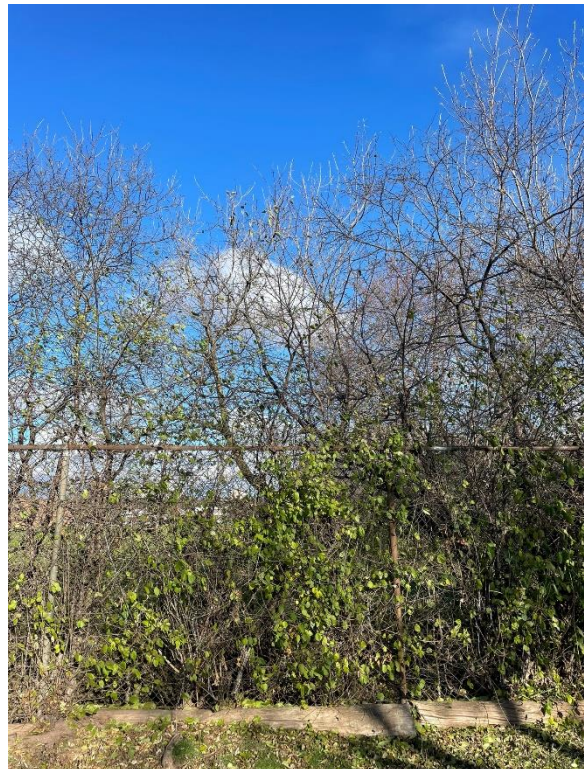
Image 40. Tree I.

I	Manitoba Maple	<i>Acer negundo</i>	~20	3	F	F	2.4	Neighbour (White Oaks S.S.)	Poor form (H), Sweep (M)	Remove
J	Siberian Elm	<i>Ulmus pumila</i>	~14, 20	4	F	F	2.4	Neighbour (White Oaks S.S.)	Calculated DBH = 24 cm , V-shaped union @ ~30 cm, Included bark, Dead branches (M)	Preserve
K	Siberian Elm	<i>Ulmus pumila</i>	~16, 20	3	F	F	2.4	Neighbour (White Oaks S.S.)	Calculated DBH = 26 cm , Bowed away from subject property, Codominant @ ground, Dead branches (L)	Preserve
