# Phase One Environmental Site Assessment

420 and 468 South Service Road East, Oakville, Ontario

Phase One Environmental Site Assessment

GTR-23006348-E1

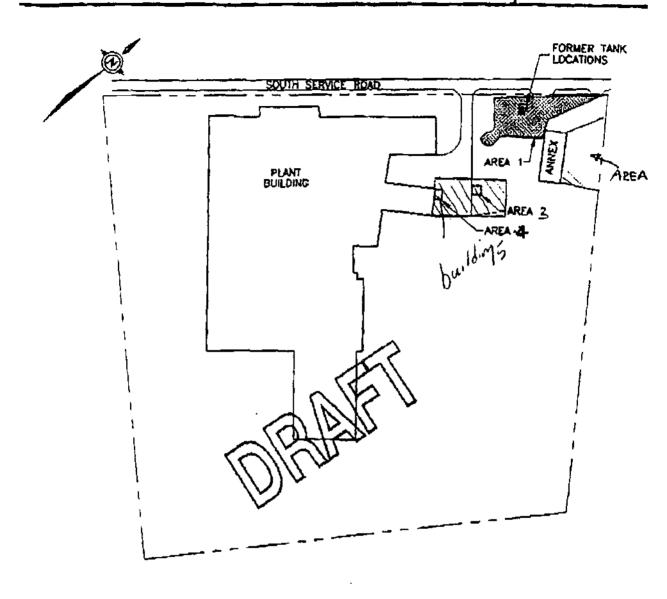
FIGURE

## LOCATION OF SOIL EXTRACTION AREAS OAKVILLE EAST PLANT GE LIGHTING CANADA

LEGEND	
	AREA OF REMEDIAL WORKS
	PROPERTY LINE
	SCALE
	1 : 2500

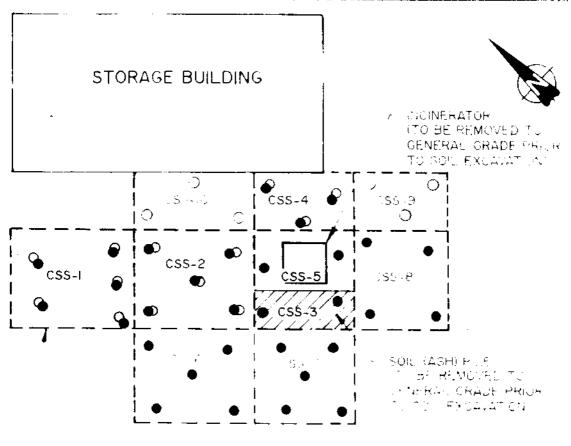
# PLAN SHOWING APPROXIMATE EXTENT OF SOIL EXCAVATION
