Phase One Environmental Site Assessment

Part of Lot 20, Concession 2
Oakville, Ontario

DS Project No : 21-455-100
Date: 2022-02-22

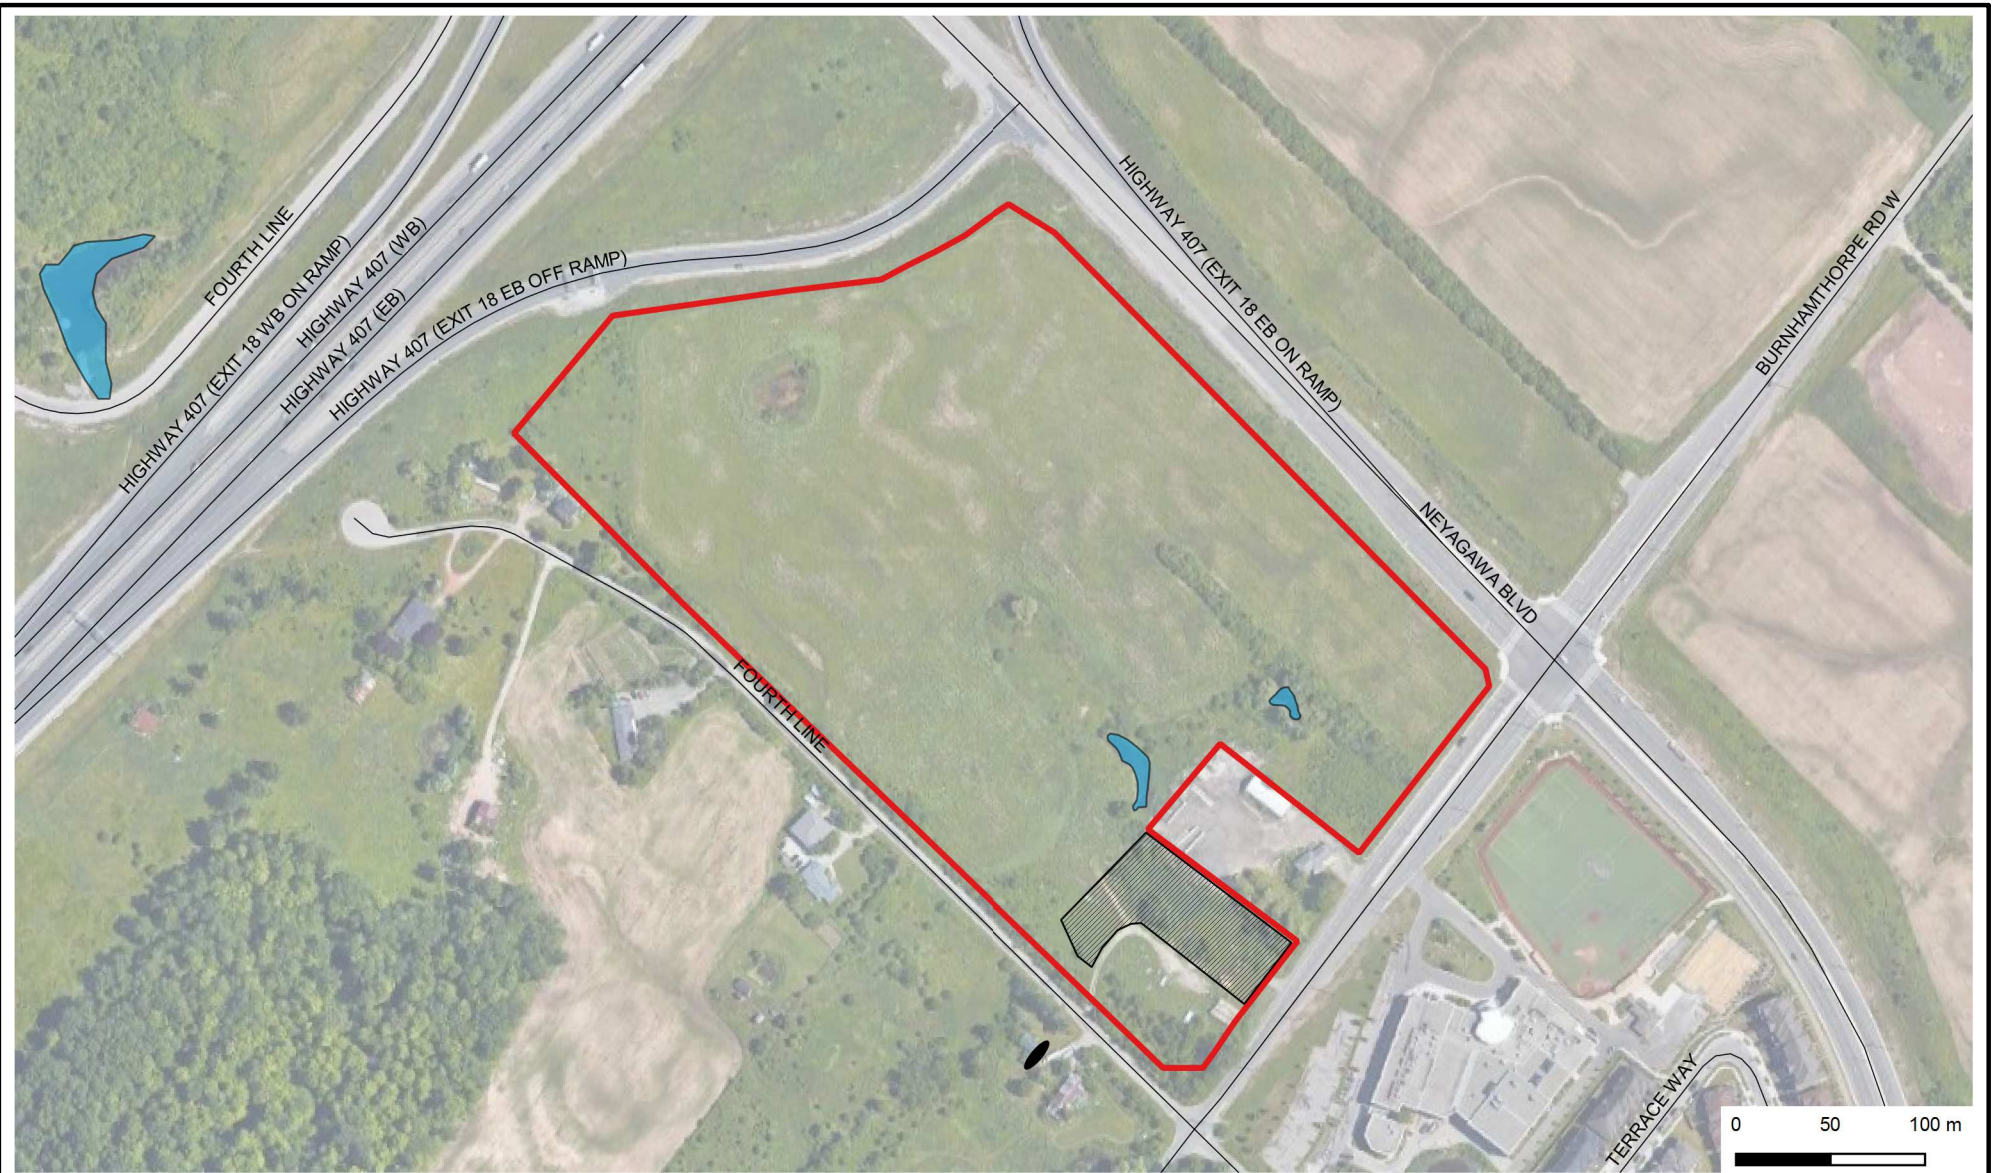
Rev: 0	Scale: As Shown	Project No.: 21-455-100	Figure No.: 2
-----------	------------------------	--------------------------------	----------------------

- Approx Property Boundary
- Location of historic soil stockpiling
- AST

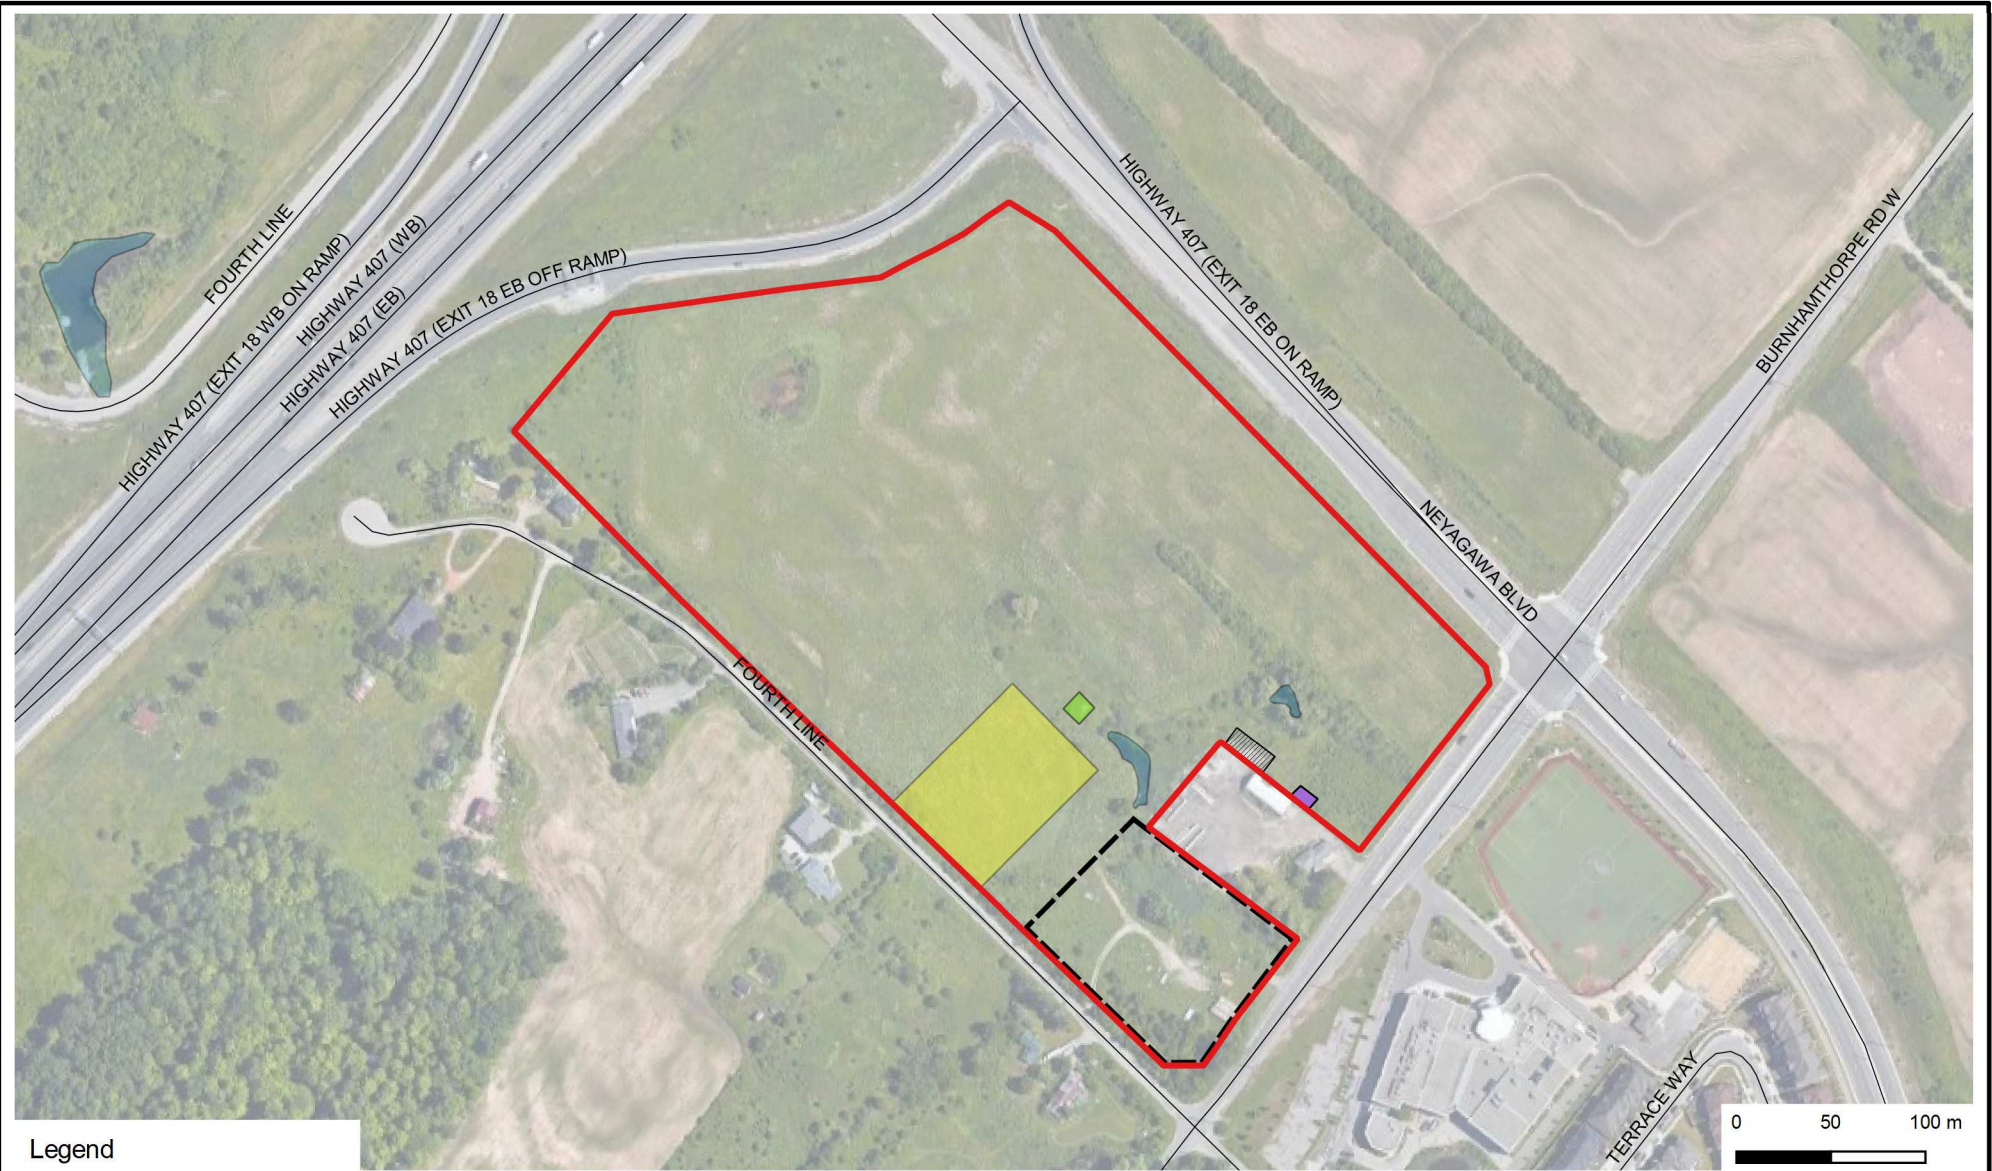
- Approx Property Boundary
- APEC1A & 2
- APEC-1B
- APEC-1C
- APEC-3
- APEC4

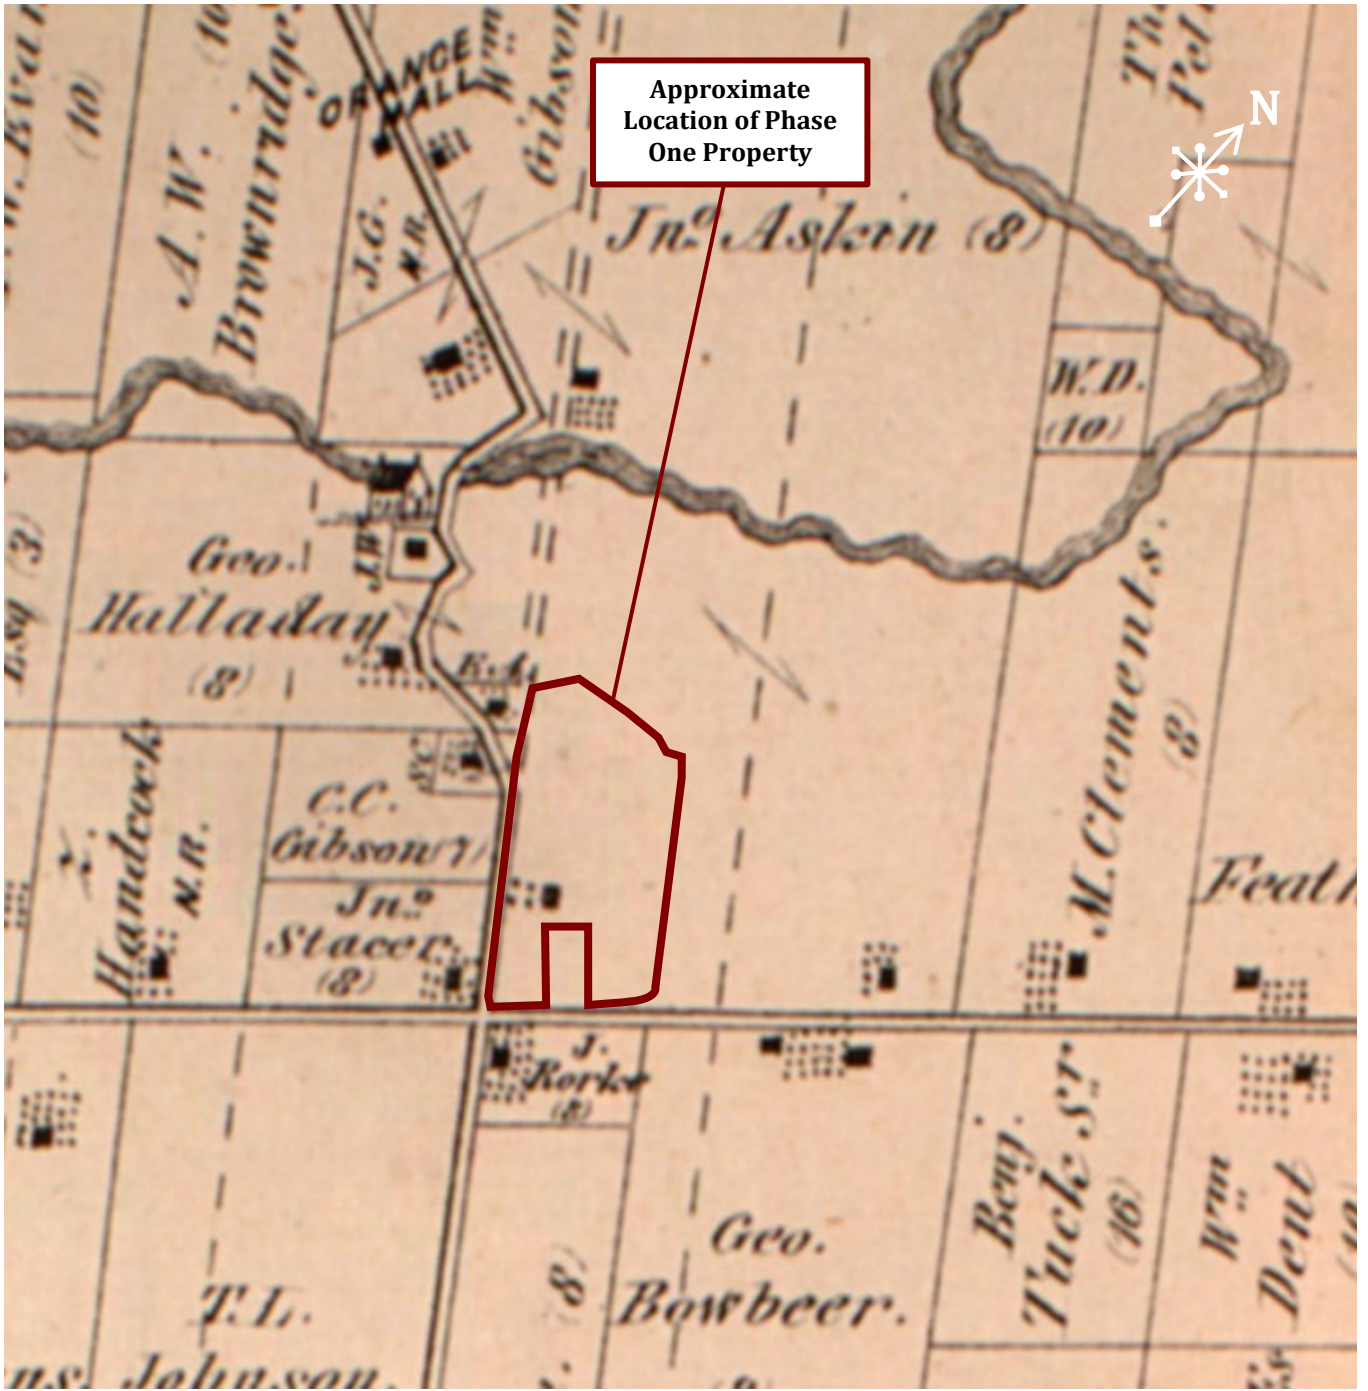
HALTON REGION COUNTY ATLAS: 1880

Location	Observations	PCA ID No.
1880		
Phase One Property	According to the Halton County Atlas from 1880, the Phase One Property is owned by Mr. Jno Askin. There appears to be a residential dwelling and an orchard located along the western boundary of the Site.	PCA-7
North of the Site	A tributary of Sixteen Mile Creek runs north of the Phase One Property. However, it appears to be beyond the Phase One Study Area.	No PCA
South of the Site	An orchard and a residential dwelling can be observed on the south adjacent property.	PCA-8
East of the Site	An orchard and a residential dwelling can be observed east of the Phase One Property.	PCA-8
West of the Site	There are three orchards and residential dwellings on the west adjacent property along the western boundary of the Phase One Property.	PCA-8
1934		
Phase One Property	The residential dwelling and orchard are no longer visible on the Phase One Property. However, the area where the historic residential dwelling and orchard were appears to be graded.	PCA-9

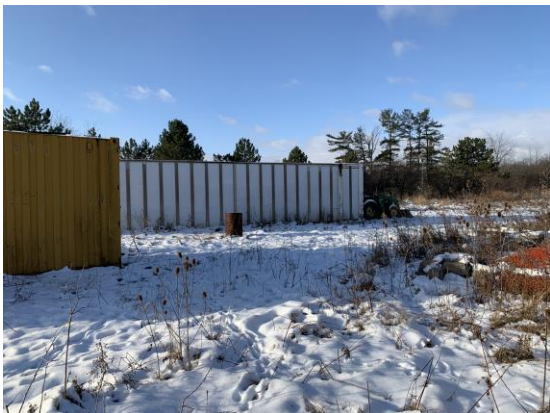
Picture 5: View of the trailers on the southwestern portion of the Phase One Property, facing west.

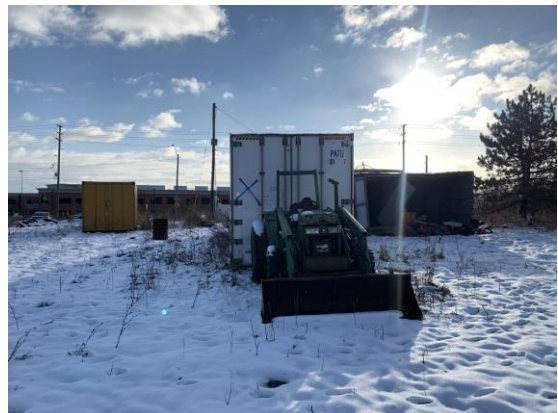
Picture 6: View of the landscaping equipment on the southwestern portion of the Phase One Property, facing north.

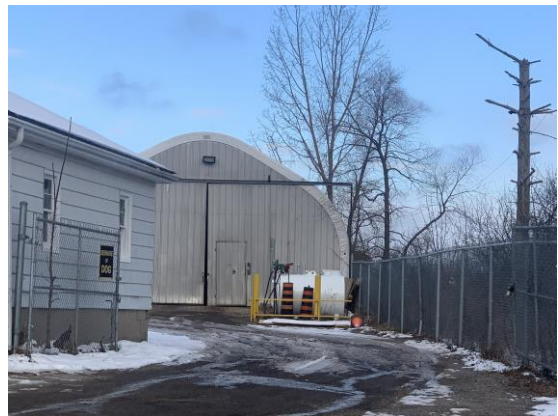
Picture 10: View of the 2 ASTs and Quonset building on the south adjacent property, facing north.

- ◆ The south adjacent Property (501 Burnhamthorpe Road West) was occupied by a residential dwelling and a Quonset Hut at the time of the Site reconnaissance, and was used for residential and commercial purposes. There were two (2) ASTs at 501 Burnhamthorpe Road West, located immediately adjacent to the southeastern boundary of the Phase One Property.

PCA ID No.	PCA Description (Per. Table 2, Schedule D of O.Reg. 153/04)	Description	Contributing to APEC (Y/N)
PCA-8	#40 – Pesticides (including Herbicides, Fungicides and Anti-Fouling Agents) Manufacturing, Processing, Bulk Storage and Large-Scale Applications	An orchard and a residential dwelling can be observed on the south, east and west adjacent properties in the 1880 Halton County Atlas map.	No – due to distance from the Phase One Property and limited mobilization of the contaminants.
PCA-9	#30 – Importation of Fill Material of Unknown Quality	In the 1934 aerial imagery, the residential dwelling and orchard are no longer visible on the Phase One Property. However, the area where the historic residential dwelling and orchard were appears to be graded.	Yes – APEC-1C
PCA-10	#28 - Gasoline and Associated Products Storage in Fixed Tanks	The south adjacent Property was occupied by a residential dwelling and a Quonset Hut at the time of the site reconnaissance, and was used for residential and commercial purposes. There were two (2) ASTs on the property.	Yes – APEC-4

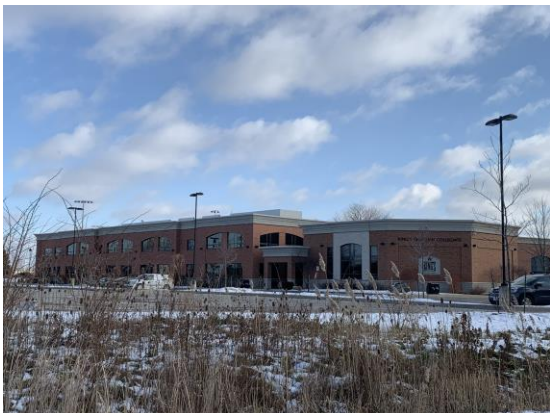
Picture 11: View of King's Christian Collegiate on the south adjacent property along Burnhamthorpe Road West, facing southeast.

Database/Date	Entry Details	PCA ID No.
Ontario Regulation 347 Waste Generator Summary (GEN)	Eleven (11) entries pertaining to King’s Christian Collegiate located at 528 Burnhamthorpe Road West, approximately 26m southeast of the Phase One Property, operating as an elementary and secondary school that has been registered as a waste generator for inorganic laboratory chemicals, waste oils and lubricants and organic laboratory chemicals from 2009 to 2021. It is anticipated that relatively minor quantities of waste are generated by the school. As such, this is not considered to be a PCA.	N/A
Ontario Spills (SPL)	One (1) entry from January 1998 for the Region of Halton Landfill on 4 th Line and Burnhamthorpe Road West, approximately 14m southeast of the Phase One Property, that reports a leachate spill of an unknown amount to the ground and creek which resulted from a container overflow during the rain leading to possible environmental impact to the land and water.	PCA-6
