**PROJECT NO.: SM 134975-E**

**PHASE I ENVIRONMENTAL SITE ASSESSMENT  
UPPER GLEN ABBEY: PHASE VI LANDS  
2327 KHALSA GATE  
OAKVILLE, ONTARIO**

**CRYSTAL HOMES**

**SOIL-MAT ENGINEERS & CONSULTANTS LTD.  
130 LANCING DRIVE  
HAMILTON, ONTARIO  
L8W 3A1**

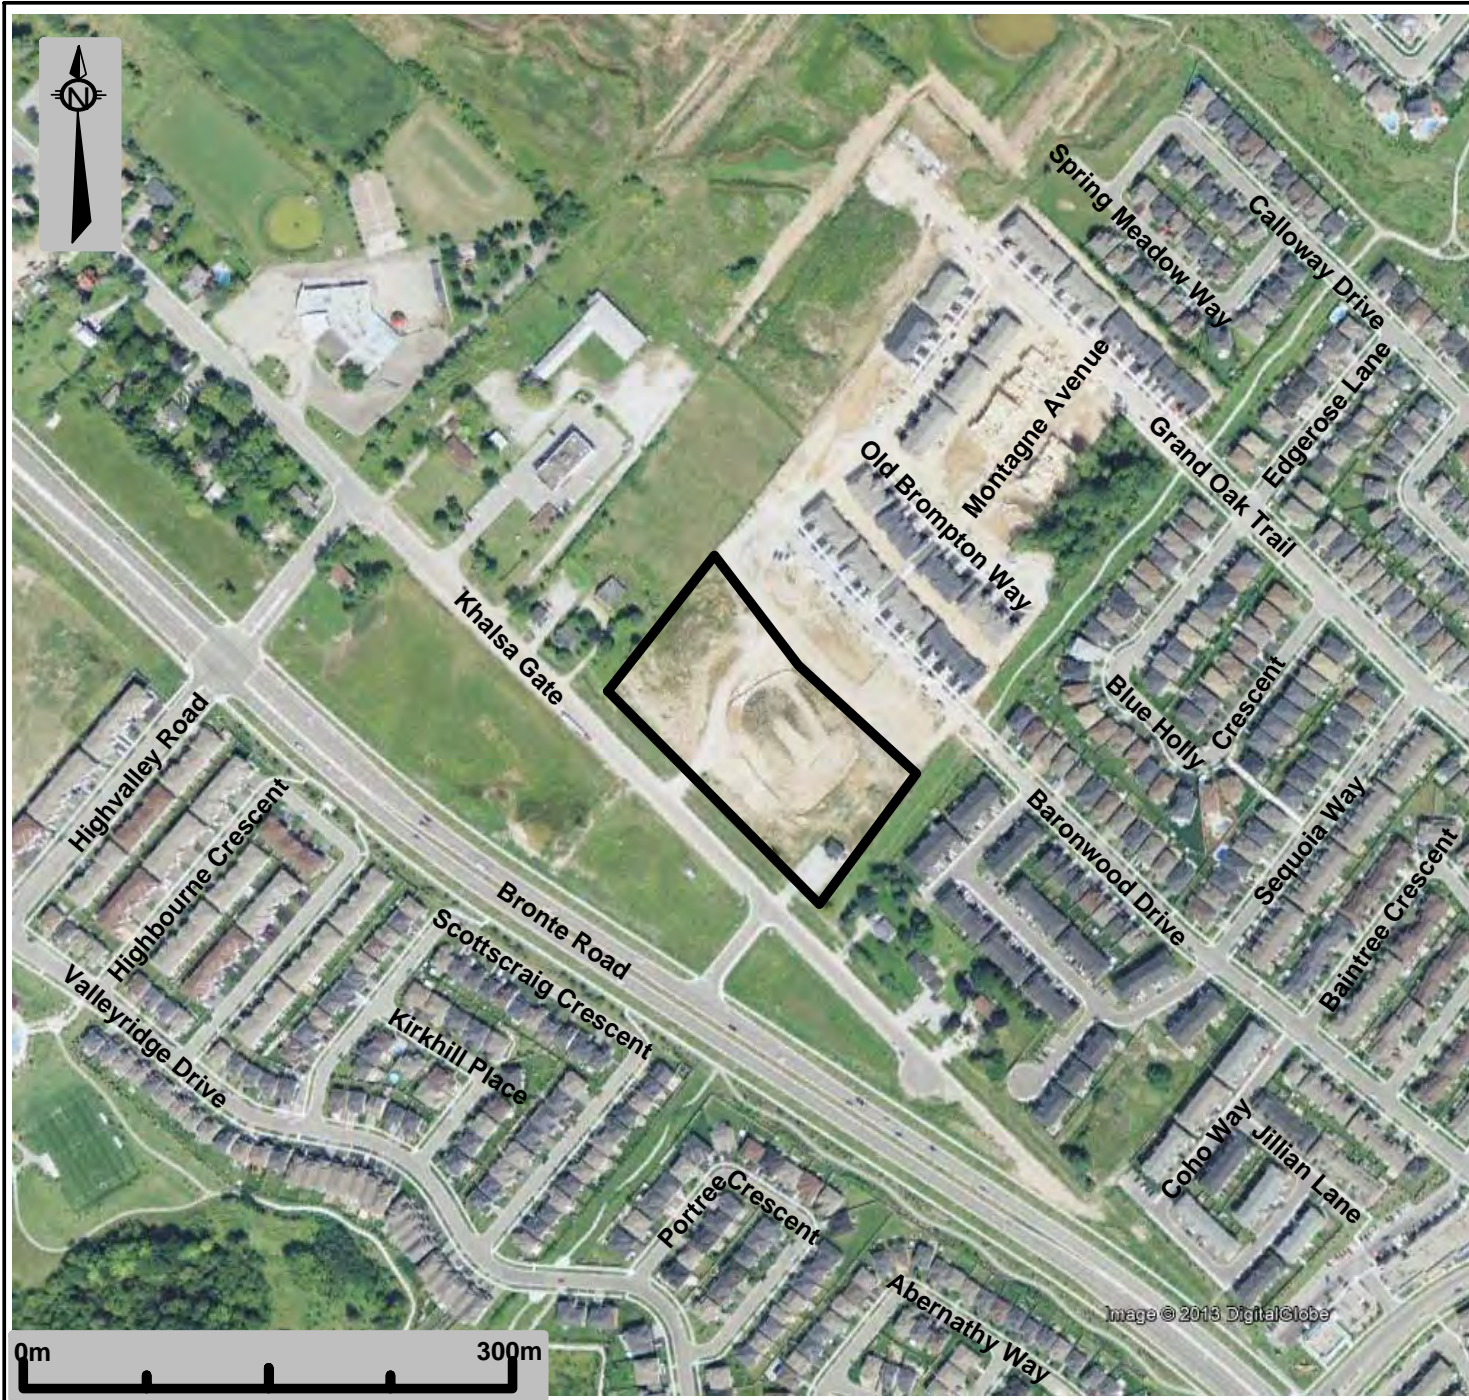
**DRAWING No. 2**

The Phase I ESA Study Area consists of the lands generally in a 250-metre radius from the limits of the Phase I ESA property.

These lands include a mixture of vacant lands and residential lands. The research undertaken during this Phase I ESA revealed no information that suggests there is a potential contaminating activity ["PCA"] on a property located in the Phase I ESA Study Area that may result in an adverse environmental impact to the Phase I ESA property.

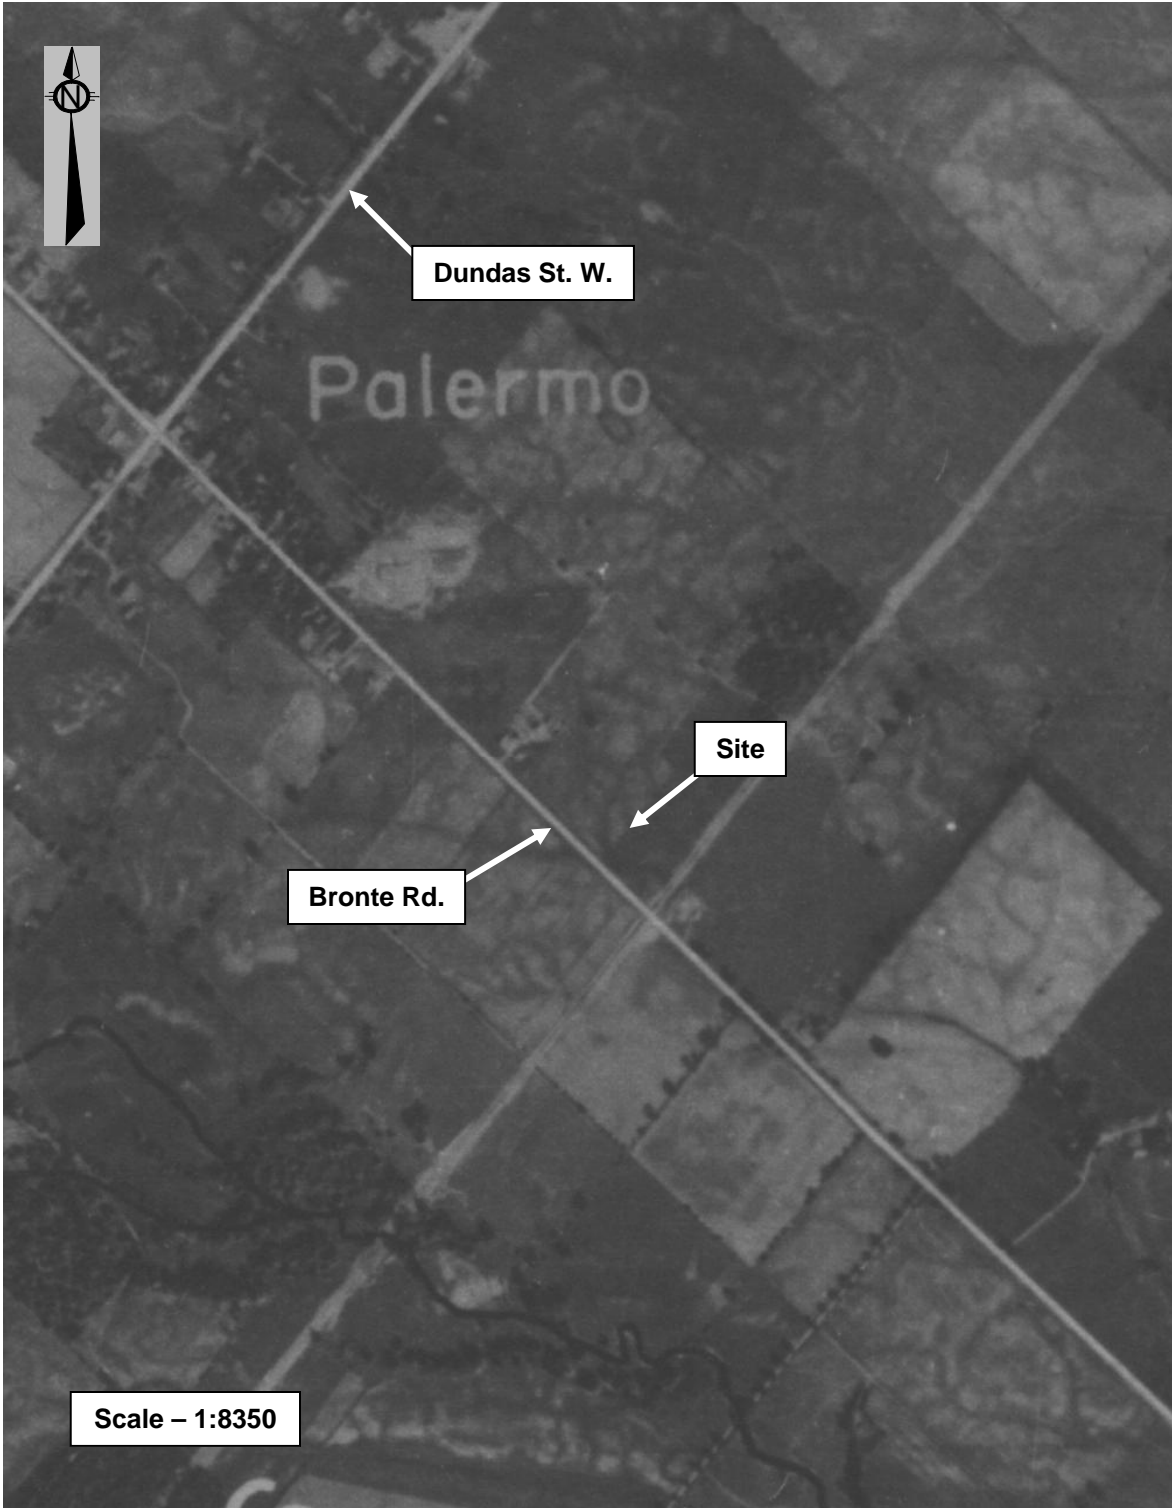
**Aerial Photo – 1954**

Aerial Photo	Site Description	Description of Adjacent Lands
1954 [1:8350]	The Site is comprised of vacant agricultural land.	The surrounding lands are comprised of primarily vacant agricultural lands with some residential along Bronte Road and Dundas Street West. It also appears that the natural gas pipeline adjacent to the south has been recently installed.
1960 [1:9700]	There are no significant changes to the Site.	There are no significant changes to the surrounding lands.
1978 [1:4850]	There are no significant changes to the Site.	Aside from a golf course to the south of the Site, there are no significant changes to the surrounding lands.
1988 [1:7800]	There are no significant changes to the Site.	There are no significant changes to the surrounding lands.
2004 [1:12,100]	There are no significant changes to the Site.	The golf course no longer exists and there is residential development to the west, east and south of the Site.

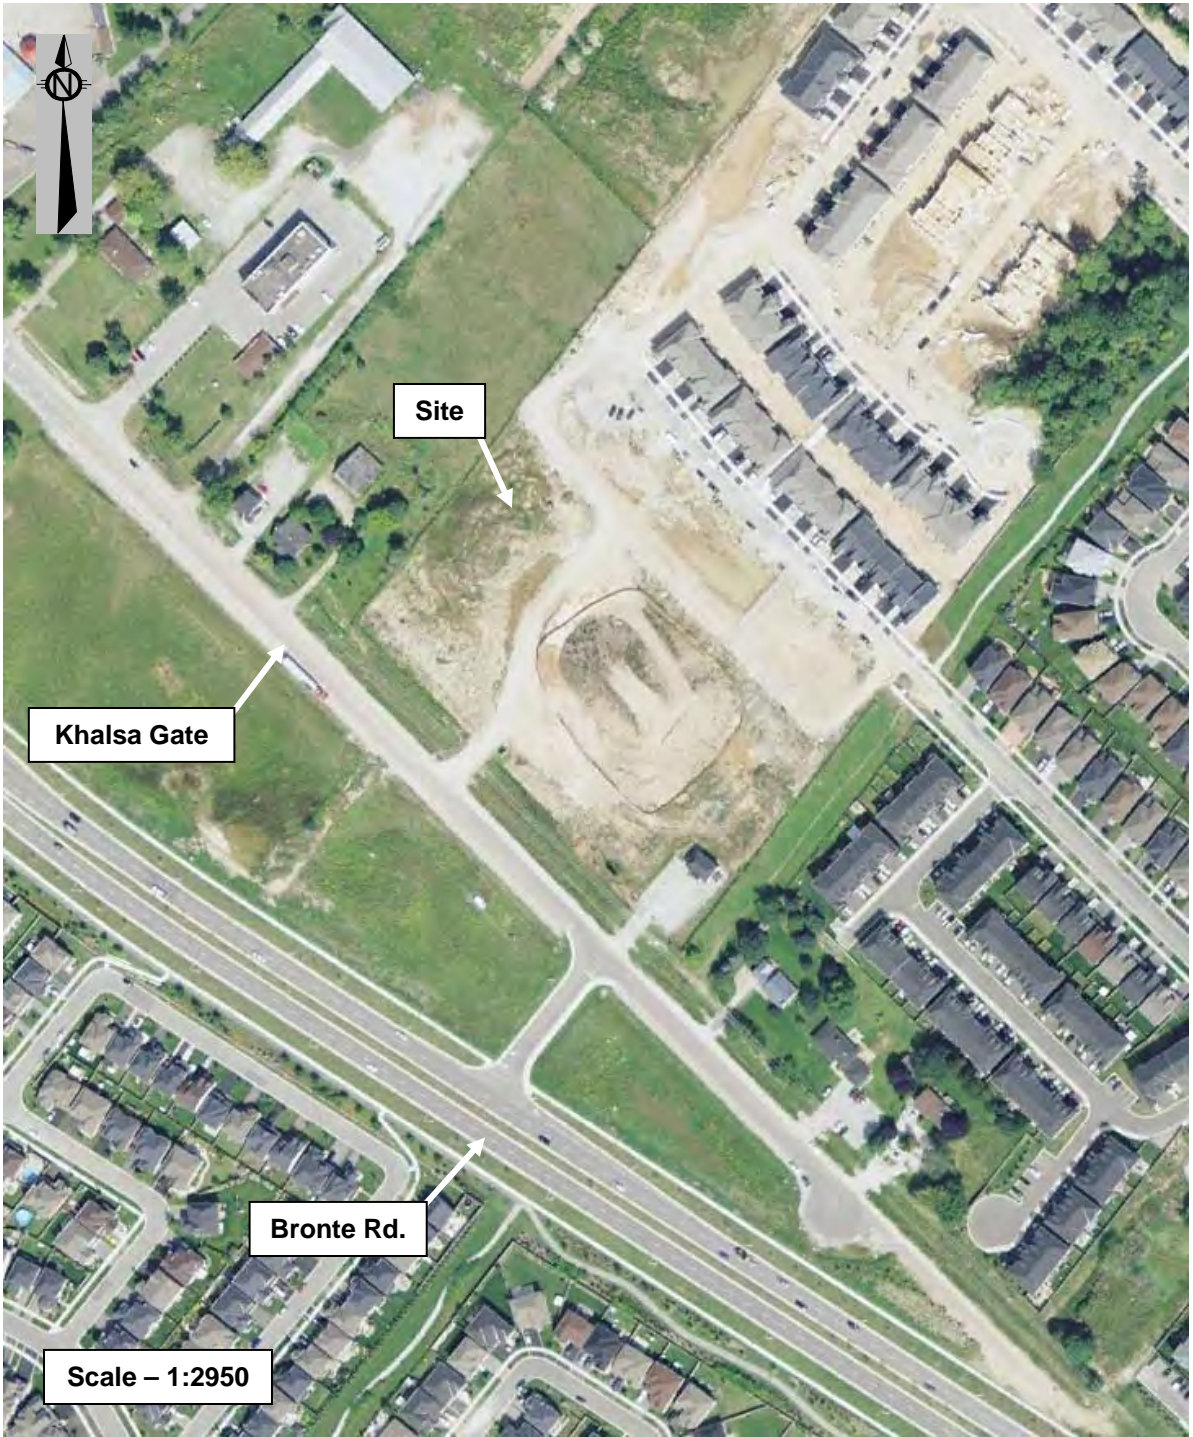
**Aerial Photo – 2009**

2009 [1:2950]	There is a sales office towards the southwest corner of the Site and there is a gravel roadway that runs east-west on the northern portion of the Site. The large soil stockpile is visible to the northeast of the sales office.	There is further residential development to the northeast.
