Phase One Environmental Site Assessment

3056 Neyagawa Boulevard & 1039 Dundas Street West
Oakville, Ontario

NEATT Sixteen Mile Creek Inc.
5926 Chercover Court
Burlington, ON
L7L 6T1

DS Project No : 22-012-101
Date: 2024-04-18

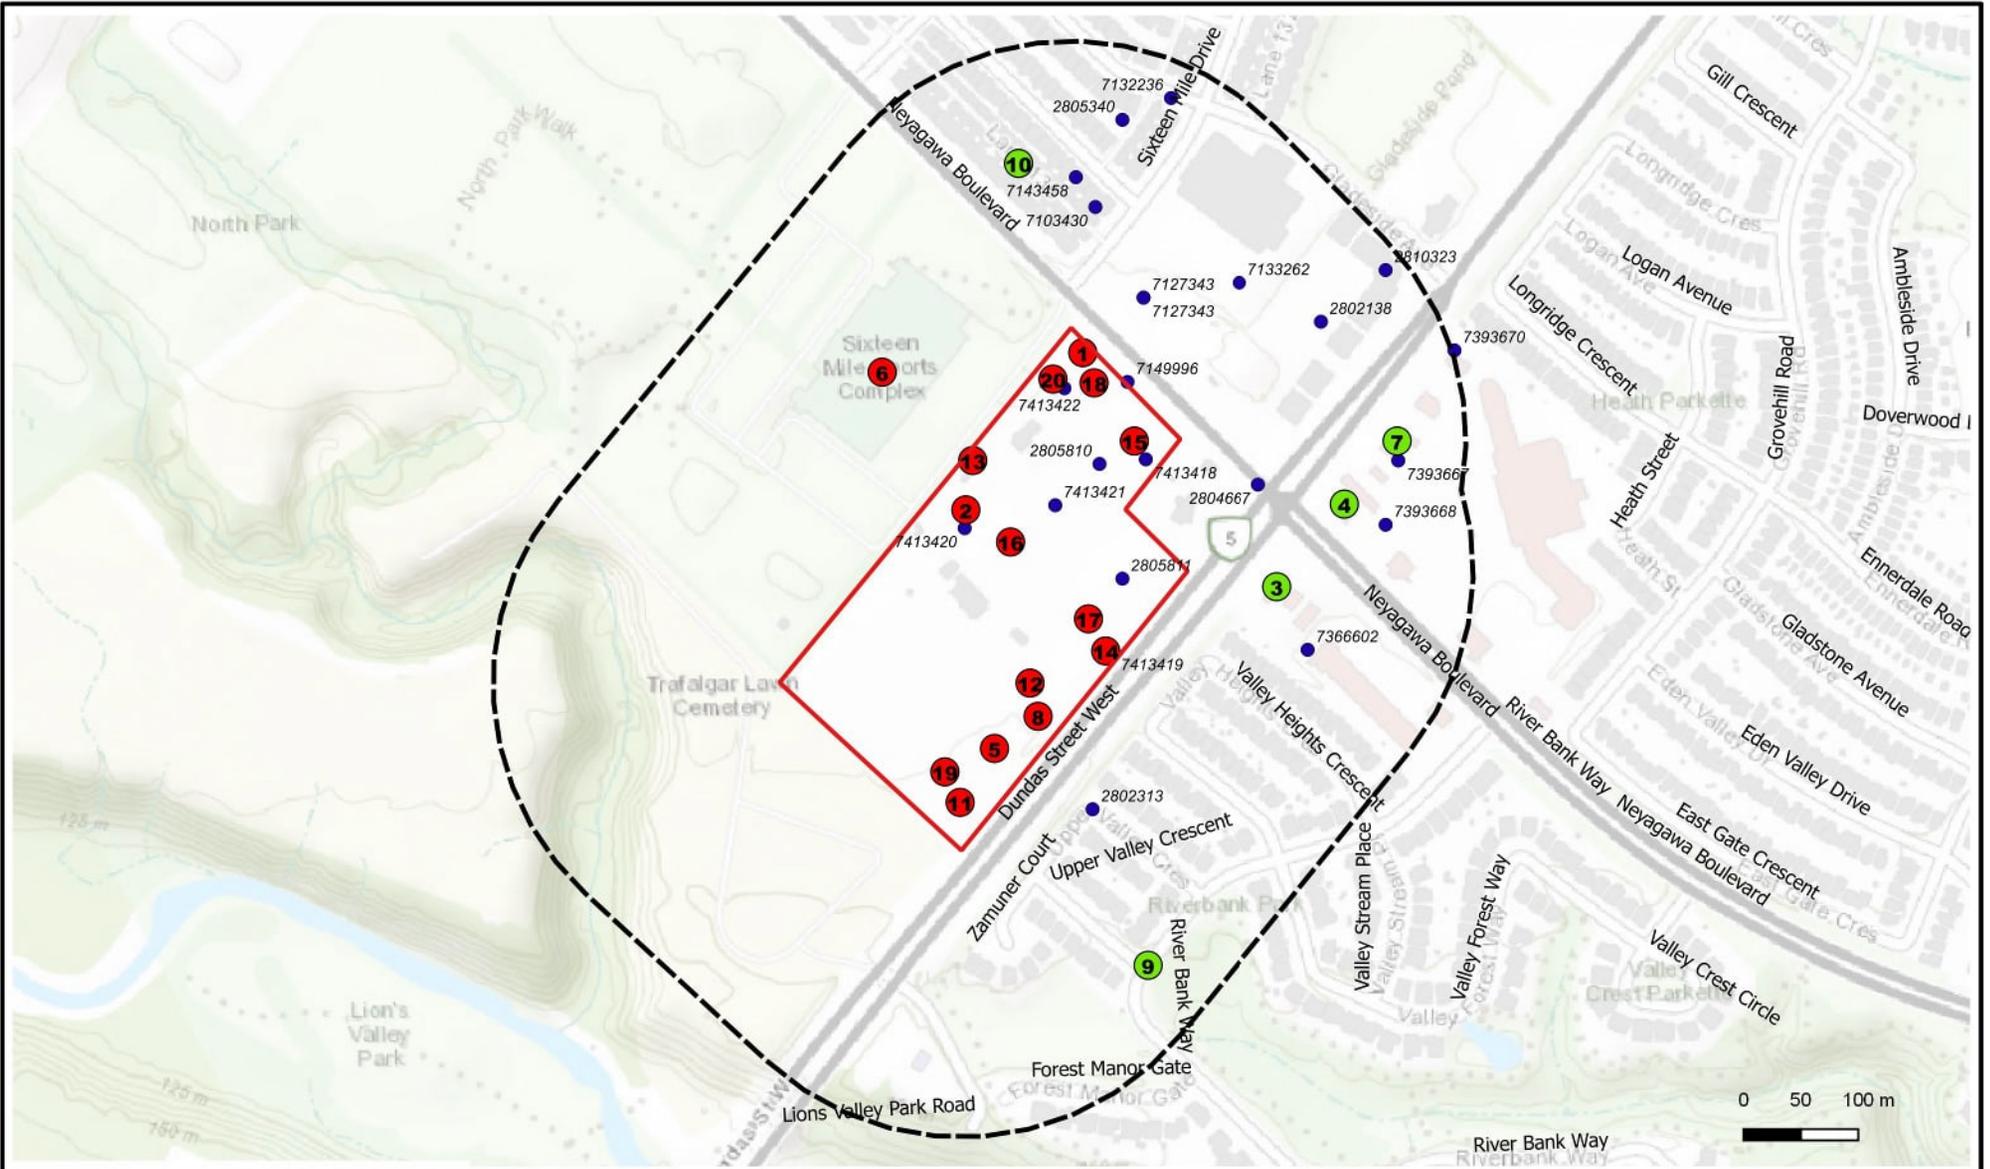
Size: 8.5 x 11	Approved By: R.F	Drawn By: P.P	Date: December 2023
Rev: 0	Scale: As Shown	Project No.: 22-012-101	Figure No.: 4
Image/Map Source: Esri Topo Image

- Property Boundary
- 250m Buffer
- PCA not contributing to APEC
- PCA contributing to APEC
- Registered Water Well (MECP WWR)

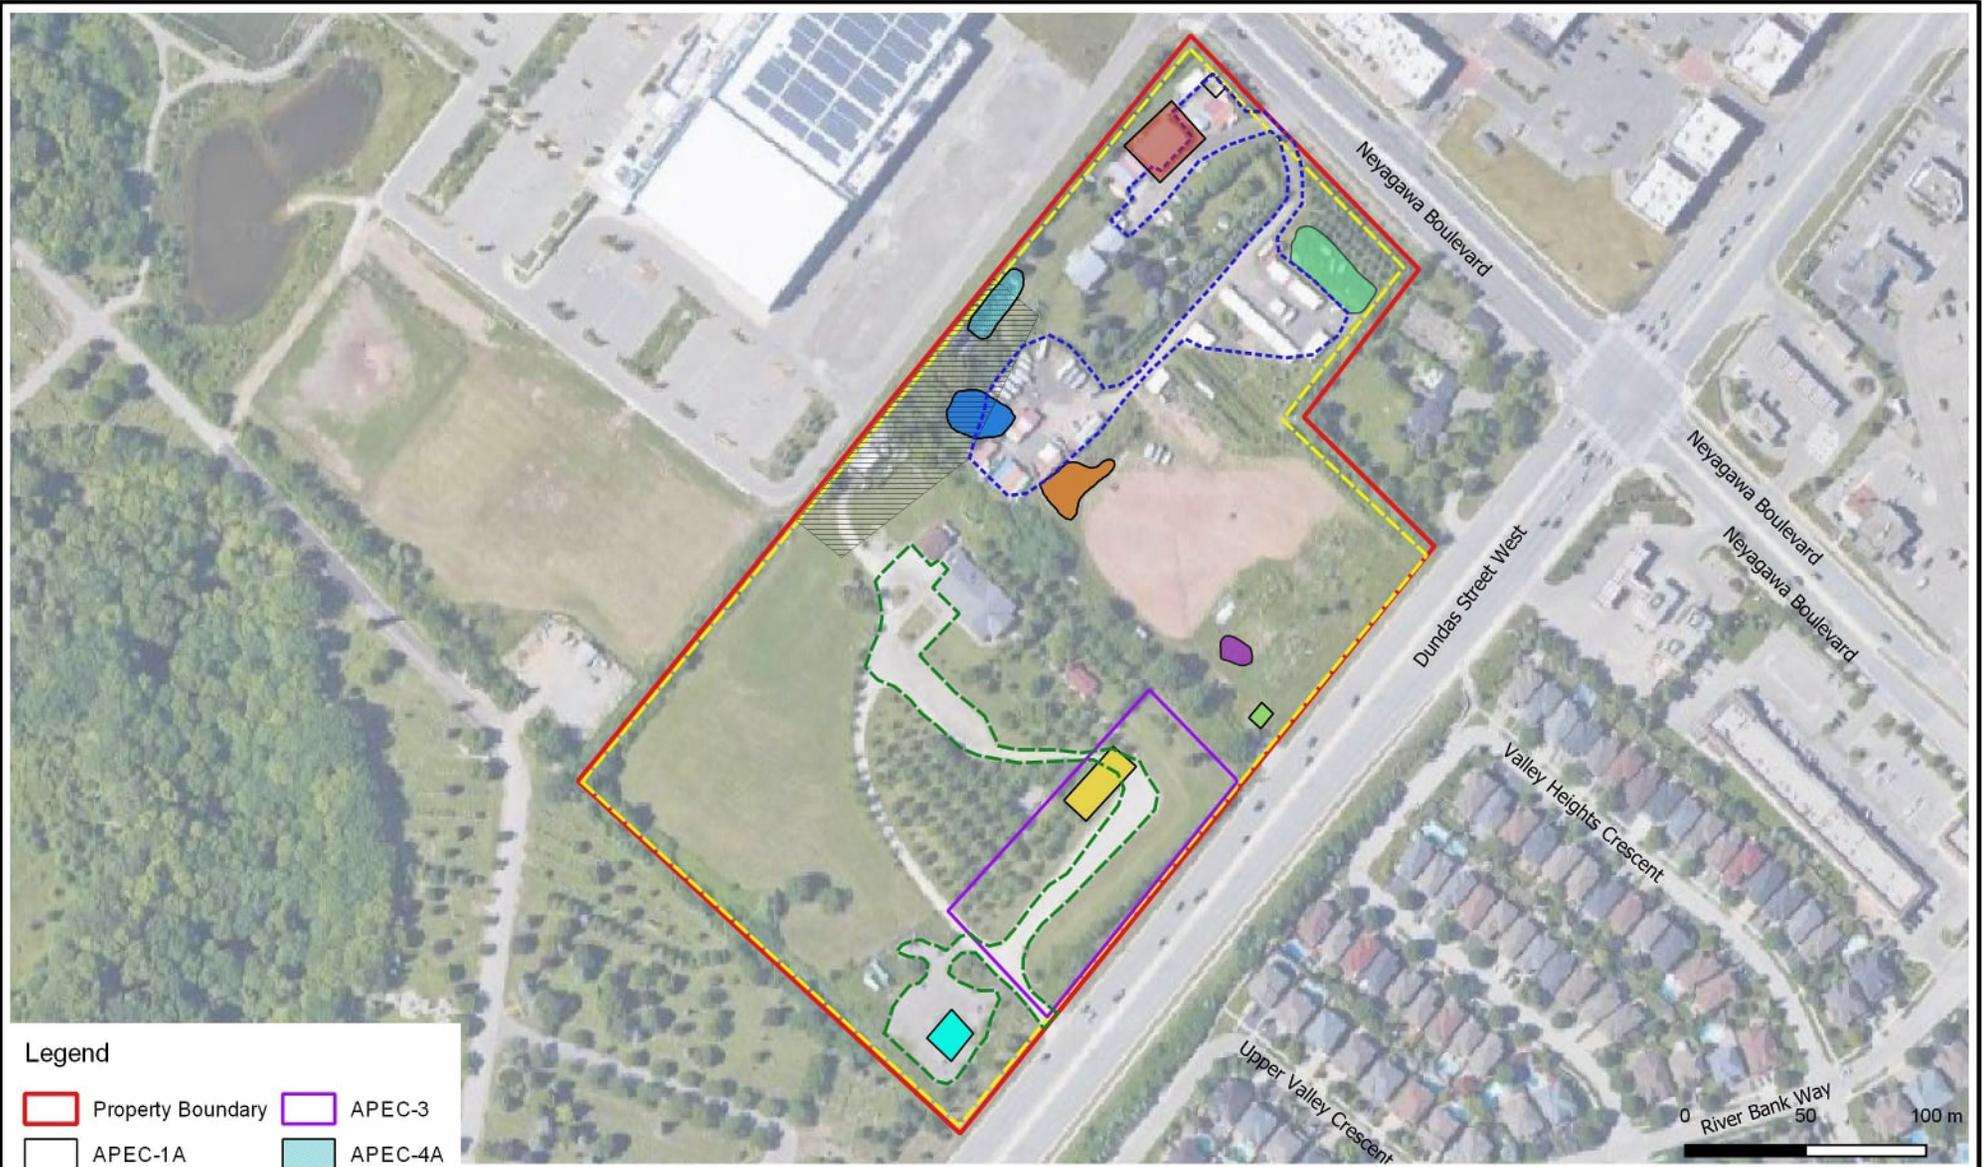
- Property Boundary
- APEC-1A
- APEC-1B
- APEC-1C
- APEC-1D
- APEC-1E
- APEC-1F
- APEC-2
- APEC-3
- APEC-4A
- APEC-4B
- APEC-4C
- APEC-4D
- APEC-5A
- APEC-5B
- APEC-6

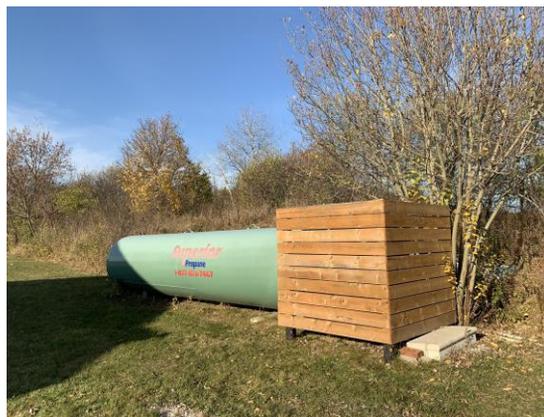
Picture 20: View of the propane tank on the northern portion of the Property, facing northeast.

- Mr. Rauscher indicated that he is not aware of any above or below ground storage tanks present on the Site. Mr. Prostran mentioned an aboveground natural gas (propane) tank is present on-Site, east of Site Building C.

ii.	Details of existing and former heating systems, including type and fuel source	The Property is municipally serviced with natural gas.	The Property utilizes propane gas from a holding tank located east of Site Building C.
iii.	Details of cooling systems, including type and fuel source, if any	None observed.	None observed.
iv.	Details of any drains, pits and sumps, including their current use, if any, and former use	None observed.	None observed.

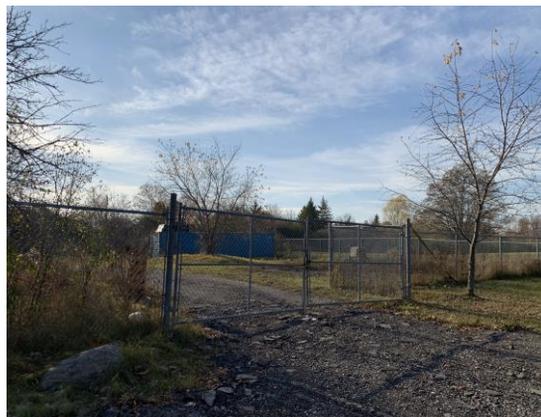
Picture 28: View of the fenced area on the southwestern portion of the Property, facing north.

- Mr. Rauscher indicated fill material is present on the Site, per his knowledge of the Phase One ESA completed by AEL. Mr. Prostran indicated that fill material is suspected to have been used when the southwestern portion of the Site was graded with an asphalt parking area.

v.	Details of any unidentified substances	None observed.	None observed.
vi.	Details, including locations of stains or corrosion on floors other than from water, where located near a drain, pit, sump, crack or other potential discharge location	None observed.	None observed.
vii.	Details, including locations, of current and former wells, including all wells described or defined in or under the <i>Ontario Water Resources Act</i> and the <i>Oil, Gas and Salt Resources Act</i>	None observed.	A domestic water well was observed on the southern portion of the Property, along the driveway, southwest of the playground.
viii.	Details of sewage works, including their location	None observed.	An underground septic tank was observed along the eastern elevation of Site Building C.
ix.	Details of ground surface, including type of ground cover, such as grass, gravel, soil or pavement	A gravel driveway is present within the northeastern, western and central portions of the Site. The southern portion of the Site was comprised of agricultural land, the remainder of the Site was landscaped grass, trees and shrubbery	A gravel paved driveway winds through the Site in a north-south orientation connecting Site Buildings C, D and E to Dundas Street West. The remaining balance of the Site was landscaped grass, trees and shrubbery. A small asphalt paved playground is present on the south-central portion of the Site along the gravel driveway. Towards the southwestern portion of the Site is an asphalt paved fenced area.

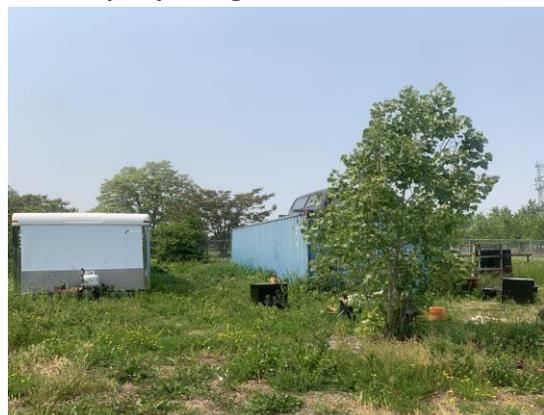
Picture 29: View of the abandoned trailers within the fenced area, facing north.

Two abandoned trailers can be observed on the asphalt paved area along the southwestern portion of the Site.	N/A
East of the Site	The east adjacent properties appear to be developed with a commercial plaza.	N/A
South, North, West of the Site	No significant changes.	N/A
2022		
Phase One Property	No significant changes.	N/A
North, South, East and West of the Site	No significant changes.	N/A

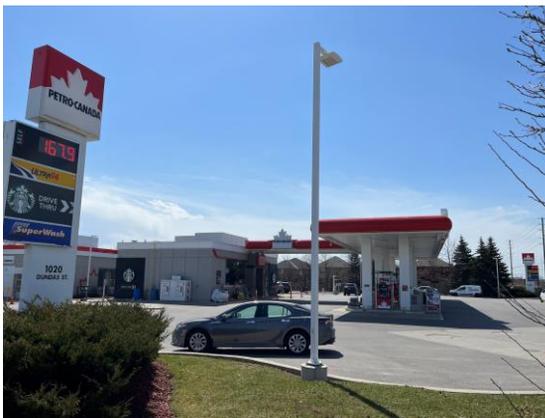
Picture 33: View of the RFO south of the Phase One Property (1020 Dundas St W, Petro Canada), facing west.

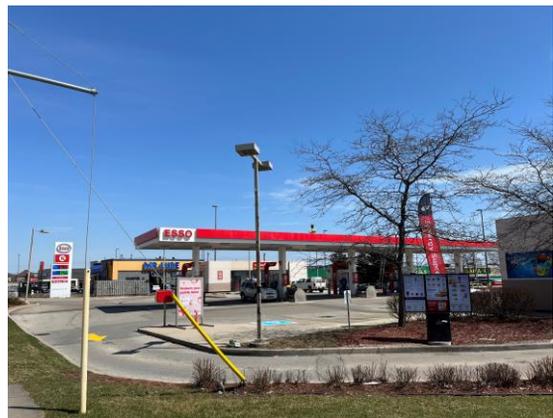
Picture 34: View of the RFO south of the Phase One Property (520 Dundas St W, Esso), facing east.

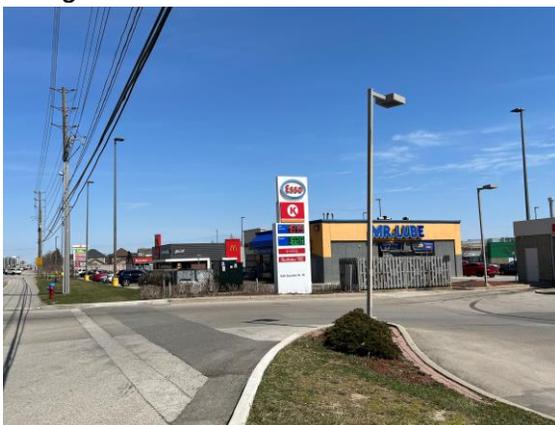
Picture 35: View of vehicle servicing shop (MR. LUBE) south of the Property, facing east.
