PROJECT No.: SM 190711-E

**PHASE TWO ENVIRONMENTAL SITE ASSESSMENT  
2170 POSTMASTER DRIVE  
OAKVILLE, ONTARIO**

**PHASE TWO ENVIRONMENTAL SITE ASSESSMENT  
PROPOSED RESIDENTIAL DEVELOPMENT  
2170 POSTMASTER DRIVE  
OAKVILLE, ONTARIO**

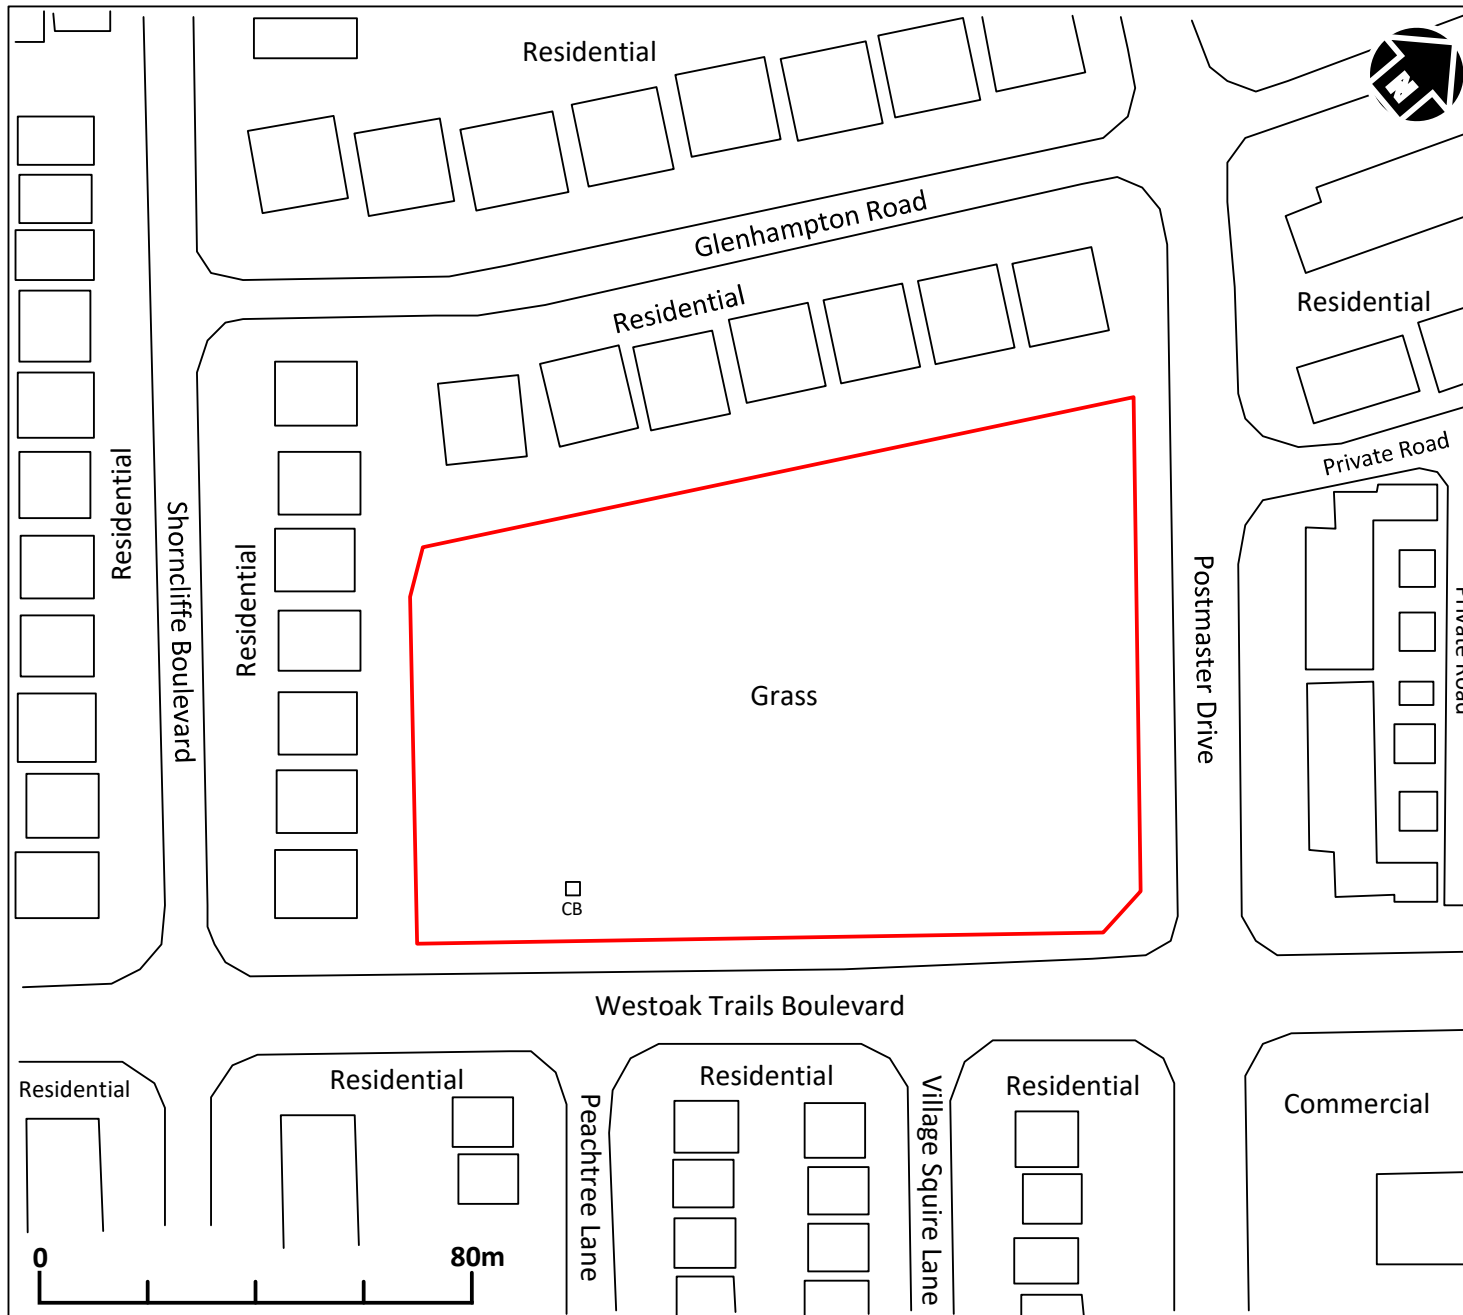
The Site is comprised of an irregular shaped parcel of vacant, undeveloped land on the northwest corner of Postmaster Drive and Westoak Trails Boulevard in the Town of Oakville, Ontario. For descriptive purposes, Postmaster Drive has been designated as having a north-south alignment.
