B.I.G.
CONSULTING
INC.

SUPPLEMENTAL
HYDROGEOLOGICAL
INVESTIGATION

3064 Trafalgar Road, Oakville, Ontario

April 17, 2024 (Revision 4)

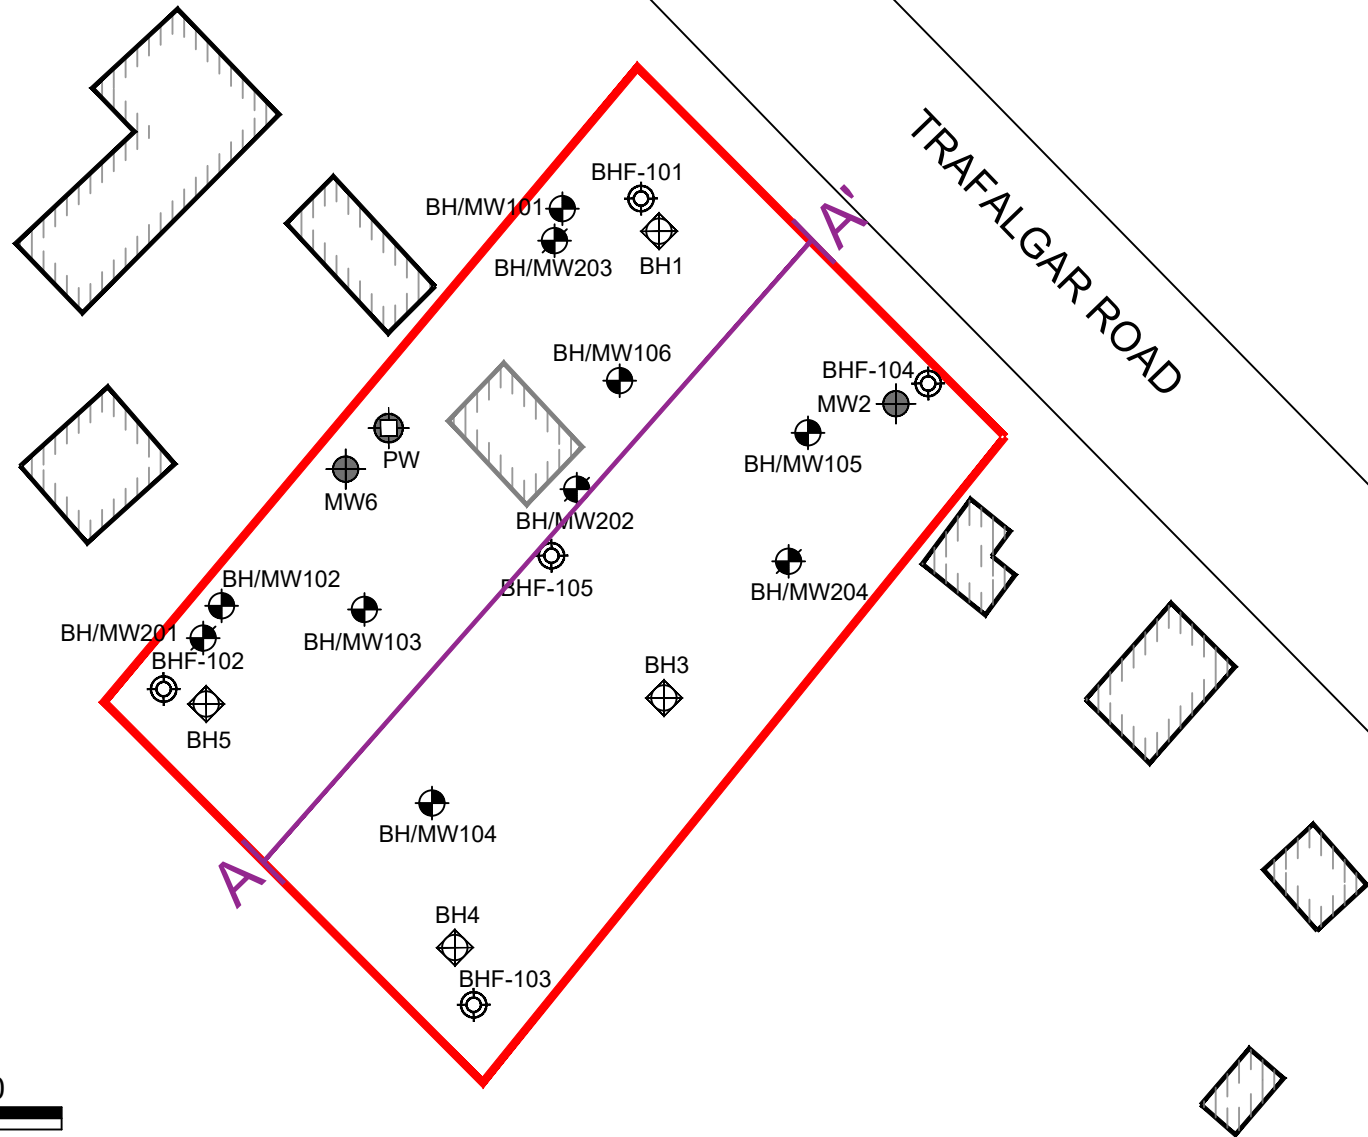
| DATE NOVEMBER 2021 | FIG NO. 6 |

The borehole locations are shown on Figure 6 and detailed subsurface conditions are presented on the borehole logs in Appendix A. The following table is provided in addition to the borehole descriptions to provide a general summary of the soil conditions. The soil descriptions are predominately based on BIG's investigation, however, where applicable soil conditions encountered during previous investigation by others are included. The soil boundaries indicated on the borehole logs and discussed herein are inferred from the visual observations and auger resistance and should not be regarded as exact planes of geological change.

The soil conditions encountered at the borehole locations are summarized below. A stratigraphic cross-section across the property as aligned on Figure 6 is included as Figure 7.
