**PROJECT No.: SM 190711-E**

**PHASE ONE ENVIRONMENTAL SITE ASSESSMENT  
2170 POSTMASTER DRIVE  
OAKVILLE, ONTARIO**

**BRANTHAVEN DEVELOPMENT CORP.**

**SOIL-MAT ENGINEERS & CONSULTANTS LTD.  
130 LANCING DRIVE  
HAMILTON, ONTARIO  
L8W 3A1**

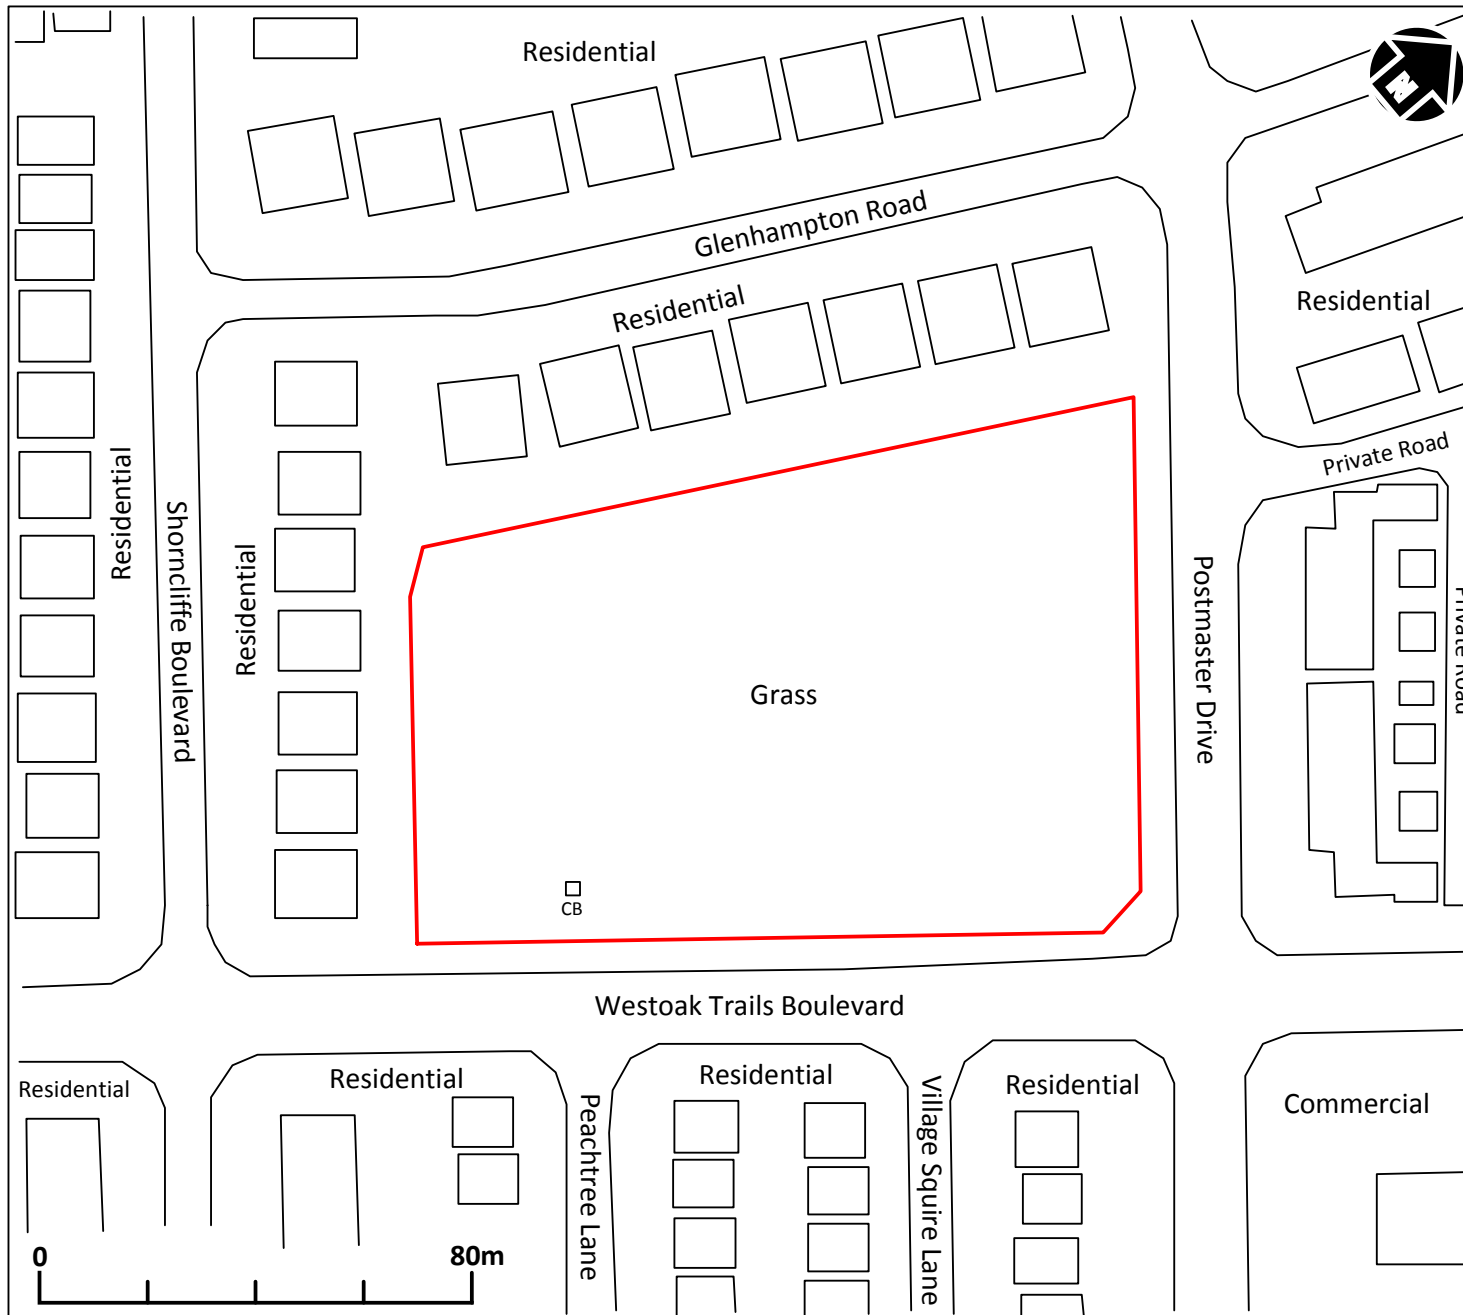
At the time of this Report, the Site was comprised of a vacant parcel of undeveloped land consisting primarily of grass covered lands and some low lying weeds.

The Site was bound to the north and west by existing residential lands, to the east by Postmaster Drive and to the south by Westoak Trails Boulevard.

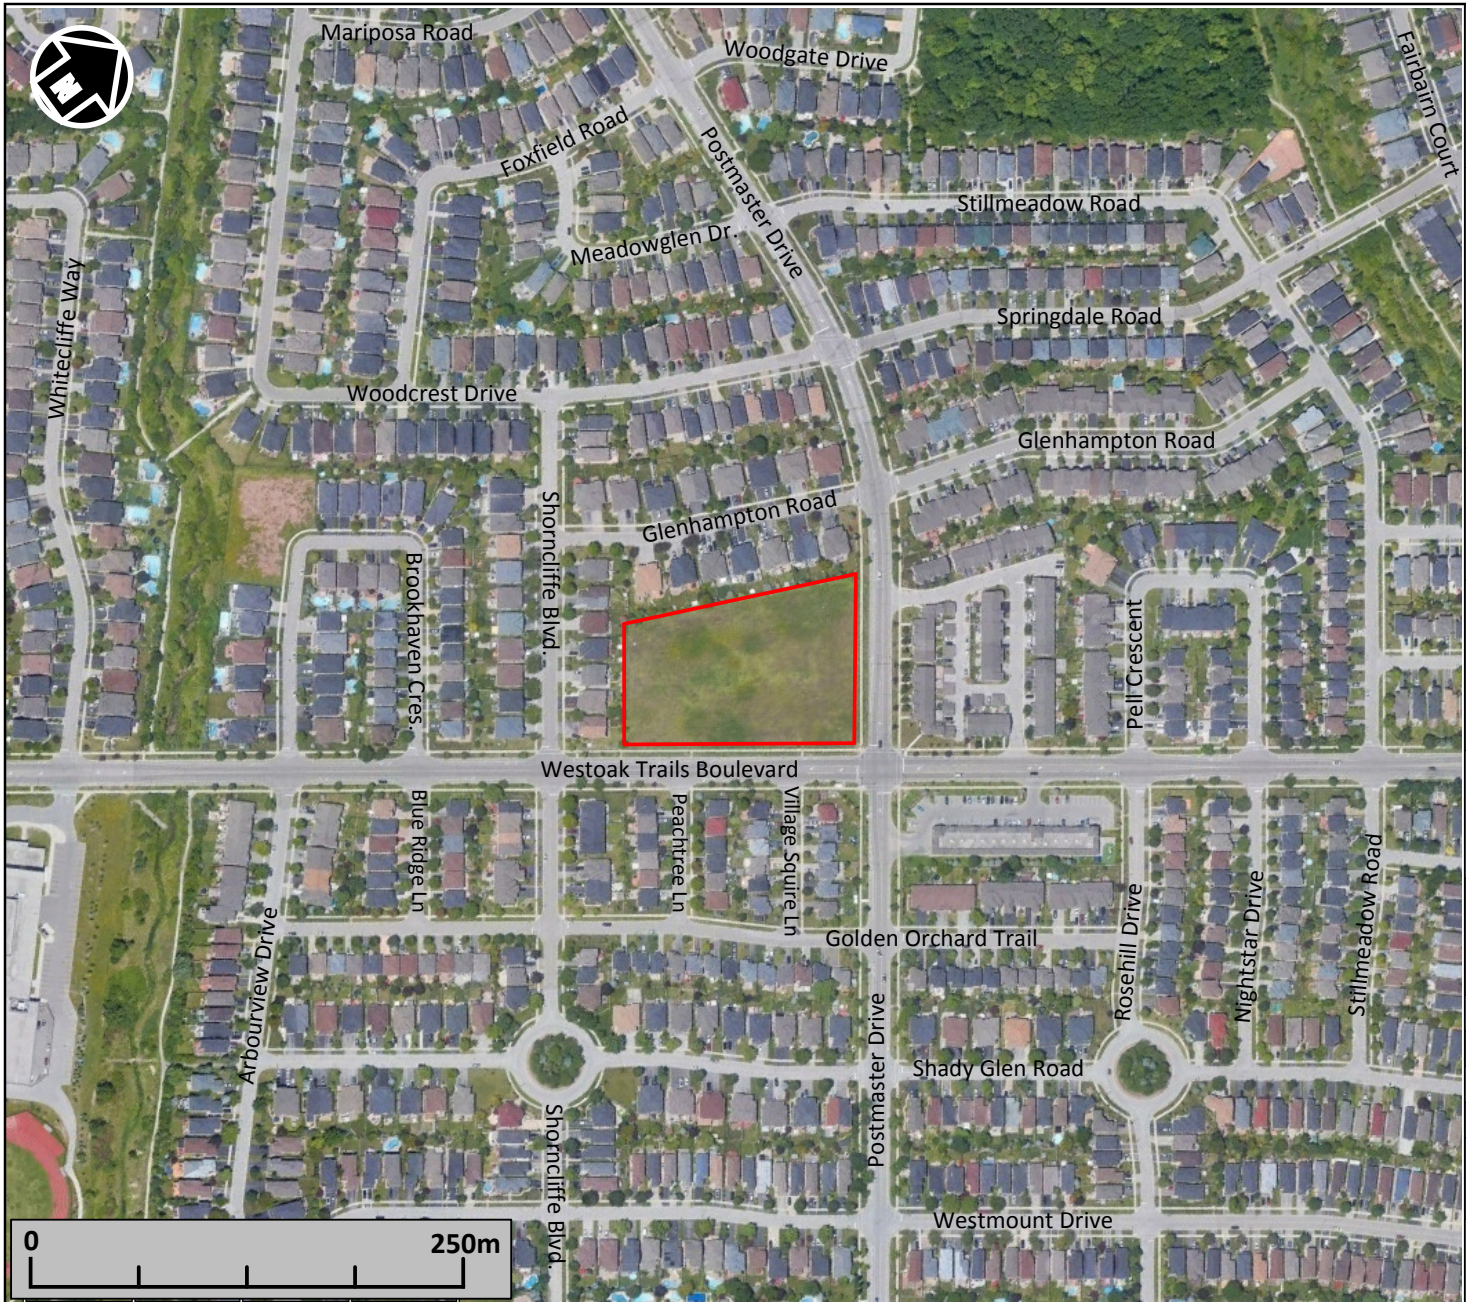
The Phase One ESA Study Area consists of the lands generally in a 250-metre radius from the limits of the Phase One ESA property. These lands are comprised primarily of a mixture of retail commercial and residential lands.

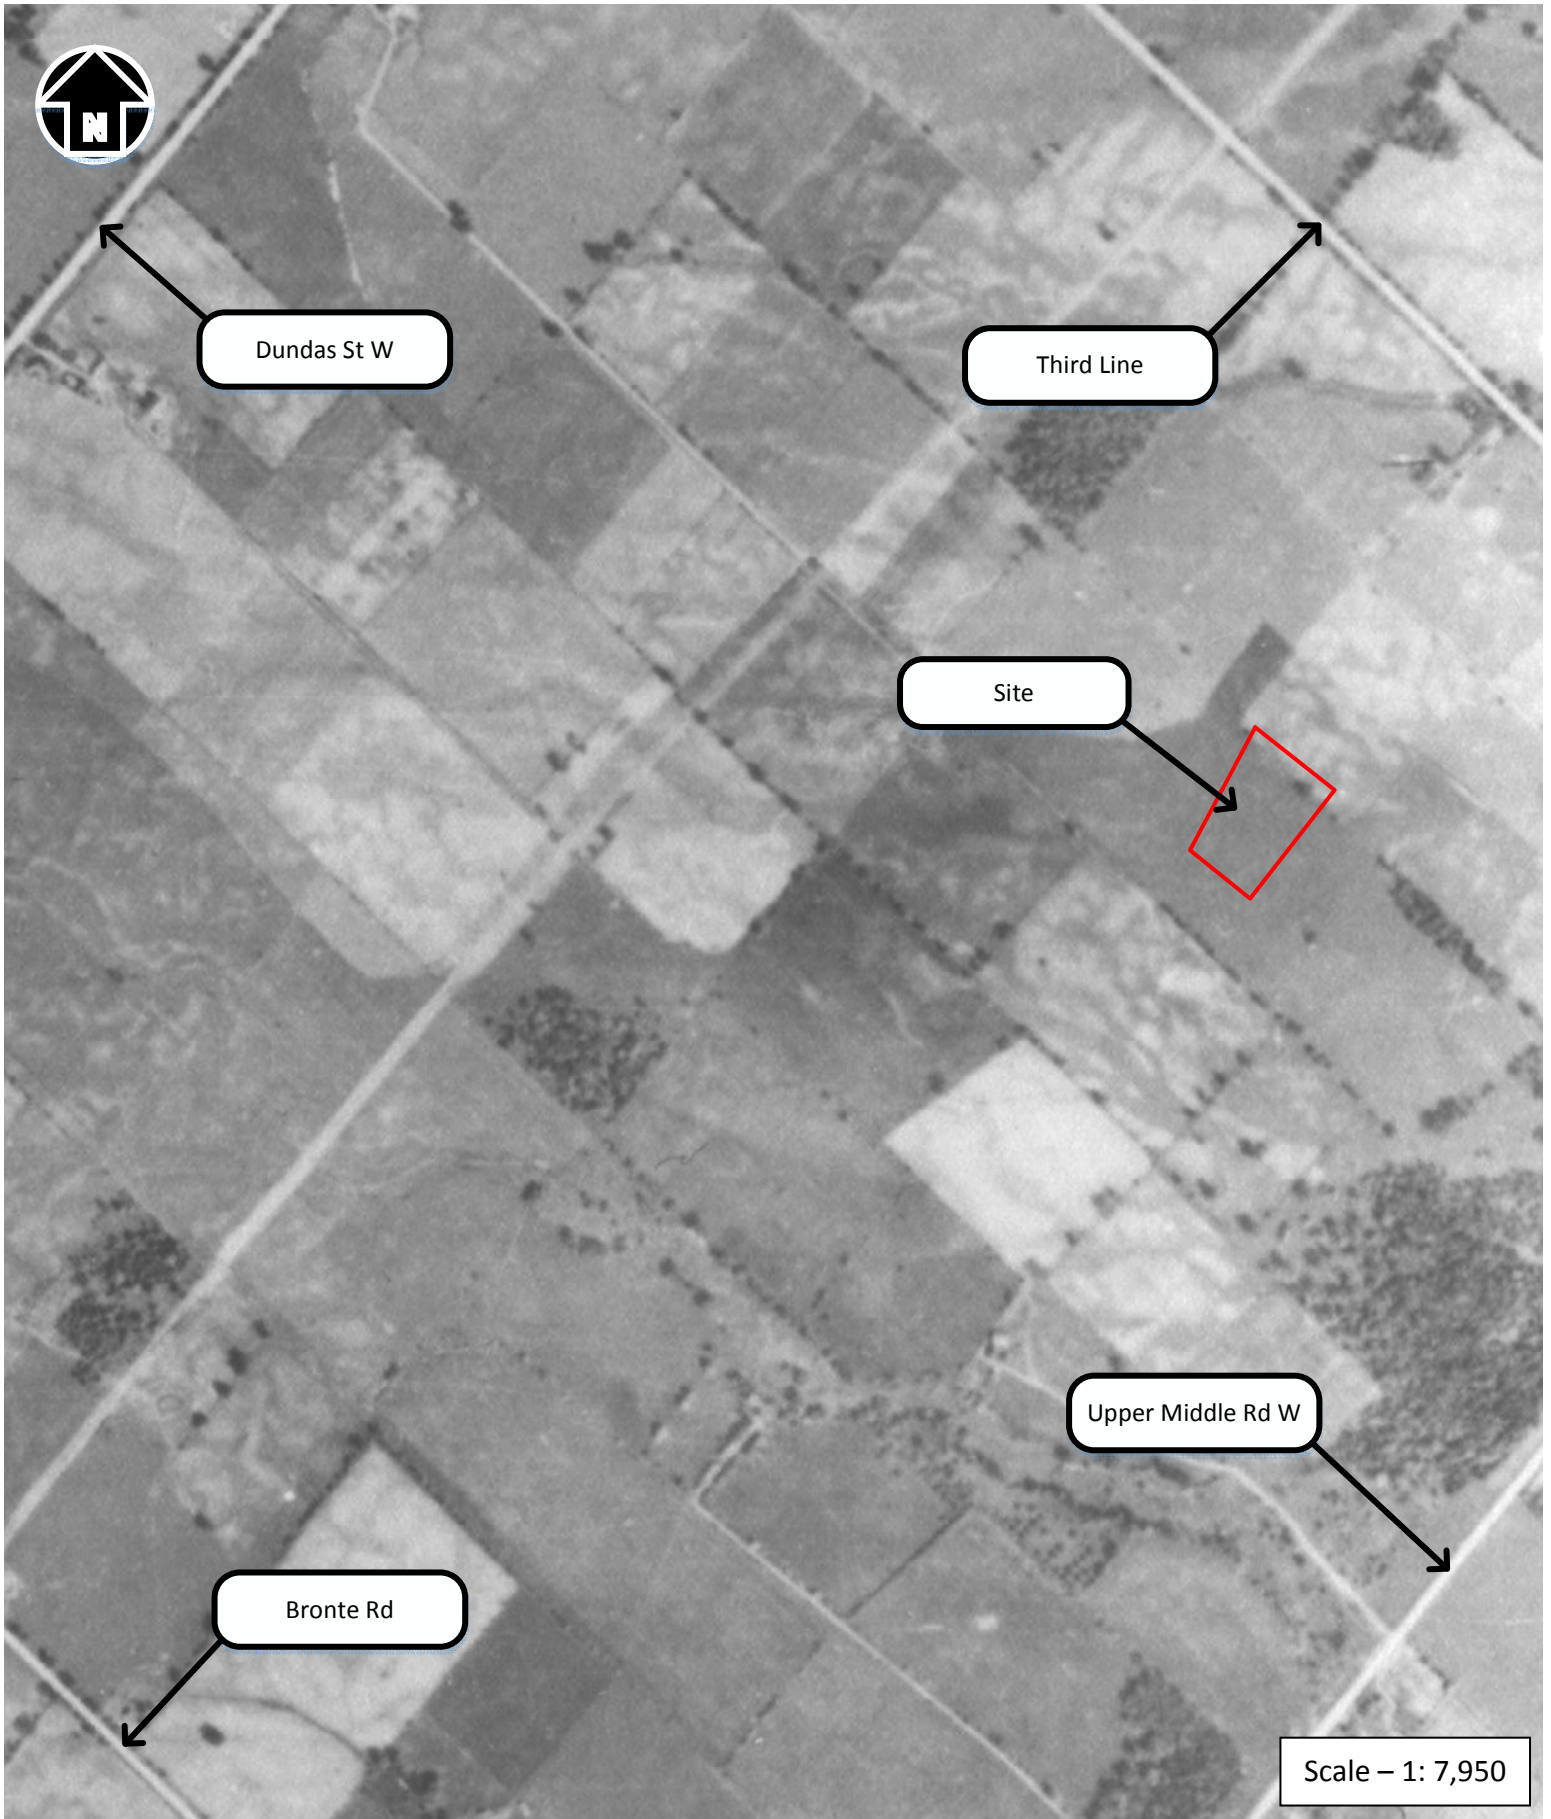
# Aerial Photo – 1954

Aerial Photo	Site Description	Description of Adjacent Lands
1954 [1:7,950]	There Site is comprised of fallow agricultural land	The surrounding lands are comprised primarily of fallow agricultural land with sparse residential and sparse forested areas.
1960 [1:7,300]	There are no significant changes to the Site.	There are no significant changes to the surrounding lands.
1978 [1:5,500]	There are no significant changes to the Site.	There are no significant changes to the surrounding lands.
1988 [1:7,100]	There are no significant changes to the Site.	There are no significant changes to the surrounding lands.
2004 [1:6,100]	The Site is no longer utilised as agricultural land, however, the Site remains undeveloped	There is significant residential development in all directions as well as some commercial development to the east of the Site.

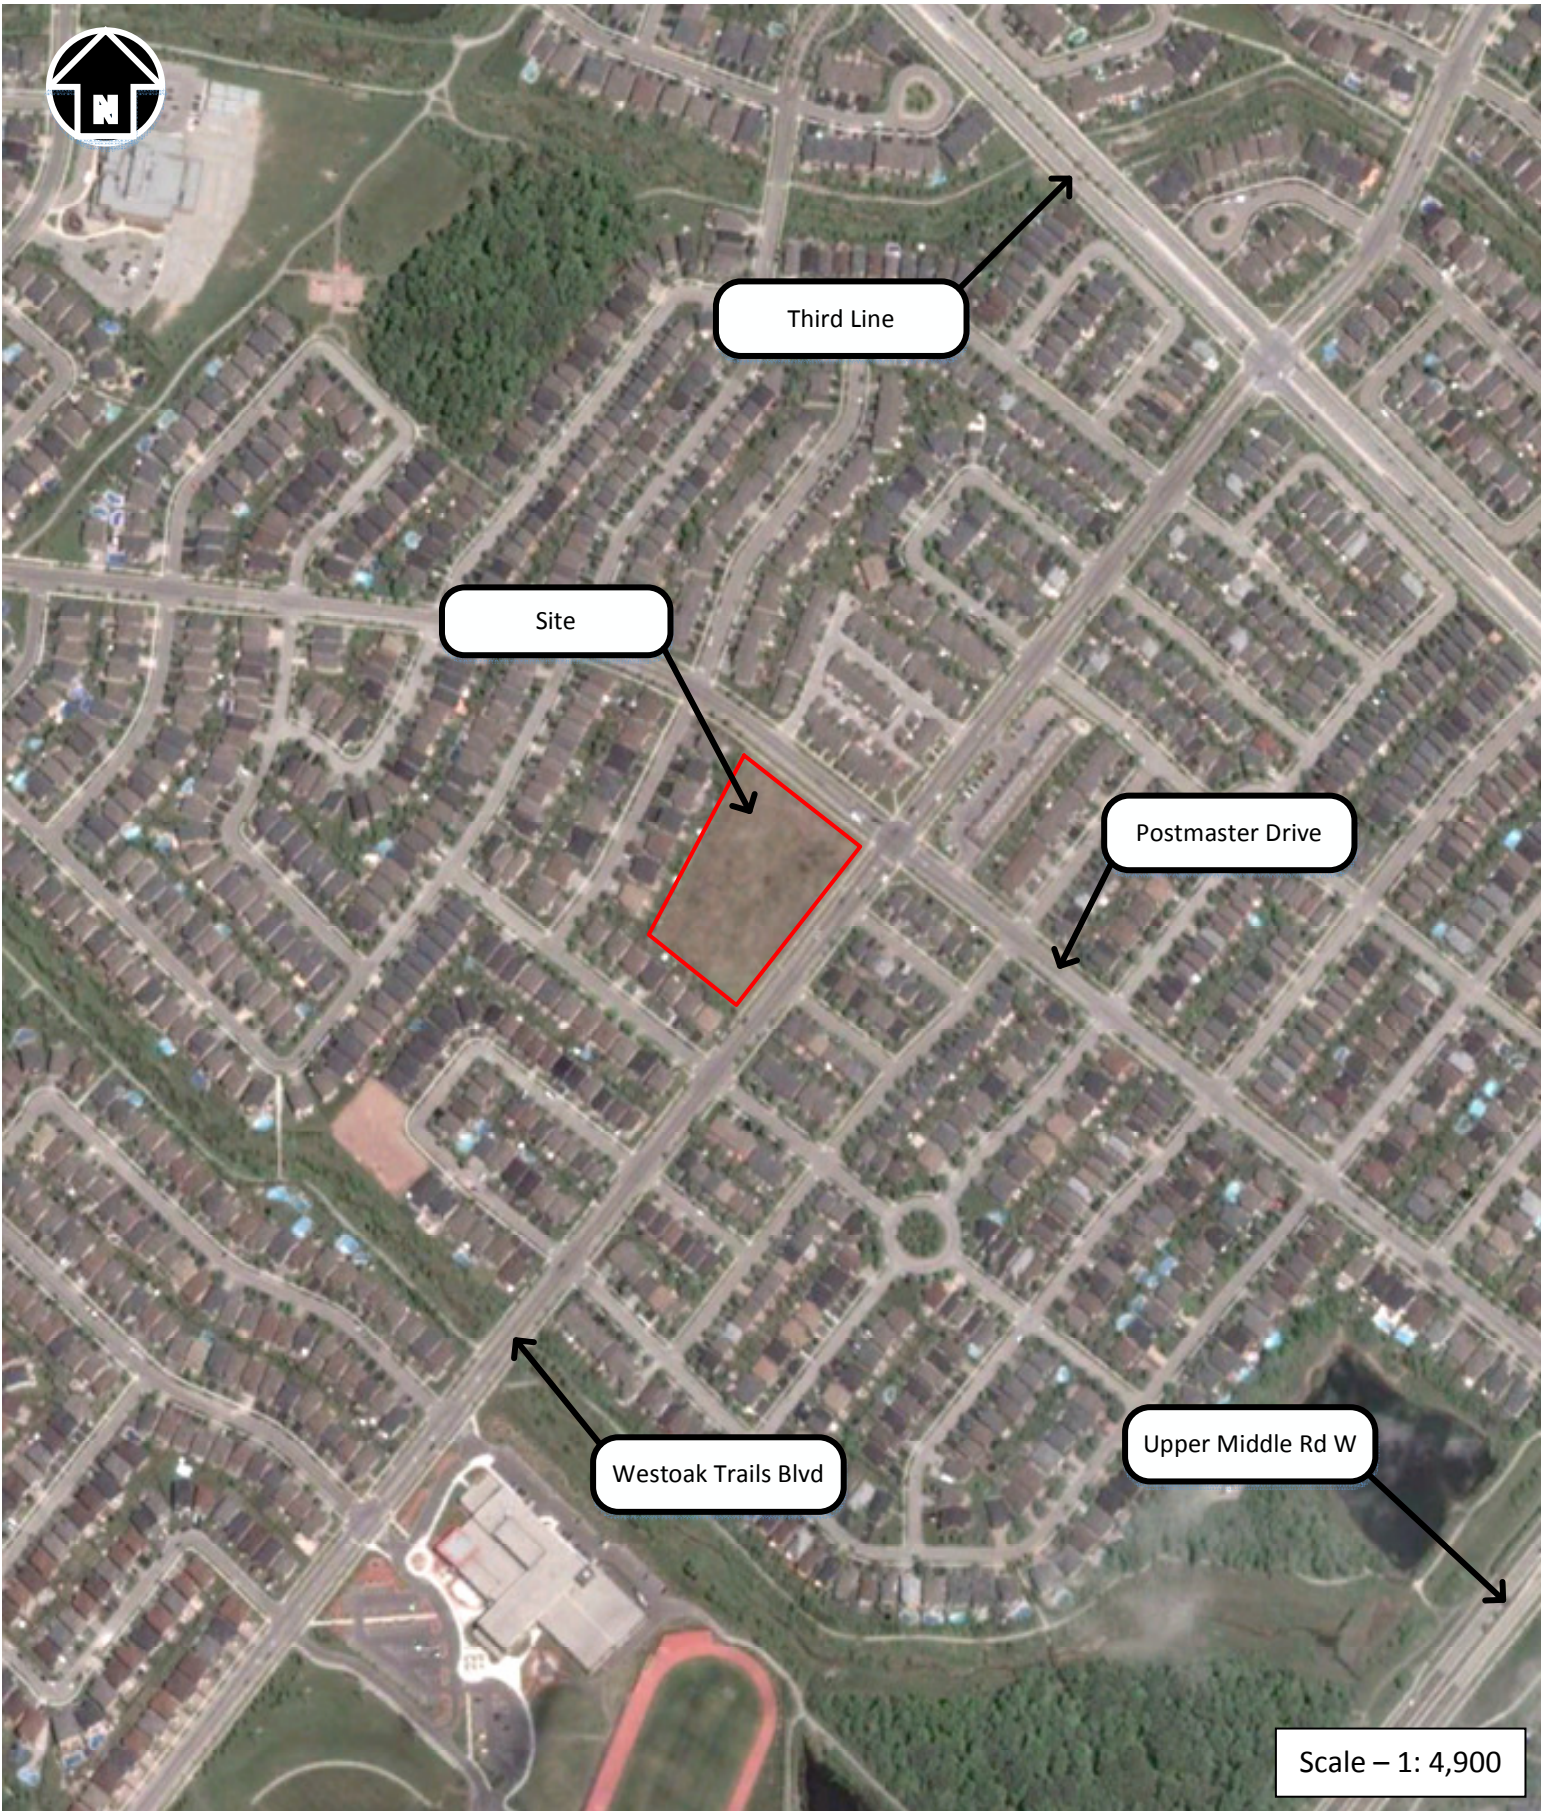
# Aerial Photo – 2013

Aerial Photo	Site Description	Description of Adjacent Lands
2013 [1:4,900]	There are no significant changes to the Site.	With the exception of some further residential development to the southwest as well as institutional to the distant south-southwest, there are no significant changes to the surrounding lands.
2018 [1:3,550]	There are no significant changes to the Site.	There are no significant changes to the surrounding lands.
