# Tree Management Plan

## **MATTAMY (JOSHUA'S CREEK NORTH) DRAFT PLAN OF SUBDIVISION**

# MATTAMY (JOSHUA'S CREEK NORTH) DRAFT PLAN OF SUBDIVISION TREE MANAGEMENT PLAN

**LGL FILE TA9380**

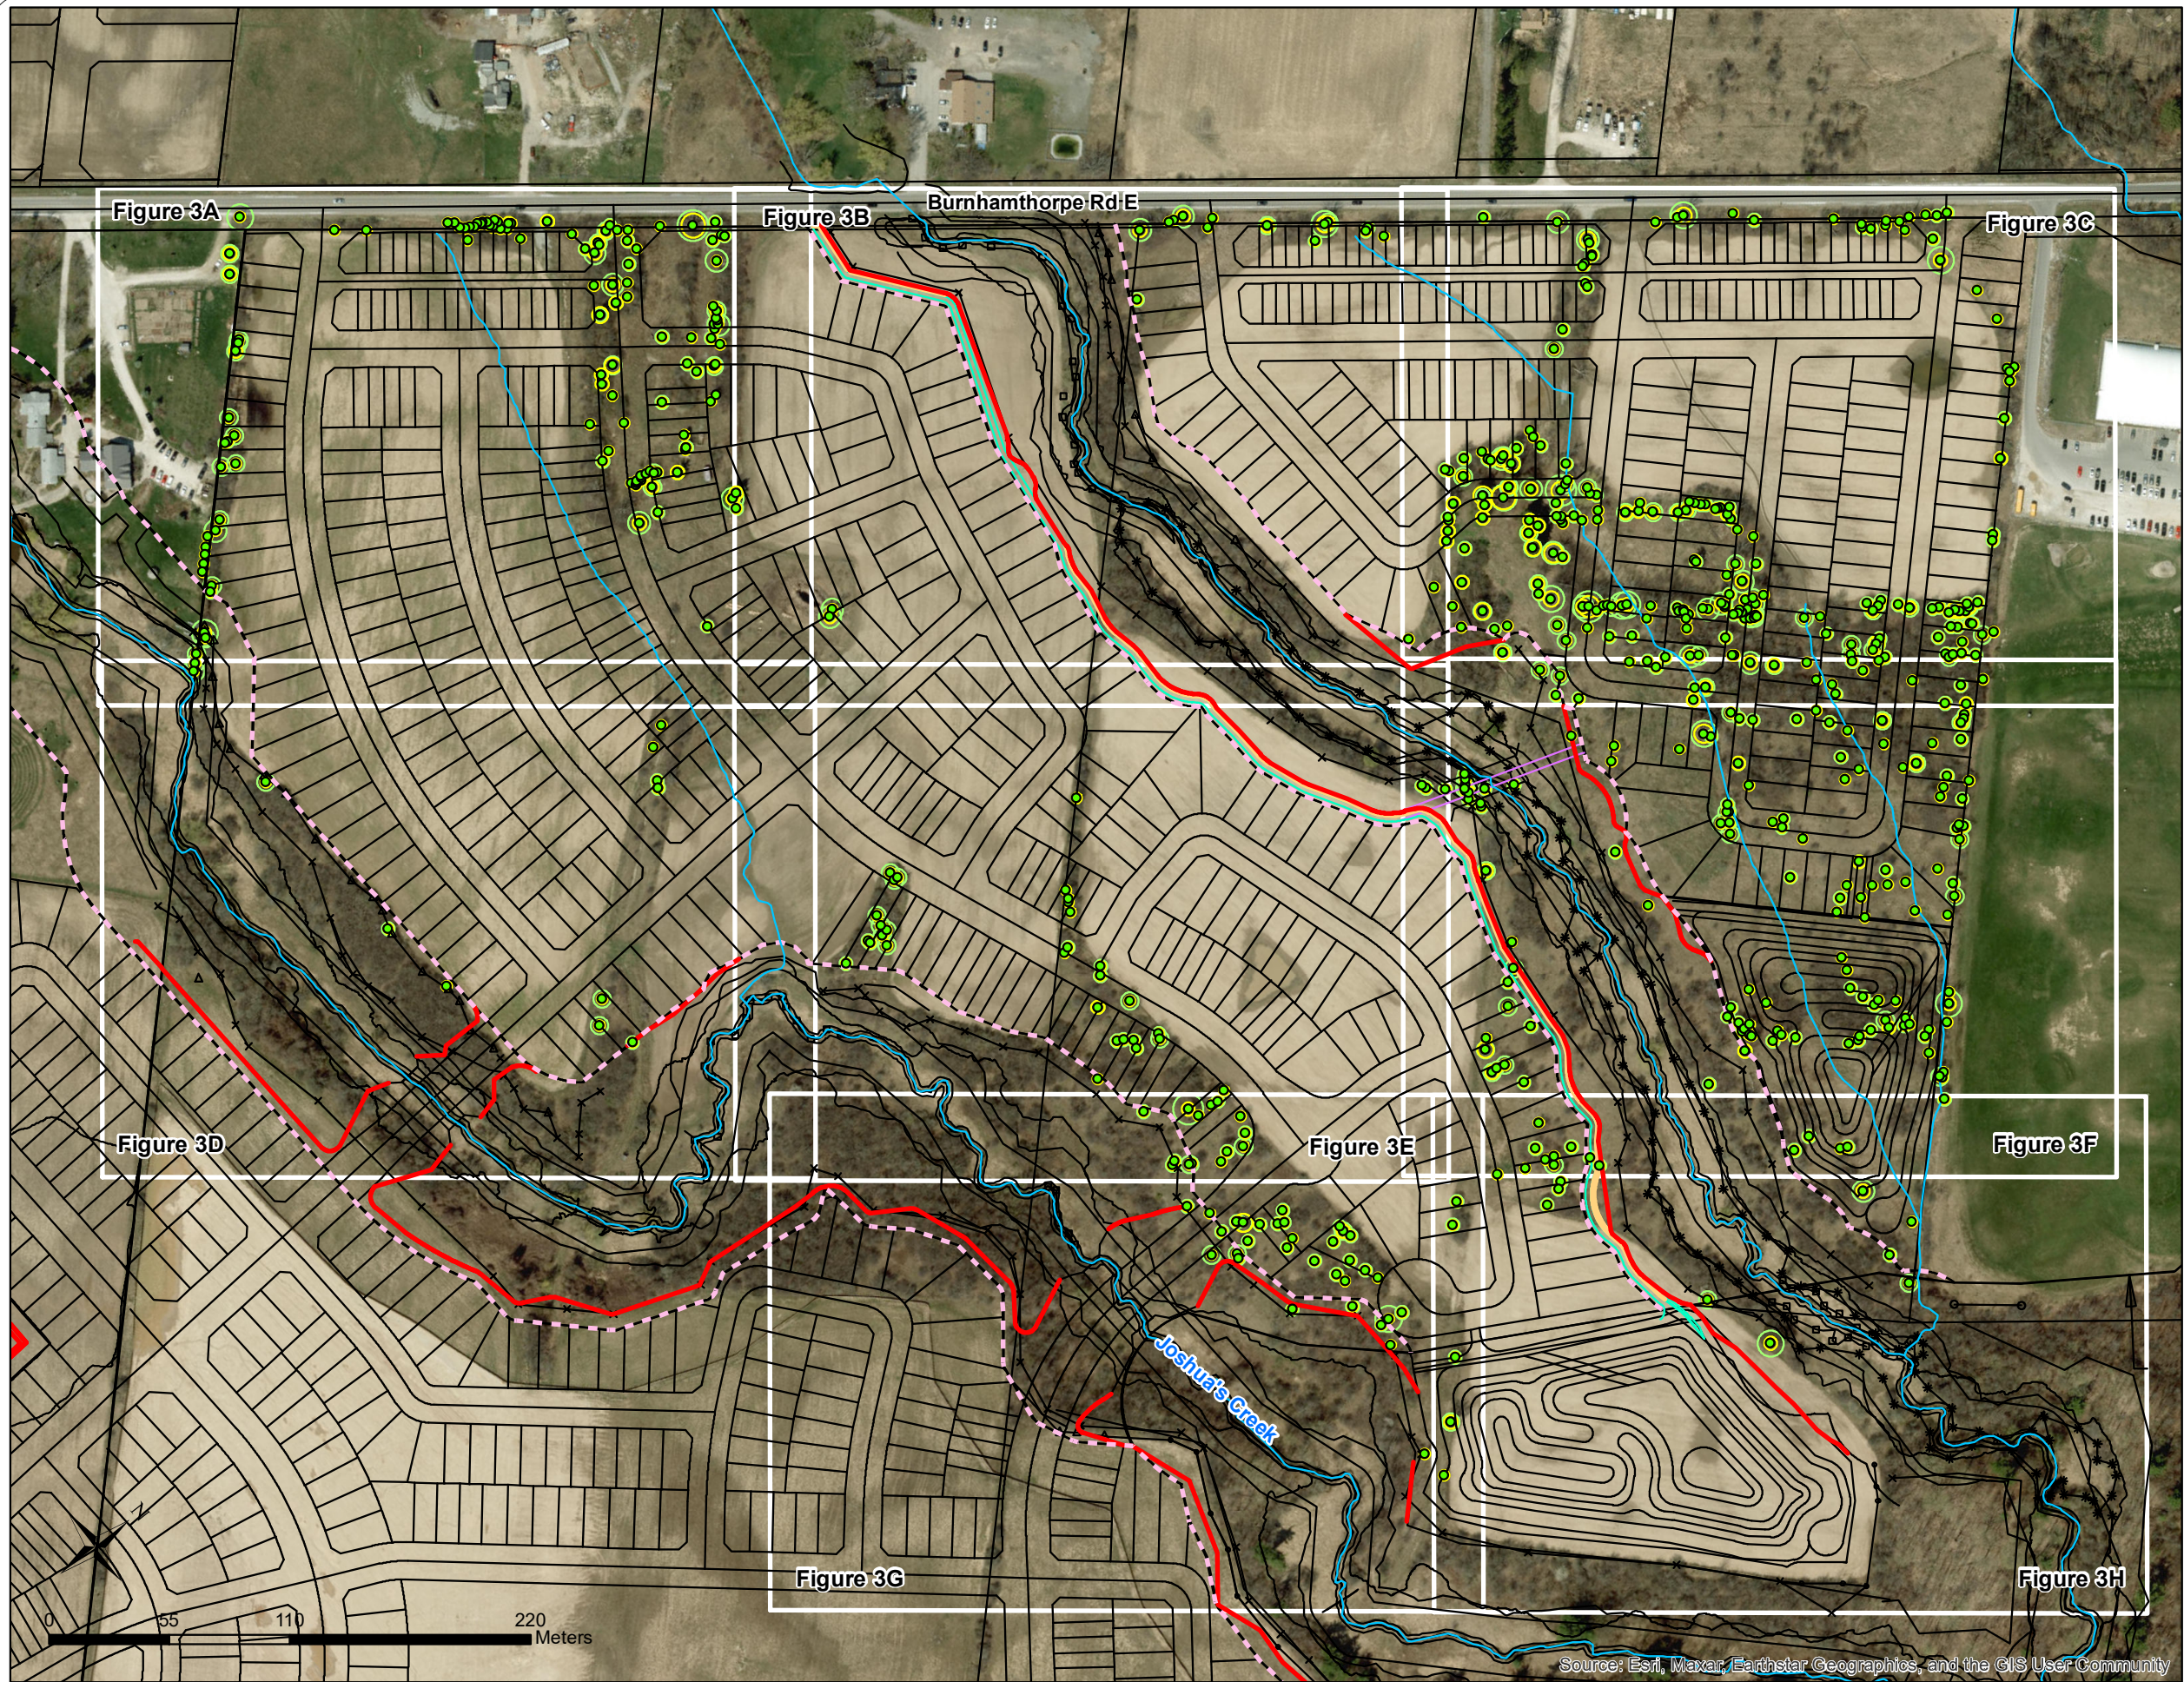
Project	TA9380	Figure	2
Date	March, 2024	Prepared By:	VLG
Scale	1:3,000	Verified By:	JPB

**Joshua's Creek North  
Tree Resources**

The Joshua's Creek North Lands include agricultural fields, hedgerows, and natural heritage system (NHS) Core 10. A total of 654 trees are included in the inventory. Thirty species have been inventoried (Table 1). Diameters of surveyed trees ranged from 10 to 90 centimetres. Refer to Figures 2-A to 2-H for tree locations and the Appendix A-Tree Inventory.

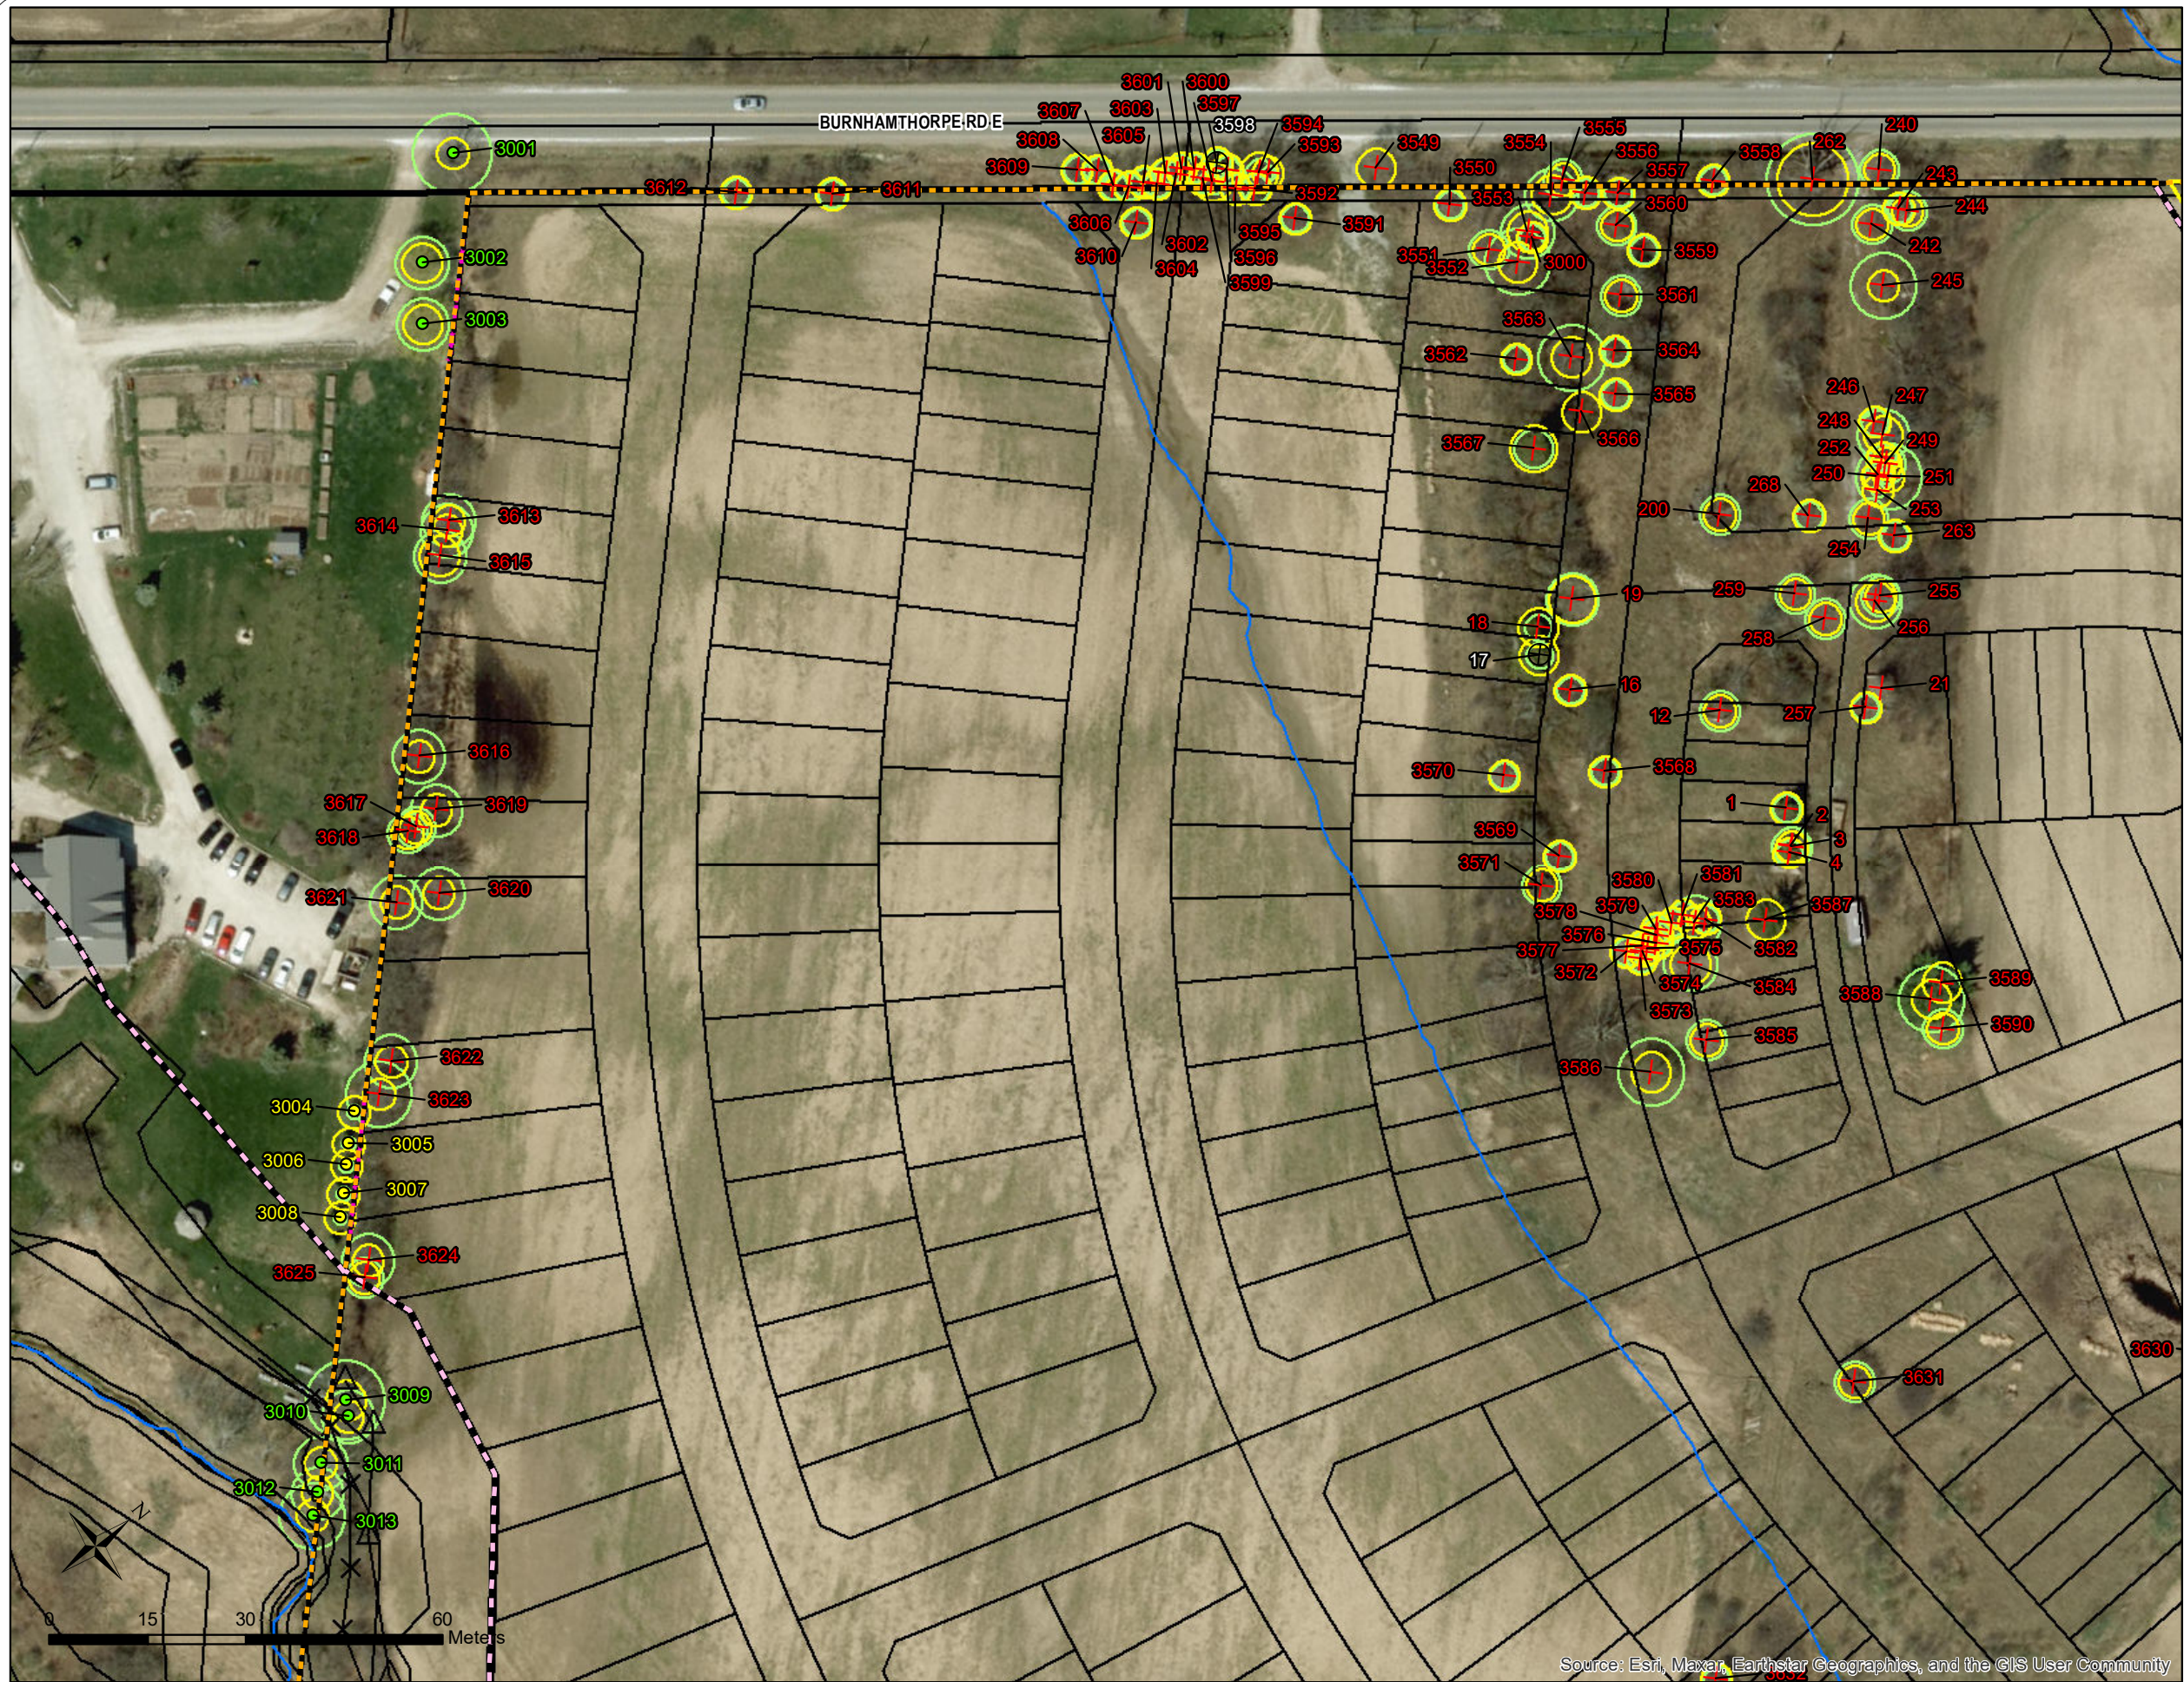
Project	TA9380	Figure	3-A
Date	September, 2024	Prepared By:	VLG
Scale	1:1,000	Verified By:	MJO

## Joshua's Creek North Tree Impacts

Approximately 30 trees are within the NHS adjacent to proposed stormwater pond outfalls. Since design details have not yet been finalized an impact assessment has been deferred. The determination of whether trees will be retained or removed in this areas will be dependent on the method of construction (open cut vs tunnelling). Therefore, these trees are illustrated with purple text/white halo on Figure 3 with unknown impacts.

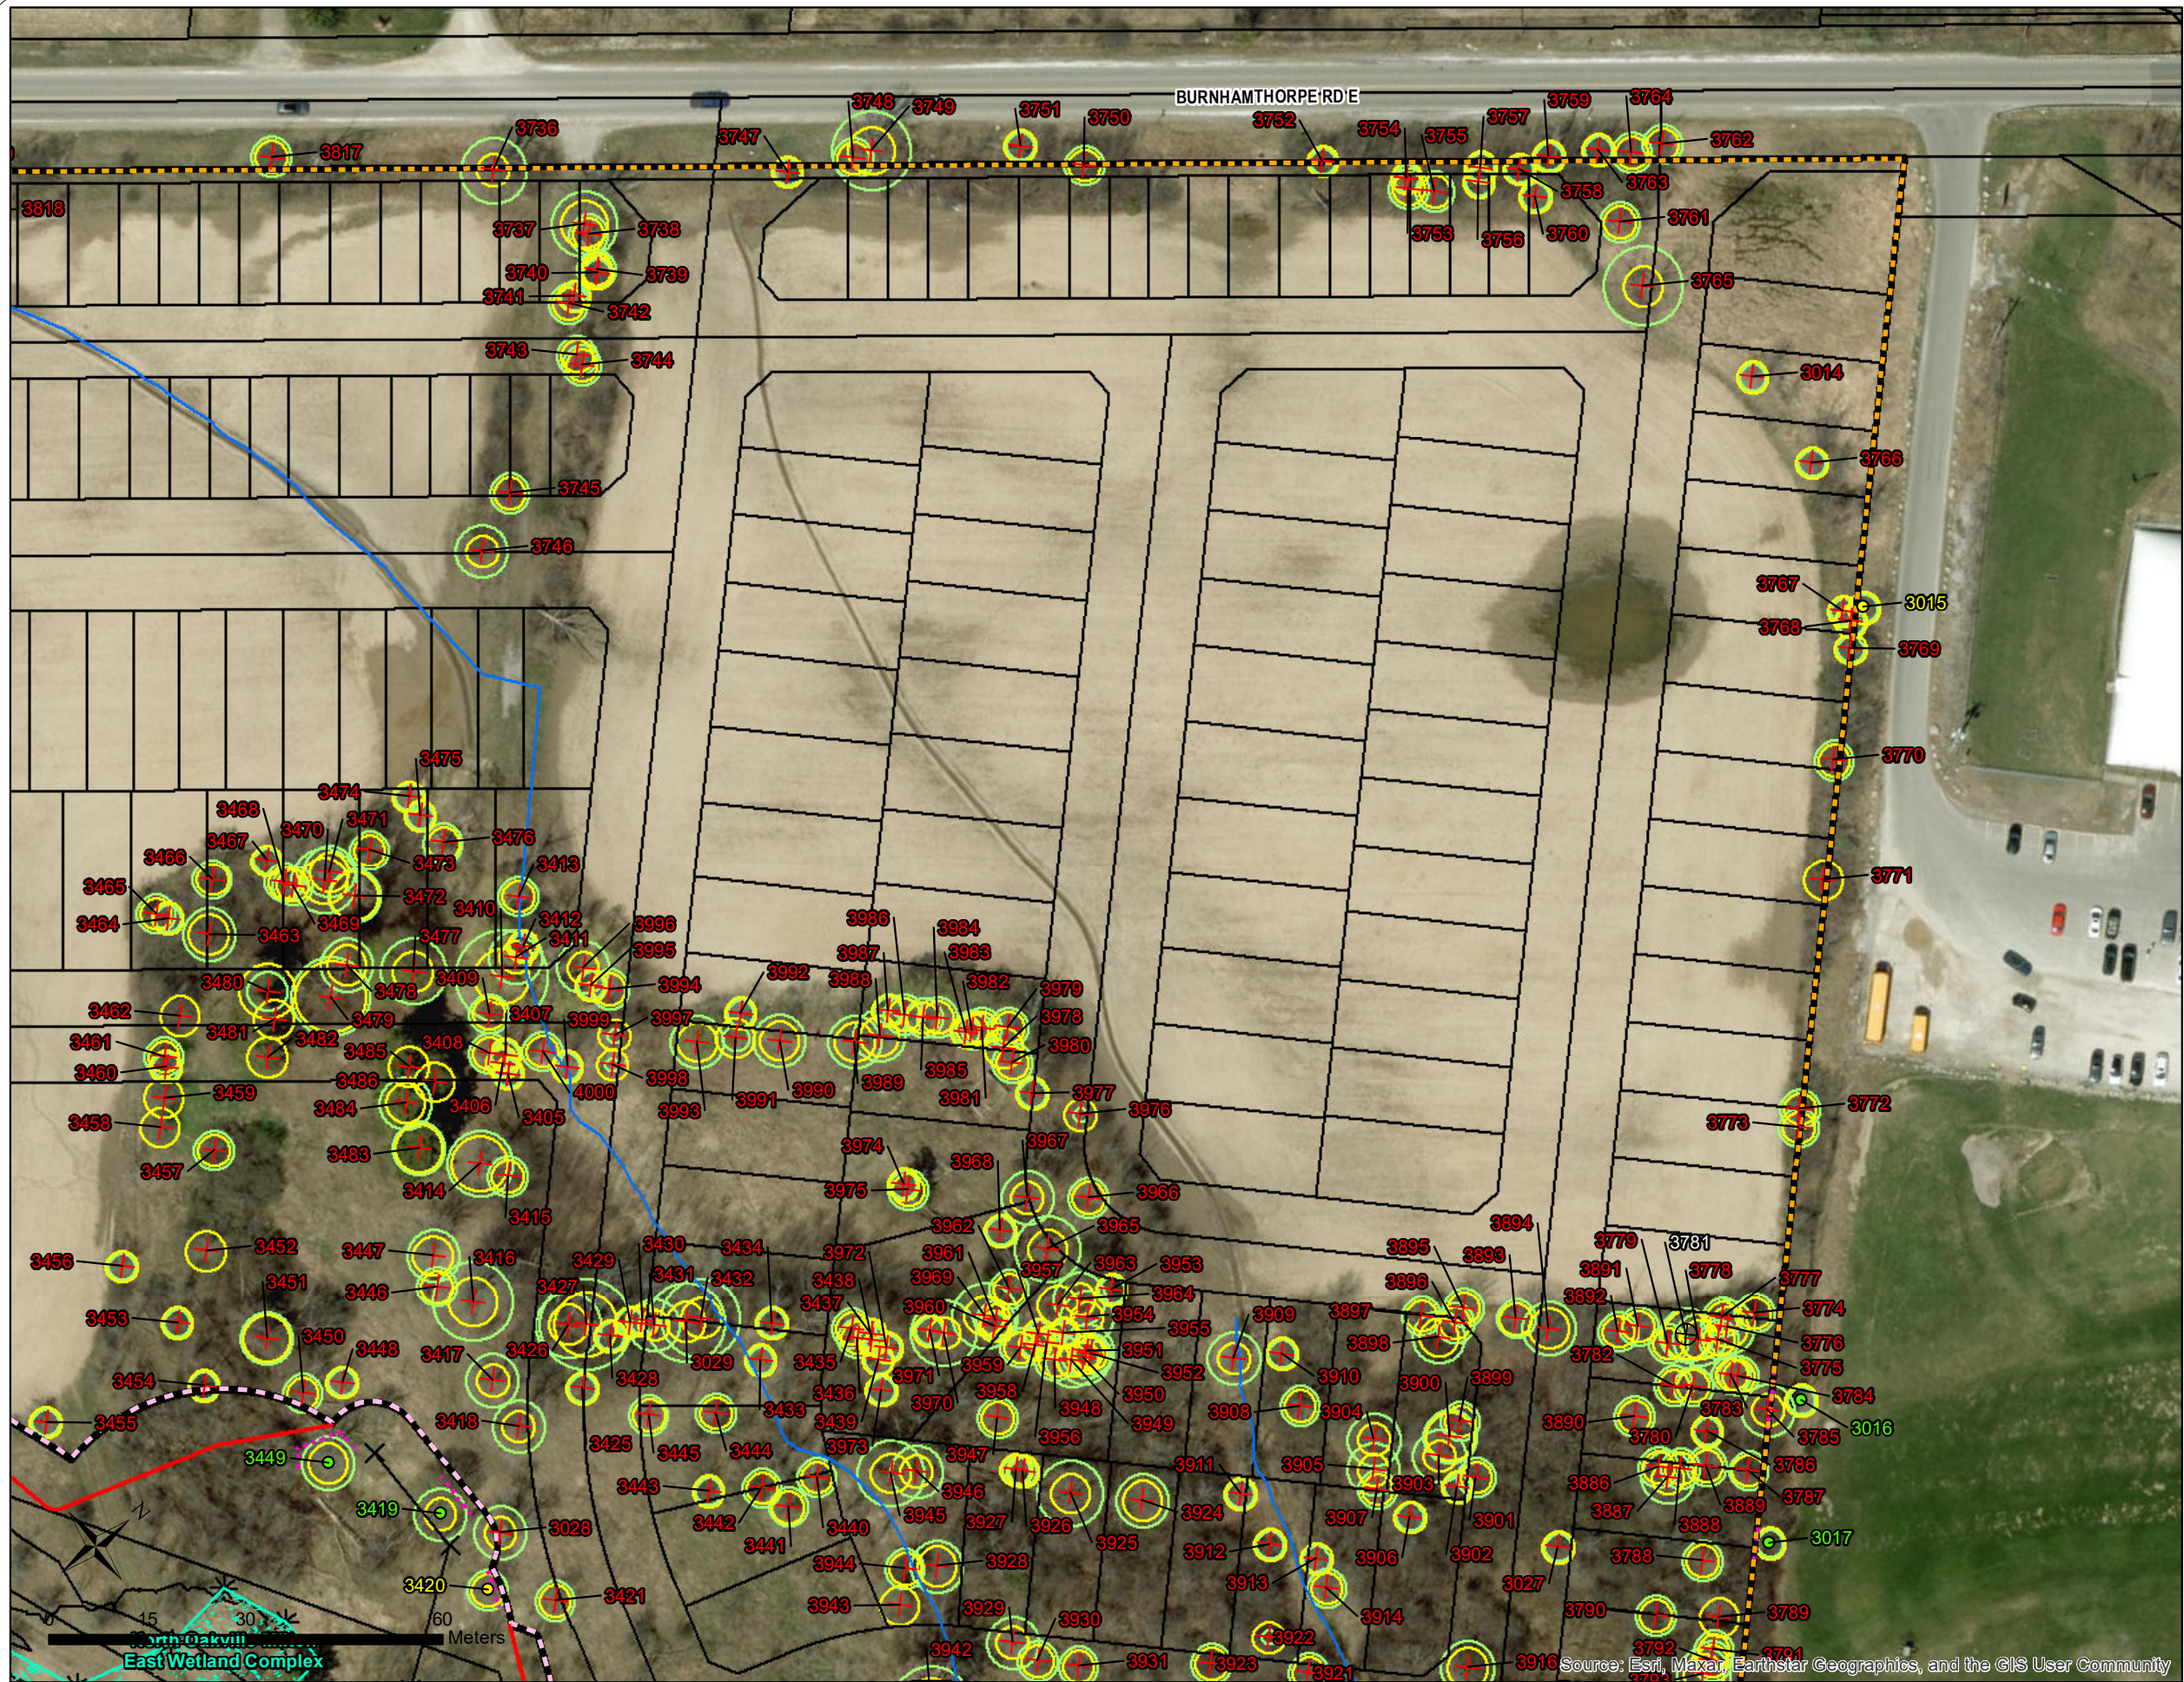
Project	TA9380	Figure	3-C
Date	September, 2024	Prepared By:	VLG
Scale	1:1,000	Verified By:	MJO

## Joshua's Creek North Tree Impacts

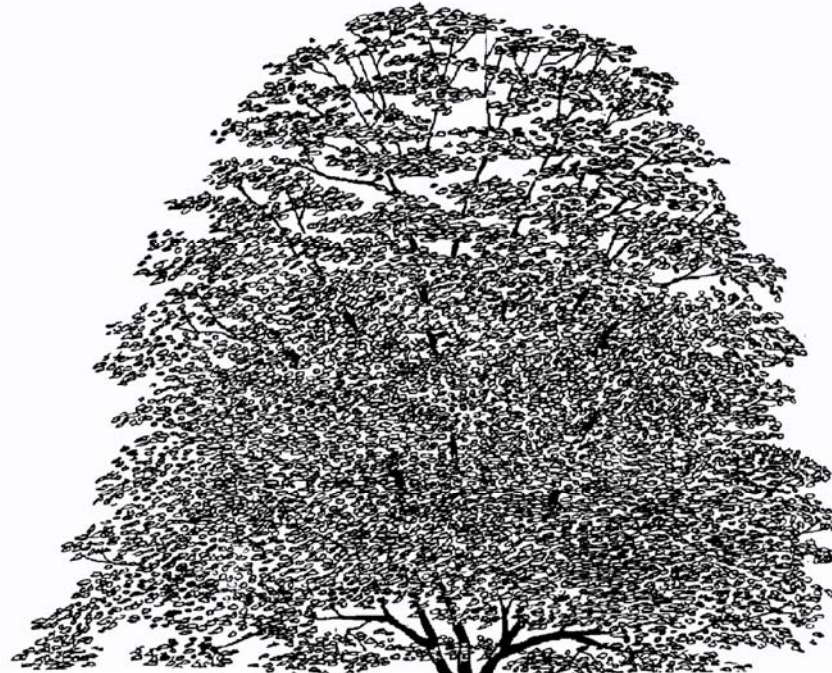
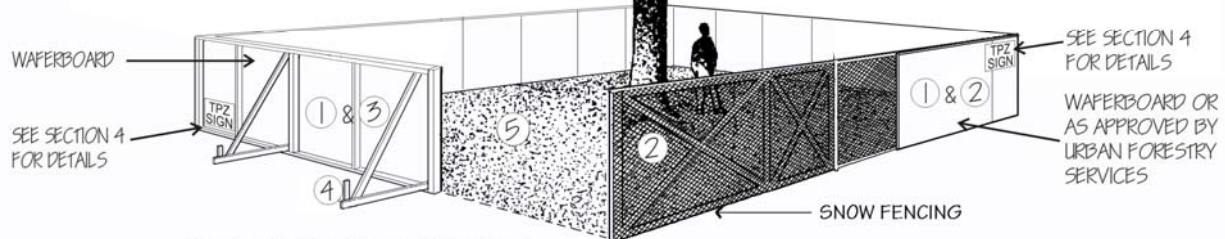
## SCHEDULE 1 TREE PROTECTION BARRIER

### Tree Protection Barriers

- ① Tree protection barriers must be 1.2m (4ft) high, waferboard hoarding or an equivalent approved by Urban Forestry Services.
- ② Tree protection barriers for trees situated on the Town road allowance where visibility must be maintained can be 1.2m (4ft.) high and consist of plastic web snow fencing on a wood frame made of 2"x 4"s .
- ③ Where some excavate or fill has to be temporarily located near a tree protection barrier, plywood must be used to ensure no material enters the Tree Protection Zone.
- ④ All supports and bracing should be outside the Tree Protection Zone. All such supports should minimize damaging roots outside the Tree Protection Barrier.
- ⑤ No construction activity, grade changes, surface treatment or excavations of any kind is permitted within the Tree Protection Zone.
