**PHASE I ENVIRONMENTAL SITE ASSESSMENT
AGRICULTURAL PROPERTY
237 DUNDAS STREET WEST
OAKVILLE, ONTARIO**

**MATTAMY DEVELOPMENT CORPORATION
2360 BRISTOL CIRCLE
OAKVILLE, ONTARIO
L6H 6M5**

December 11, 2007

TT73055

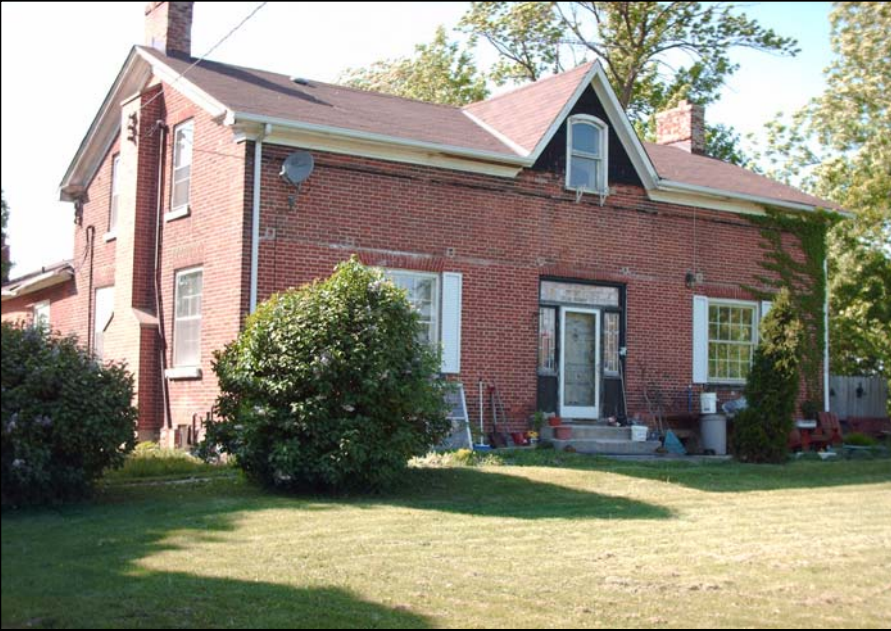
<table border="1"> <tr> <td data-bbox="1127 384 1380 443">PHOTOGRAPH</td> <td data-bbox="1380 384 1455 443">1</td> </tr> </table>	PHOTOGRAPH	1
PHOTOGRAPH	1		
<table border="1"> <thead> <tr> <th data-bbox="1127 472 1455 531">Description</th> </tr> </thead> <tbody> <tr> <td data-bbox="1127 531 1455 1010"> <p>On-Site residential dwelling.</p> </td> </tr> </tbody> </table>		Description	<p>On-Site residential dwelling.</p>
Description			
<p>On-Site residential dwelling.</p>

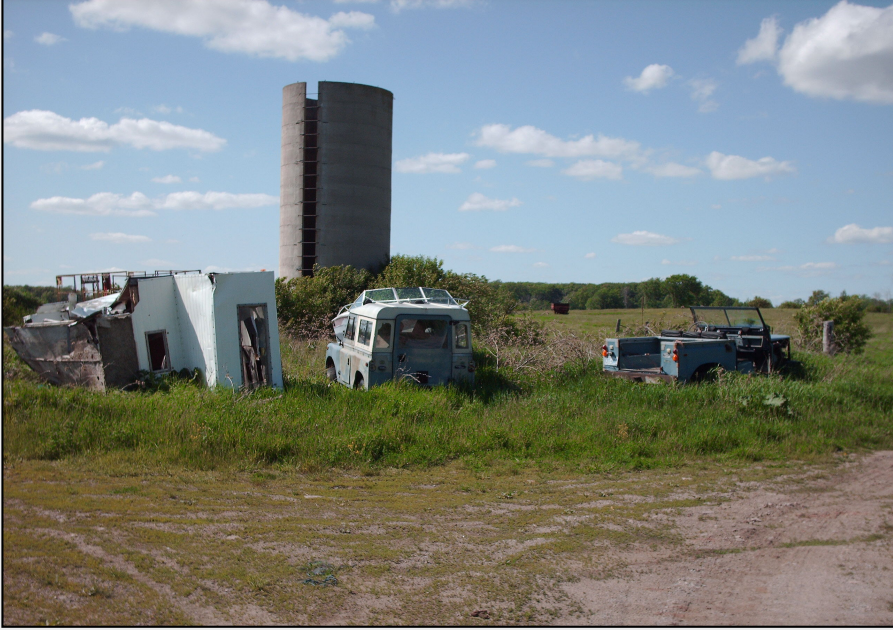
- AMEC observed various abandoned vehicles and farm equipment on Site; and

<table border="1"> <tr> <td>PHOTOGRAPH</td> <td>5</td> </tr> </table>	PHOTOGRAPH	5
	PHOTOGRAPH	5	
<table border="1"> <tr> <td>Description</td> </tr> <tr> <td>Abandoned vehicles near former structure.</td> </tr> </table>	Description	Abandoned vehicles near former structure.	
Description			
Abandoned vehicles near former structure.
