## **APPENDIX B**

### **SITE RECONNAISSANCE PHOTOGRAPHY**

**Coronation Park  
November 21, 2013**

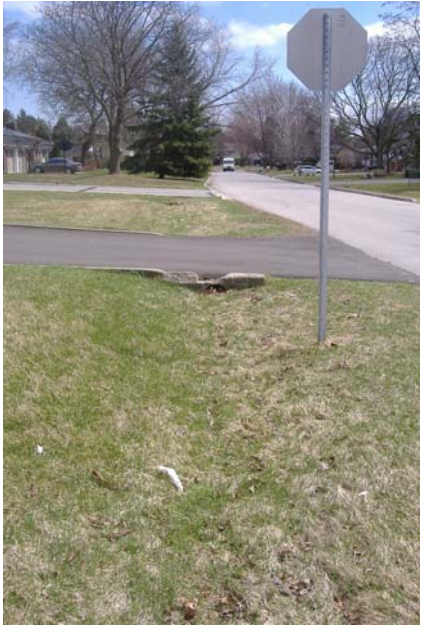
Photo 28: Looking south on Tracina at Hixon.  
Note filled ditch/culvert.

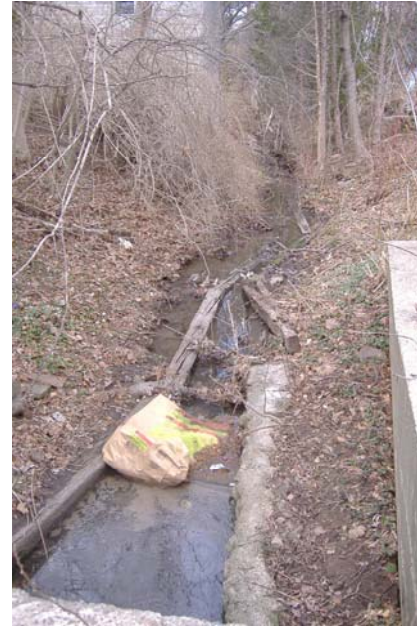
Photo 31: Looking downstream at storm sewer outfall at Willowdown Road. Note debris and minor erosion.

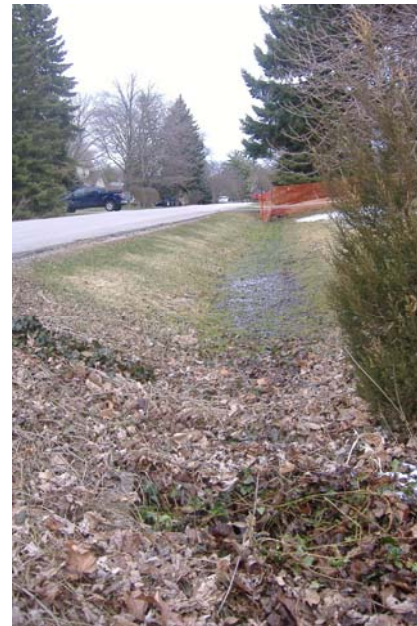
Photo 33: Looking south-east along west side of Willowdown Road. Note debris blockage of catchbasin & standing water further upstream.

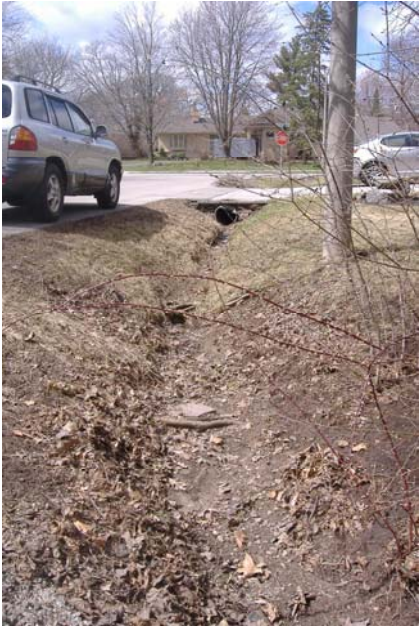
Photo 35: Looking upstream along Woodhaven Park Drive. Note channel erosion.

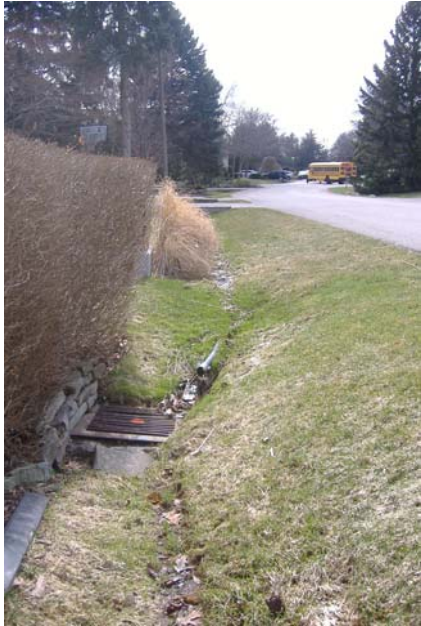
Photo 51: Looking west along Hixon Street at catchbasin manhole.

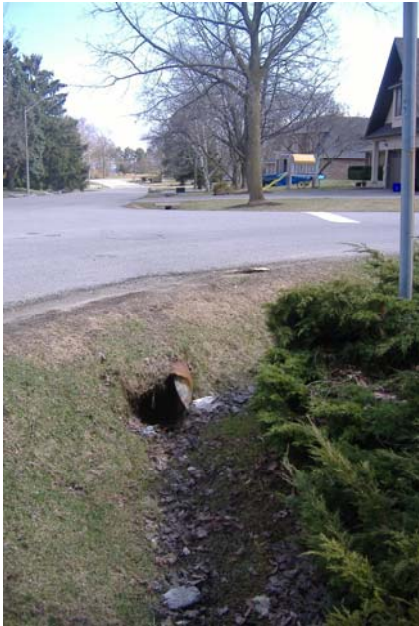
Photo 56: Looking downstream at partially crushed culvert at Selgrove Crescent and Woodhaven Park Drive.

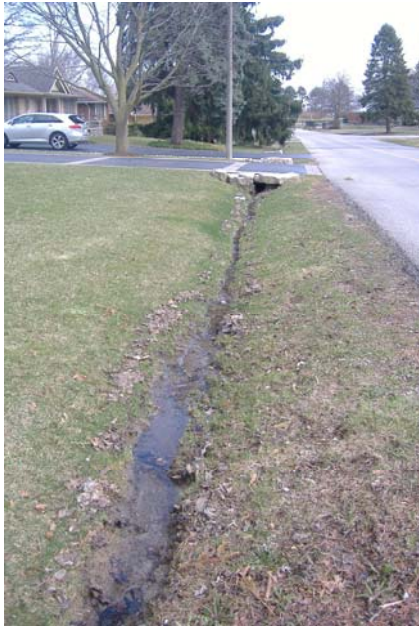
Photo 57: Looking south along east ditch of Woodhaven Park Drive.  
Note standing water and channel erosion/rutting.

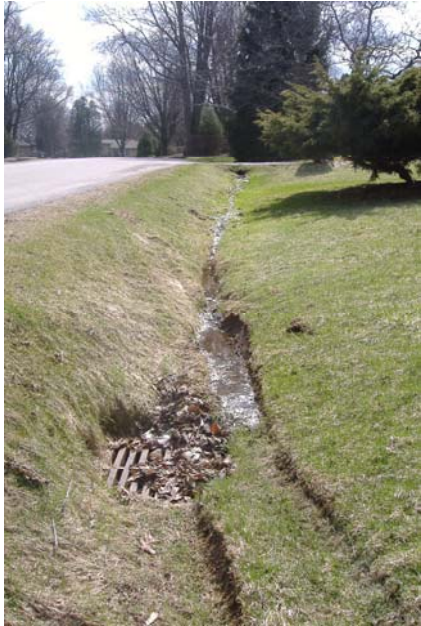
Photo 59: Looking west along Selgrove Crescent. Note tire tracks and significant erosion.

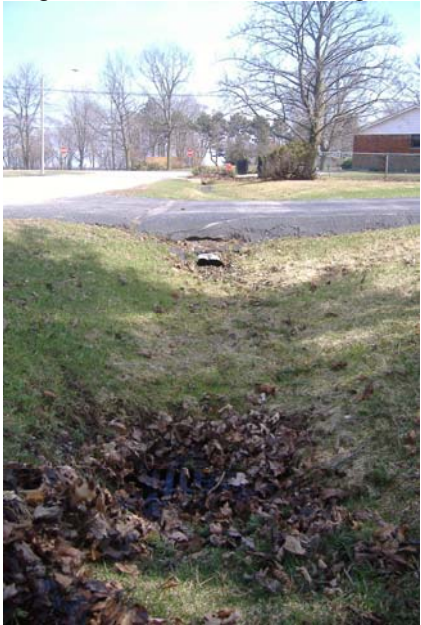
Photo 60: Looking south along west ditch of Woodhaven Park Drive. Note obstructed catchbasin and crushed culvert.

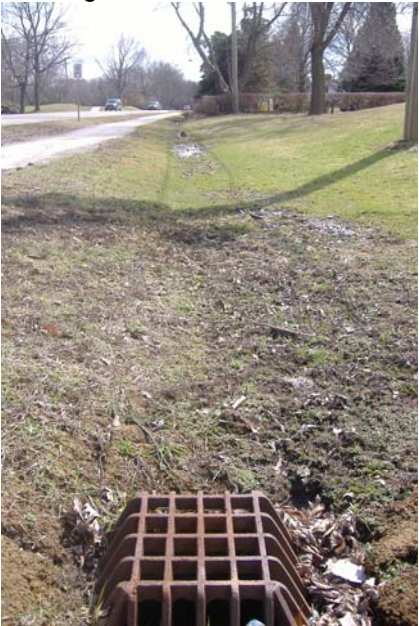
Photo 68: Looking west from catchbasin manhole along Lakeshore Road.

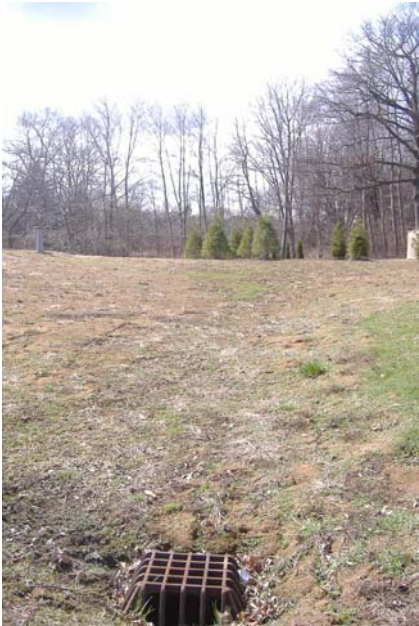
Photo 69: Looking north from catchbasin manhole onto WWTP site.

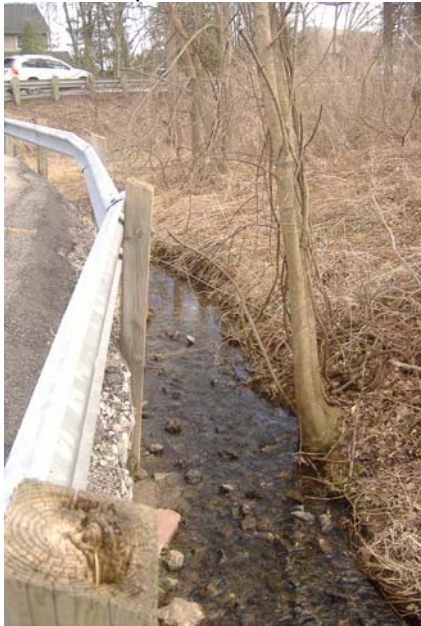
Photo 73: Looking downstream at channel from parking lot of  
Jehovah's Witness Hall. Note steep bank.

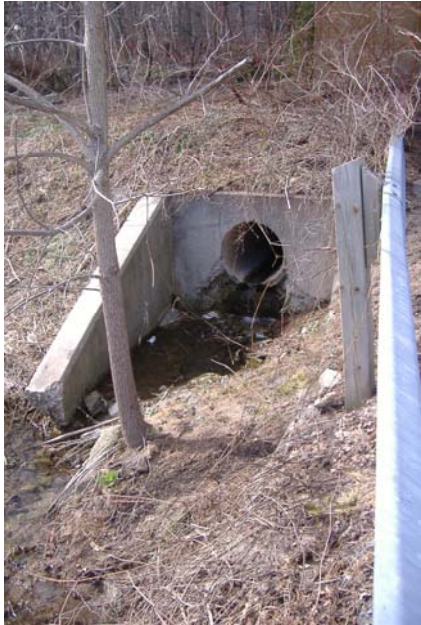
Photo 77: Storm sewer outfall adjacent to Lakeshore Road.

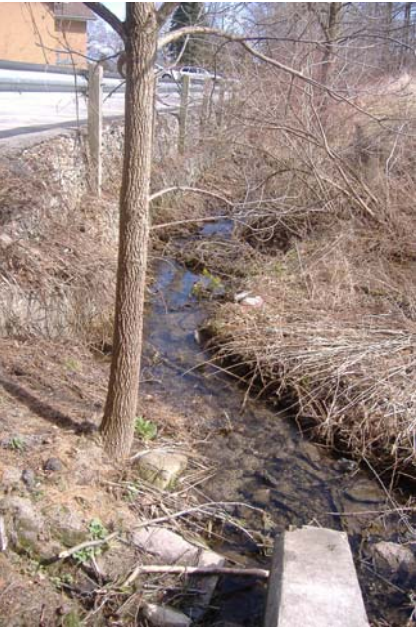
Photo 79: Looking downstream at open channel from storm sewer outfall at Lakeshore Road. Note bank erosion.

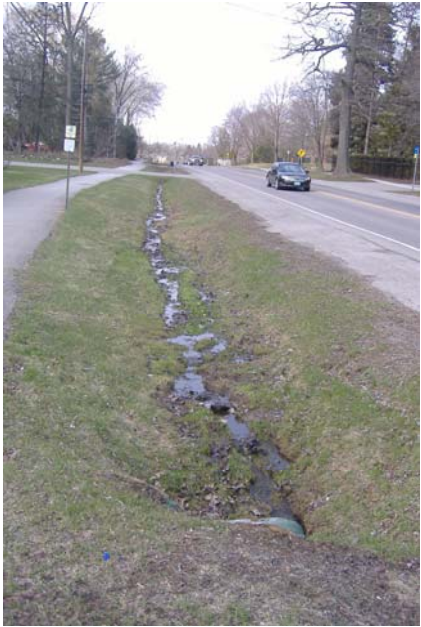
Photo 80: Looking east along north ditch of Lakeshore Road. Note standing water and erosion/rutting.

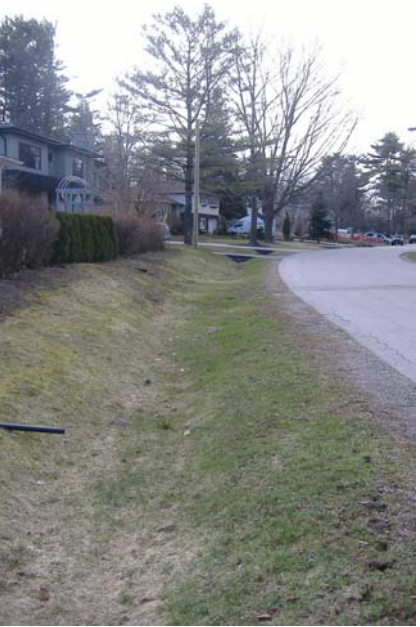
Photo 81: Looking along west ditch on Sandwell Drive.

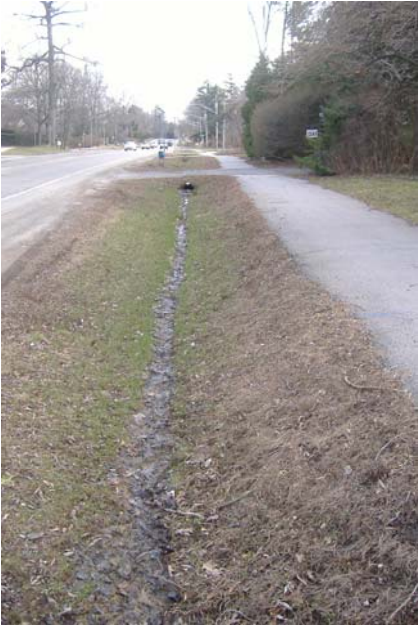
Photo 84: Looking west along north ditch of Lakeshore Road.  
Note standing water and erosion/rutting.
