**PHASE ONE - ENVIRONMENTAL
SITE ASSESSMENT**

**109, 113, 117, 121, 127, 131 Garden Drive
Oakville, Ontario**

Job No:
F199504014

Report Date:
May 10, 2024

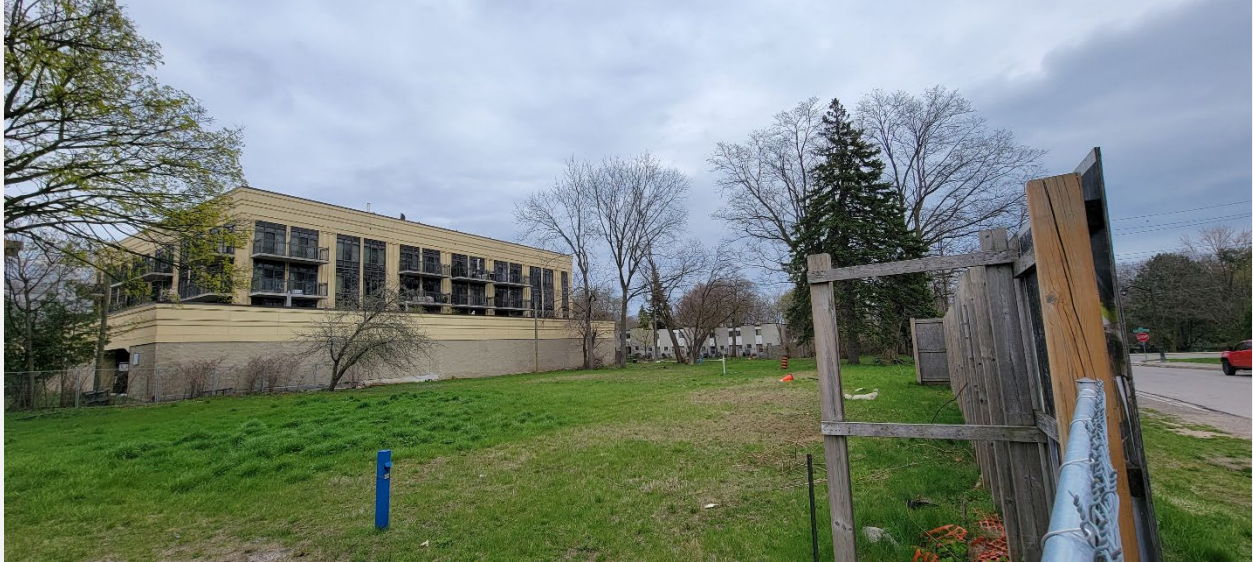
Exterior view of the site – monitoring wells identified from historical geotechnical investigations
