PHASE ONE
ENVIRONMENTAL SITE
ASSESSMENT

3064 Trafalgar Road, Oakville, Ontario

BIGC-ENV-397C

August 27, 2020

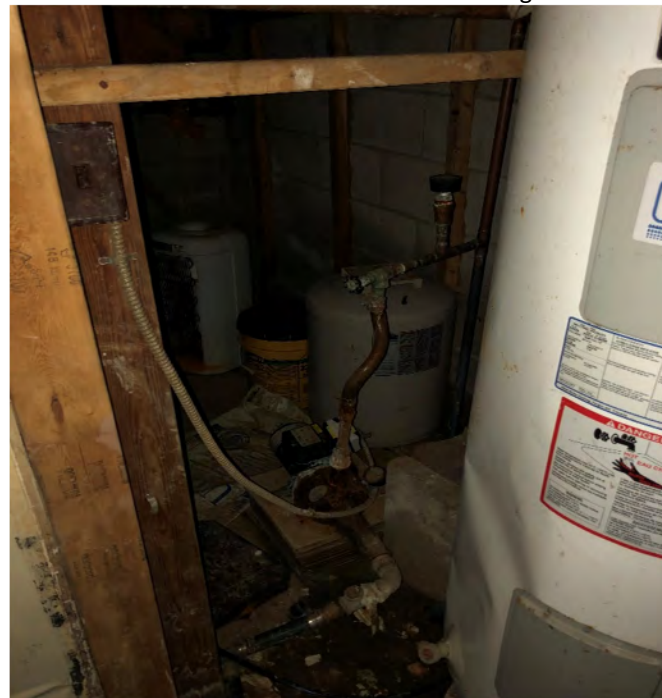
A sump pump was identified within the basement of the residential dwelling on-Site. As no hazardous materials, waste oils, tanks or potentially contaminating activities were identified within the residential dwelling, the sump pump is not considered a concern.

Photo 8: Sump Pump in the interior of the Site Building

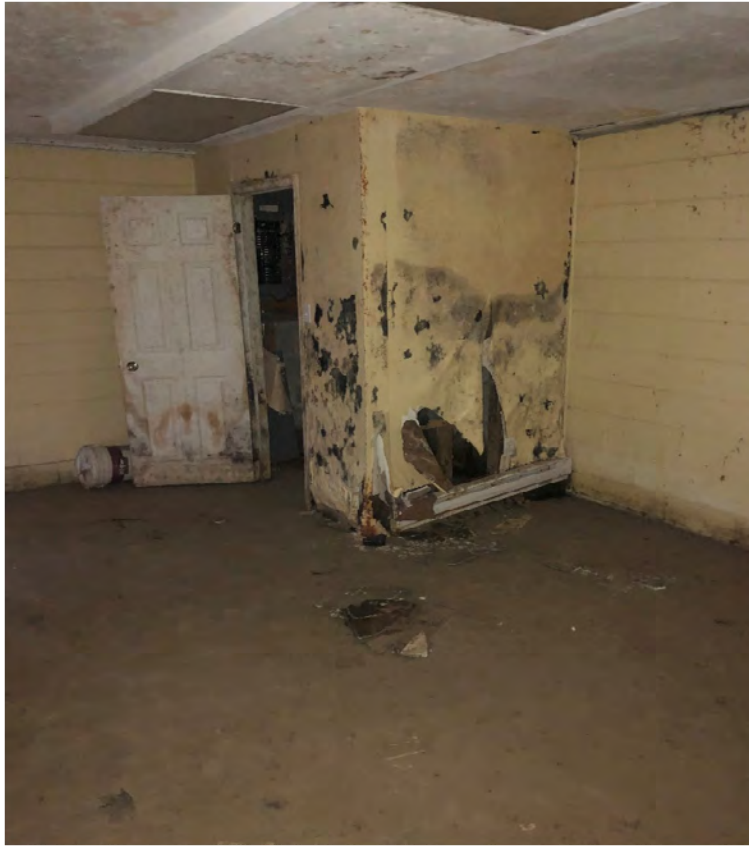
Chemical storage and household cleaning products were not observed at the Site. Floor conditions indicated presence of water damage and mould.

Photo 9: Interior Water Damage of Site Building
