## **APPENDIX B**

### **SITE RECONNAISSANCE PHOTOGRAPHY**

**Coronation Park  
November 21, 2013**

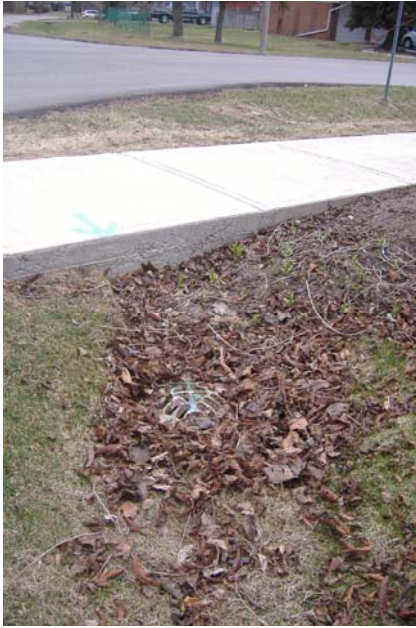
Photo 30: Beehive CB at north-west corner of Tracina/Hixon.  
Note debris blockage.
